NYC Department of Education
Building Condition Assessment Survey 2023 - 2024

Architectural Inspection

Asset: LONG ISLAND CITY HS (NEW) - Q, 14-30 BROADWAY, New York, 11101

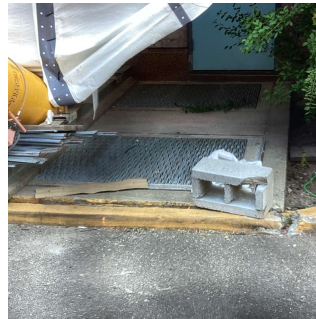
Facade E - AW1

AREAWAY WALLS: CRACKS AND SPALLING

REPAIR

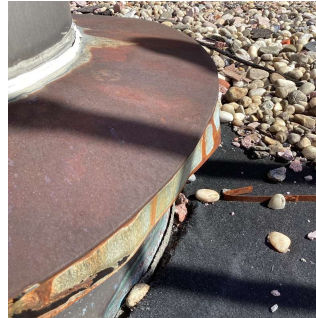
Roof 1 - Chimney 1

METAL: DENTS, MAJOR RUSTING

Deficiency Quantity	10
Quantity Uom	S.F.
Potential Action	REPLACE-UPGRADE
Urgency of Action	PRIORITY 4
Purpose of Action	LEVEL 2
Deficiency Photo1

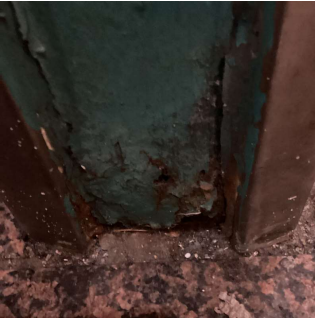
Deficiency METAL: DETERIORATED DOOR AND FRAME - MAJOR DETERIORATION

Deficiency Quantity	10
Quantity Uom	EACH
Potential Action	REPLACE
Urgency of Action	PRIORITY 4
Purpose of Action	LEVEL 2
Deficiency Photo1

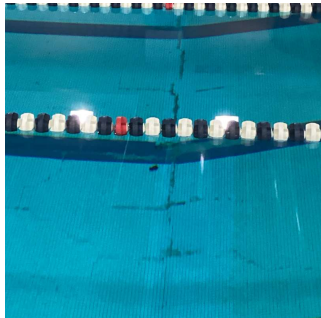
Violations	1st Floor No violations recorded.
DIVING BOARD/PLATFORM	
Instance on 1st Floor	Inspected
Condition	2 - Between Good and Fair
Deficiency	No deficiencies recorded
POOL LINING	
Instance on 1st Floor	Inspected
Condition	4 - Between Fair and Poor
Deficiency	TILE: BROKEN/MISSING/WORN TILES
Deficiency Location/Instance	1st Floor
Deficiency Quantity	100
Quantity Uom	S.F.
Potential Action	REPLACE
Urgency of Action	PRIORITY 4
Purpose of Action	LEVEL 2
Deficiency Photo1

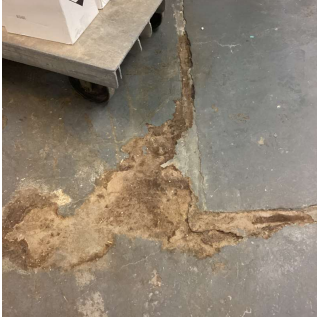
Question	Response
INTERIOR	
STRUCTURAL	
FLOOR STRUCTURE	
Urgency of Action	PRIORITY 3
Purpose of Action	LEVEL 5
Deficiency Photo1

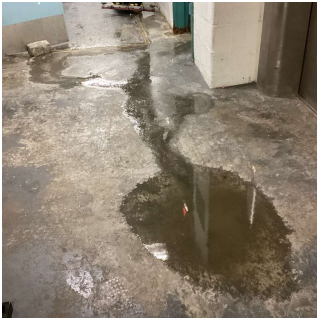
Basement - Corridor
Violations	No violations recorded.
Deficiency	CONCRETE SLAB ON GRADE: WATER INFILTRATION IN NON-INSTRUCTIONAL SPACE
Deficiency Location/Instance	Basement - near Freight Elevator and Staircase C, Fire Pump Room, Acid Tank Area, Pool Mechanical Equipment Room, Shop, Water Meter Room, Electrical Panel Room
Deficiency Quantity	700
Quantity Uom	S.F.
Potential Action	INSTALL WATERPROOFING
Urgency of Action	PRIORITY 5
Purpose of Action	LEVEL 5
Deficiency Photo1

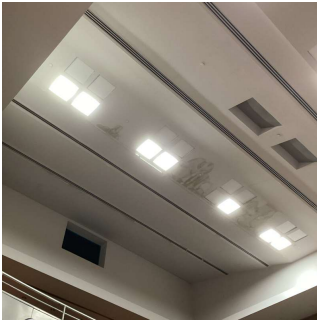
Question	Response
INTERIOR	
AUDITORIUM	
Ceiling	
Deficiency Photo1

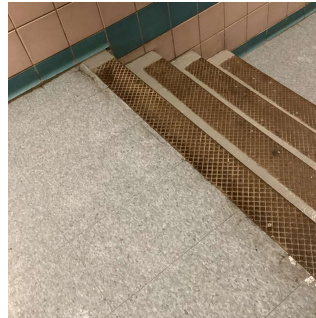
Lateral Entrance

VINYL TILES: BROKEN/DETERIORATED/MISSING TILES

REPLACE

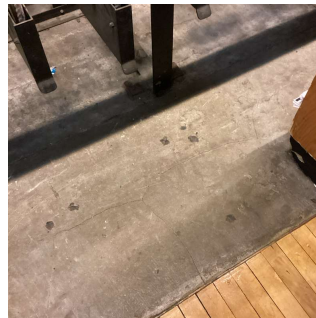
Near Lateral Right Side

CONCRETE: CRACKS

REPLACE

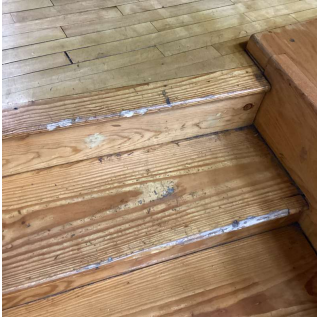
Question	Response
INTERIOR	
AUDITORIUM	
Sliding-folding Partition	
Instance on 1st Floor (605 Seats)	Does not Exist
Stage	
Instance on 1st Floor (605 Seats)	Inspected
Stage	Inspected
Instance on 1st Floor (605 Seats)	Inspected
Condition	3 - Fair
Deficiency	DAMAGED STEPS
Deficiency Location/Instance	Right Side
Deficiency Quantity	20
Quantity Uom	S.F.
Potential Action	REPLACE
Urgency of Action	PRIORITY 3
Purpose of Action	LEVEL 2
Deficiency Photo1

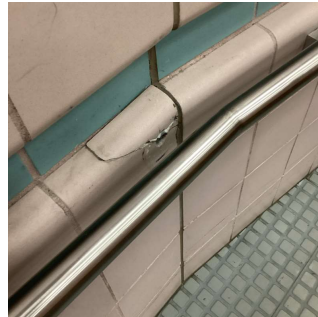
Near Seat L/28

Instance on 1st Floor (605 Seats)	Inspected
Condition	2 - Between Good and Fair
Deficiency	GLAZED BLOCK: CRACKS/SPALLING
Deficiency Location/Instance	Near Seats DD/32, L/28
Deficiency Quantity	10
Quantity Uom	S.F.
Potential Action	REPLACE
Urgency of Action	PRIORITY 3
Purpose of Action	LEVEL 2
Deficiency Photo1

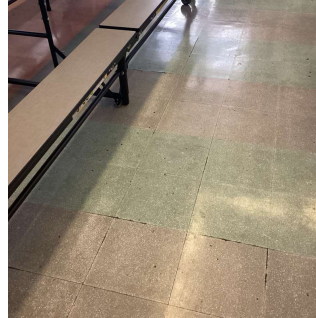
Near Windows

Deficiency	VINYL TILES: BROKEN/DETERIORATED/MISSING TILES
Deficiency Location/Instance	Near Windows, Serving Area
Deficiency Quantity	120
Quantity Uom	S.F.
Potential Action	REPLACE
Urgency of Action	PRIORITY 3
Purpose of Action	LEVEL 2
Deficiency Photo1

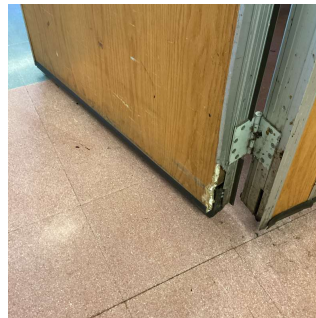
Near center

Deficiency	MOVABLE PANELS: DAMAGED
Deficiency Location/Instance	Near center, Windows
Deficiency Quantity	80
Quantity Uom	S.F.
Potential Action	REPLACE
Urgency of Action	PRIORITY 3
Purpose of Action	LEVEL 2
Deficiency Photo1

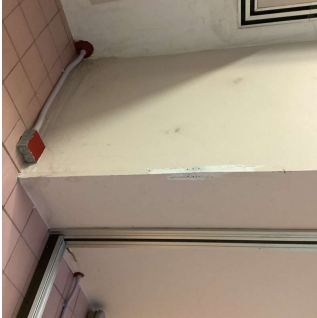
Instance on 6th Floor	Inspected
Condition	2 - Between Good and Fair
Deficiency	GYPSON BOARD: DETERIORATED
Deficiency Location/Instance	Near Serving Area
Deficiency Quantity	20

Question	Response
INTERIOR	
CAFETERIA	
Walls	
Quantity Uom	S.F.
Potential Action	REPLACE
Urgency of Action	PRIORITY 3
Purpose of Action	LEVEL 2
Deficiency Photo1

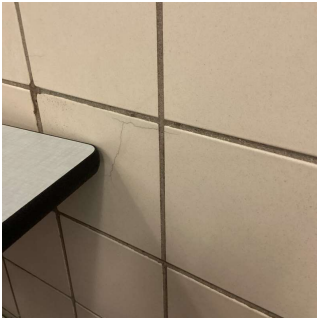
Near Serving Area
Violations	No violations recorded.
Deficiency	GLAZED BLOCK: CRACKS/SPALLING
Deficiency Location/Instance	Near Windows
Deficiency Quantity	10
Quantity Uom	S.F.
Potential Action	REPLACE
Urgency of Action	PRIORITY 3
Purpose of Action	LEVEL 2
Deficiency Photo1

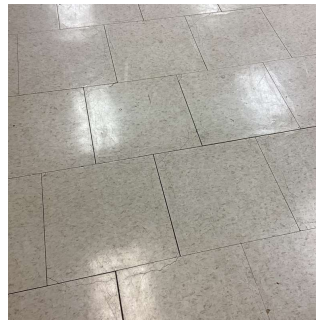
Room 274A

VINYL TILES: BROKEN/DETERIORATED/MISSING TILES

REPLACE

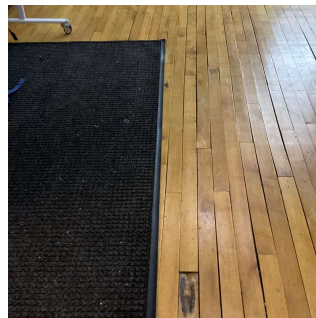
WOOD: DAMAGED/DETERIORATED

REPLACE

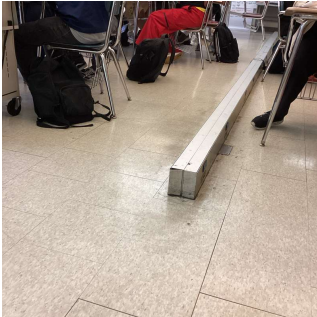
Question	Response
INTERIOR	
CLASSROOMS/CORRIDORS/ADMIN SPACES	
Floor Finish	
Violations	Room 294 No violations recorded.
Deficiency	VINYL TILES: TRIPPING HAZARD - ELECTRICAL OUTLET
Deficiency Location/Instance	Rooms 313, 380
Deficiency Quantity	100
Quantity Uom	S.F.
Potential Action	REMOVE
Urgency of Action	PRIORITY 5
Purpose of Action	LEVEL 6
Deficiency Photo1

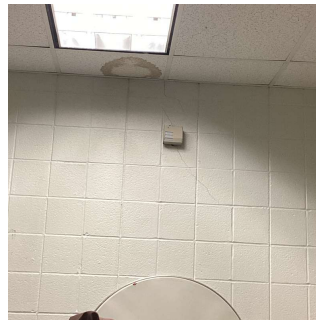
Room 189

MASONRY: CRACKS/SPALLING

REPLACE

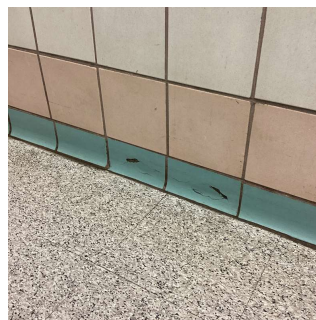
GLAZED BLOCK: CRACKS/SPALLING

REPLACE

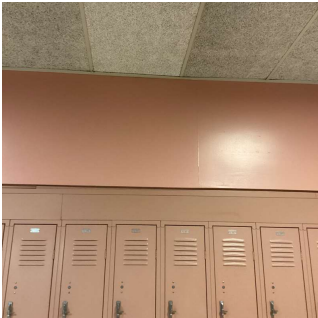
Question	Response
INTERIOR	
CLASSROOMS/CORRIDORS/ADMIN SPACES	
Walls	
Violations	Corridor near Room 382 No violations recorded.
Deficiency	GYP SUM BOARD: DETERIORATED
Deficiency Location/Instance	Corridor near Rooms 220, 274, 349, 369, 674, and others
Deficiency Quantity	200
Quantity Uom	S.F.
Potential Action	REPLACE
Urgency of Action	PRIORITY 3
Purpose of Action	LEVEL 2
Deficiency Photo1

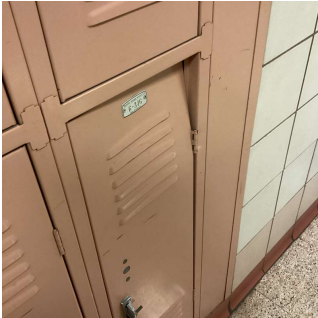
Violations	Corridor near Room 674 No violations recorded.
Specialties	Inspected
Classroom Locker(s)	Inspected
Condition	2 - Between Good and Fair
Deficiency	DAMAGED UNITS
Deficiency Location/Instance	Locker 6-130, 346
Deficiency Quantity	2
Quantity Uom	EACH
Potential Action	REPLACE
Urgency of Action	PRIORITY 3
Purpose of Action	LEVEL 2
Deficiency Photo1

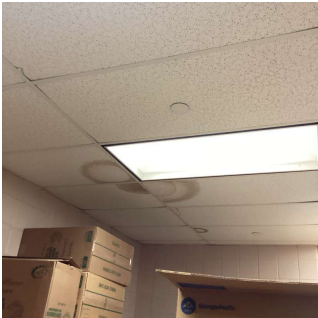
Question	Response
INTERIOR	
KITCHEN	
Ceiling	
Violations	Entrance room From Cafeteria Left Serving Area No violations recorded.
Deficiency	ACOUSTIC TILES: DAMAGED/MISSING
Deficiency Location/Instance	Rooms 647J, 647N, 647Q
Deficiency Quantity	120
Quantity Uom	S.F.
Potential Action	REPLACE
Urgency of Action	PRIORITY 3
Purpose of Action	LEVEL 2
Deficiency Photo1

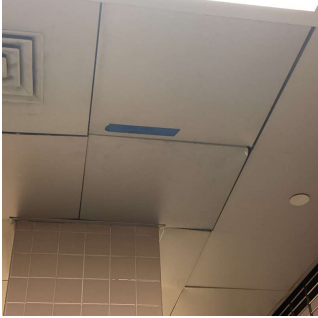
Violations	Room 647N No violations recorded.
Deficiency	METAL PAN: DAMAGED/MISSING
Deficiency Location/Instance	Serving Area Right and Left Side
Deficiency Quantity	30
Quantity Uom	S.F.
Potential Action	REPLACE
Urgency of Action	PRIORITY 3
Purpose of Action	LEVEL 2
Deficiency Photo1

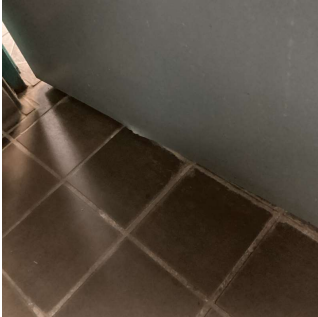
Front Serving Area
Violations	No violations recorded.

Violations	Serving Area Right Side No violations recorded.
Door(s)	
Instance on Sixth Floor	Inspected
Condition	3 - Fair
Deficiency	METAL: DETERIORATED DOOR
Deficiency Location/Instance	Front Serving Area
Deficiency Quantity	1
Quantity Uom	EACH
Potential Action	MAINTENANCE
Urgency of Action	PRIORITY 3

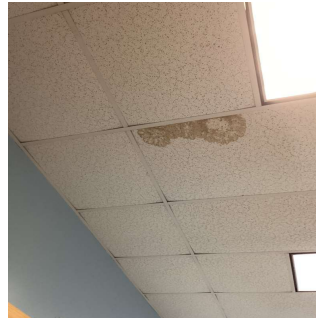
Room 446C

Deficiency	ACOUSTIC TILES: DAMAGED/MISSING
Deficiency Location/Instance	Rooms 446C, 446E, Near Entrance, Room 446D
Deficiency Quantity	60
Quantity Uom	S.F.
Potential Action	REPLACE
Urgency of Action	PRIORITY 3
Purpose of Action	LEVEL 2
Deficiency Photo1

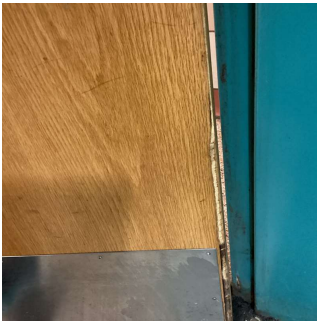
Instance on Room 446	Inspected
Condition	5 - Poor
Deficiency	WOOD: DETERIORATED DOOR
Deficiency Location/Instance	Entrances, Room 446E
Deficiency Quantity	3
Quantity Uom	EACH
Potential Action	MAINTENANCE
Urgency of Action	PRIORITY 3
Purpose of Action	LEVEL 2

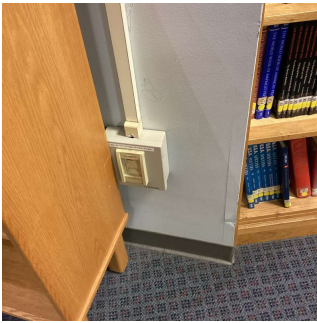
Violations	Entrance No violations recorded.
Floor Finish	
Instance on Room 446	Inspected
Condition	2 - Between Good and Fair
Deficiency	No deficiencies recorded
Walls	
Instance on Room 446	Inspected
Condition	2 - Between Good and Fair
Deficiency	GYPSON BOARD: DETERIORATED
Deficiency Location/Instance	Near Windows
Deficiency Quantity	20
Quantity Uom	S.F.
Potential Action	REPLACE
Urgency of Action	PRIORITY 3
Purpose of Action	LEVEL 2
Deficiency Photo1

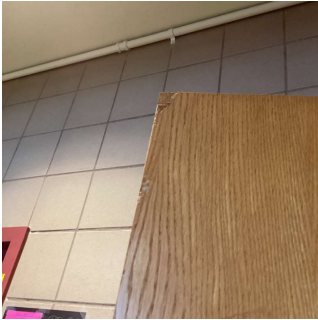
Question	Response
INTERIOR	
LOCKER ROOM	
Instance on 4th Floor - Boys (957 Lockers)	Inspected
Alternative use	Yes
Instance on 4th Floor - Girls (658 Lockers)	Inspected
Alternative use	Yes
Ceiling	
Instance on 2nd Floor - Boys (746 Lockers)	Does not Exist
Instance on 2nd Floor - Girls (776 Lockers)	Does not Exist
Instance on 2nd Floor - Visitors (76 Lockers - 500 SF)	Does not Exist
Instance on 4th Floor - Girls (658 Lockers)	Does not Exist
Instance on 4th Floor - Boys (957 Lockers)	Does not Exist
Instance on 1st Floor - Boys (70 Lockers)	Inspected
Condition	2 - Between Good and Fair
Deficiency	No deficiencies recorded
Instance on 1st Floor - Girls (70 Lockers)	Inspected
Condition	2 - Between Good and Fair
Deficiency	No deficiencies recorded
Door(s)	
Instance on 4th Floor - Girls (658 Lockers)	Inspected
Condition	3 - Fair
Deficiency	WOOD: DETERIORATED DOOR
Deficiency Location/Instance	Entrance
Deficiency Quantity	1

Quantity Uom	EACH
Potential Action	MAINTENANCE
Urgency of Action	PRIORITY 3
Purpose of Action	LEVEL 2
Deficiency Photo1

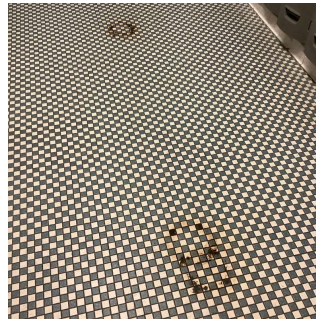
Instance on 1st Floor - Boys (70 Lockers)	Inspected
Condition	2 - Between Good and Fair
Deficiency	CERAMIC TILE: BROKEN/MISSING TILES
Deficiency Location/Instance	Near locker 132
Deficiency Quantity	10
Quantity Uom	S.F.
Potential Action	REPLACE
Urgency of Action	PRIORITY 3
Purpose of Action	LEVEL 2
Deficiency Photo1

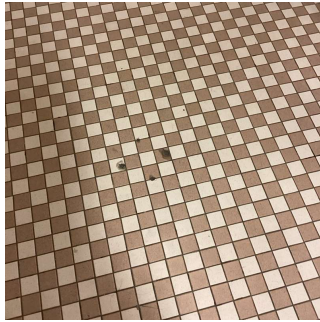
Violations	Near Locker 405 No violations recorded.
Instance on 4th Floor - Boys (957 Lockers)	Inspected
Condition	2 - Between Good and Fair
Deficiency	CERAMIC TILE: BROKEN/MISSING TILES
Deficiency Location/Instance	Near Lockers 154, 304, 322, 886
Deficiency Quantity	20
Quantity Uom	S.F.
Potential Action	REPLACE
Urgency of Action	PRIORITY 3
Purpose of Action	LEVEL 2
Deficiency Photo1

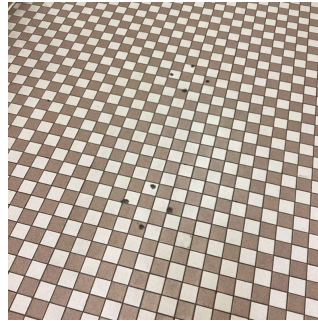
Near Locker 34

Violations	Near Locker 322 No violations recorded.
Instance on 4th Floor - Girls (658 Lockers)	Inspected
Condition	2 - Between Good and Fair
Deficiency	CERAMIC TILE: BROKEN/MISSING TILES
Deficiency Location/Instance	Near Lockers 34, 324, 704, 720, 879, and others
Deficiency Quantity	20
Quantity Uom	S.F.
Potential Action	REPLACE
Urgency of Action	PRIORITY 3
Purpose of Action	LEVEL 2

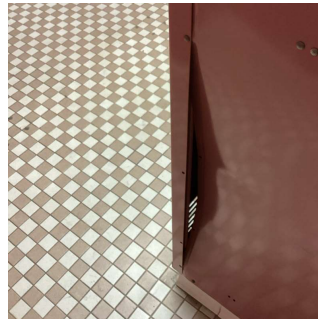
Lockers 89, 90

Instance on 2nd Floor - Visitors (76 Lockers - 500 SF)	Inspected
Condition	2 - Between Good and Fair
Deficiency	DAMAGED UNITS
Deficiency Location/Instance	Lockers 77, 89, 90, 103, 104
Deficiency Quantity	5
Quantity Uom	EACH
Potential Action	REPLACE
Urgency of Action	PRIORITY 3
Purpose of Action	LEVEL 2
Deficiency Photo1

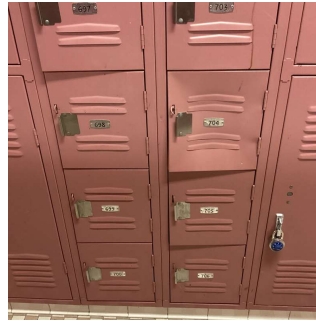
Locker 704

Instance on 4th Floor - Girls (658 Lockers)	Inspected
Condition	2 - Between Good and Fair
Deficiency	DAMAGED UNITS
Deficiency Location/Instance	Lockers 704, 705
Deficiency Quantity	2
Quantity Uom	EACH
Potential Action	REPLACE
Urgency of Action	PRIORITY 3
Purpose of Action	LEVEL 2

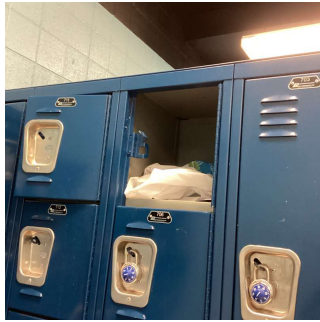
Locker 519
Violations	No violations recorded.
Instance on 2nd Floor - Boys (746 Lockers)	Inspected
Condition	2 - Between Good and Fair
Deficiency	DAMAGED UNITS
Deficiency Location/Instance	Lockers 420, 478, 705, 734
Deficiency Quantity	4
Quantity Uom	EACH
Potential Action	REPLACE
Urgency of Action	PRIORITY 3
Purpose of Action	LEVEL 2
Deficiency Photo1

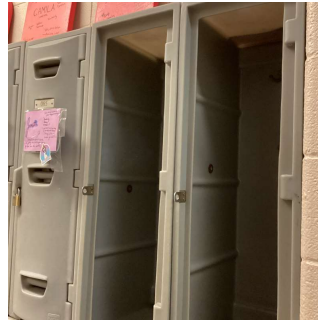
Locker 067

Locker 705
Violations	No violations recorded.
Instance on 1st Floor - Girls (70 Lockers)	Inspected
Condition	5 - Poor
Deficiency	DAMAGED UNITS
Deficiency Location/Instance	Lockers 042, 055, 061, 067, 069, and others
Deficiency Quantity	15
Quantity Uom	EACH
Potential Action	REPLACE
Urgency of Action	PRIORITY 3
Purpose of Action	LEVEL 2

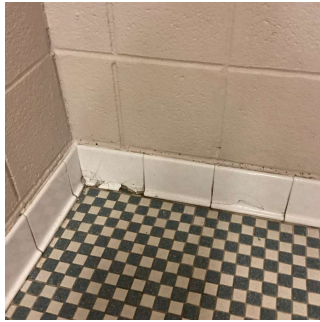
Near Shower Room
Violations	No violations recorded.
Instance on 1st Floor - Girls (70 Lockers)	Inspected
Condition	2 - Between Good and Fair
Deficiency	CERAMIC TILE: BROKEN/ MISSING
Deficiency Location/Instance	Near Entrance, Shower Room
Deficiency Quantity	20
Quantity Uom	S.F.
Potential Action	REPLACE
Urgency of Action	PRIORITY 3
Purpose of Action	LEVEL 2
Deficiency Photo1

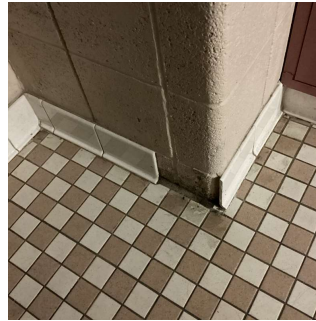
Near Entrance
Violations	No violations recorded.
Instance on 2nd Floor - Visitors (76 Lockers - 500 SF)	Inspected
Condition	2 - Between Good and Fair
Deficiency	CERAMIC TILE: BROKEN/ MISSING
Deficiency Location/Instance	Near Entrance
Deficiency Quantity	10
Quantity Uom	S.F.
Potential Action	REPLACE
Urgency of Action	PRIORITY 3
Purpose of Action	LEVEL 2

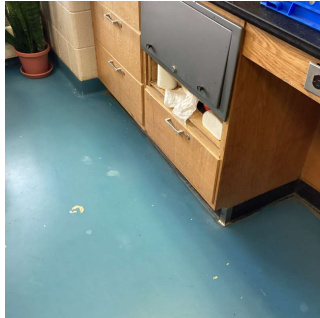
Room 684
Violations	No violations recorded.
SCIENCE PREP ROOM	
	Inspected
Instance on Room 674	Inspected
Alternative use	No
Instance on Room 602	Inspected
Alternative use	No
Fixed Equipment	
Instance on Room 674	Inspected
Condition	3 - Fair
Deficiency	CABINETS: MISSING/DAMAGED
Deficiency Location/Instance	Room 674
Deficiency Quantity	10
Quantity Uom	L.F.
Potential Action	REPLACE
Urgency of Action	PRIORITY 3
Purpose of Action	LEVEL 2
Deficiency Photo1

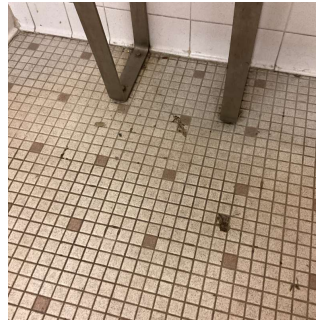
Condition	3 - Fair
Deficiency	CERAMIC TILE: BROKEN/MISSING TILES
Deficiency Location/Instance	Near Entrance
Deficiency Quantity	10
Quantity Uom	S.F.
Potential Action	REPLACE
Urgency of Action	PRIORITY 3
Purpose of Action	LEVEL 2

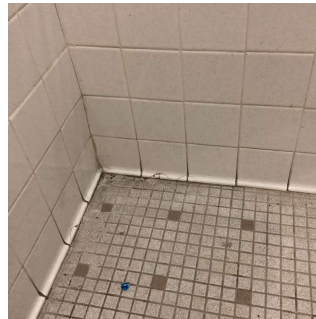
Instance on 2nd Floor - Boys	Inspected
Condition	2 - Between Good and Fair
Deficiency	CERAMIC TILE: BROKEN/ MISSING
Deficiency Location/Instance	Inside Multiple Shower Room
Deficiency Quantity	10
Quantity Uom	S.F.
Potential Action	REPLACE
Urgency of Action	PRIORITY 3
Purpose of Action	LEVEL 2
Deficiency Photo1

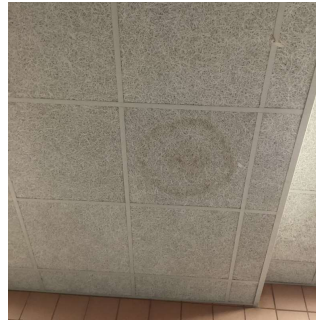
Condition	Inspected
	2 - Between Good and Fair
Deficiency	TECTUM: DAMAGED/MISSING
Deficiency Location/Instance	Stair F/1
Deficiency Quantity	10
Quantity Uom	S.F.
Potential Action	REPLACE
Urgency of Action	PRIORITY 3
Purpose of Action	LEVEL 2

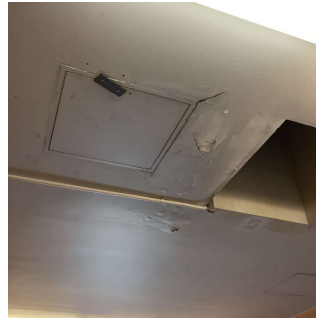
Stair A/6

GYPSUM BOARD: DAMAGED/DETERIORATED

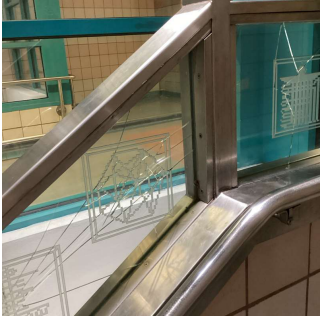
Question	Response
INTERIOR	
STAIRS/RAMPS: INTERIOR	
Door(s)	Inspected
	Stair E/2
Violations	No violations recorded.
Partition	Inspected
Condition	2 - Between Good and Fair
Deficiency	GLASS PANEL: DAMAGED/DETERIORATED
Deficiency Location/Instance	Main Entrance Stair
Deficiency Quantity	30
Quantity Uom	S.F.
Potential Action	REPLACE
Urgency of Action	PRIORITY 3
Purpose of Action	LEVEL 2
Deficiency Photo1

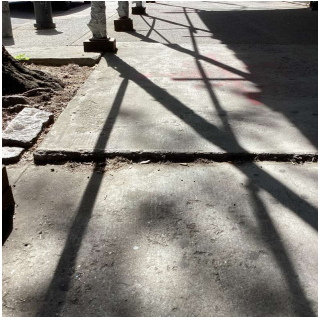
Question	Response
SITE	
PAVING	
Site Sidewalks & Walkways	Inspected
Concrete	Inspected
Violations	No violations recorded.
Pavers	Does not Exist
DOT Sidewalk	Inspected
Asphalt	Does not Exist
Concrete	Inspected
Condition	3 - Fair
Deficiency	HEAVING
Deficiency Location/Instance	Broadway avenue
Deficiency Quantity	50
Quantity Uom	S.F.
Potential Action	REPLACE
Urgency of Action	PRIORITY 5
Purpose of Action	LEVEL 6
Deficiency Photo1

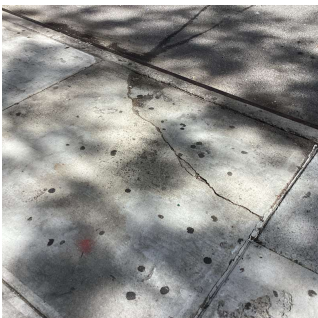
Violations	Broadway Avenue No violations recorded.
Deficiency	DAMAGED/DETERIORATED/MISSING SECTIONS
Deficiency Location/Instance	Broadway Avenue, 33rd Ave
Deficiency Quantity	250
Quantity Uom	S.F.
Potential Action	REPLACE
Urgency of Action	PRIORITY 3
Purpose of Action	LEVEL 2
Deficiency Photo1

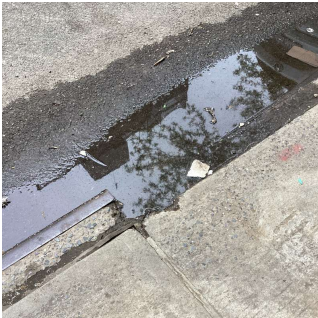
Violations	Broadway Avenue No violations recorded.
Deficiency	DAMAGED CURBS
Deficiency Location/Instance	Broadway Avenue
Deficiency Quantity	50

Question	Response
SITE	
PAVING	
DOT Sidewalk	Inspected
Concrete	
Quantity Uom	L.F.
Potential Action	REPLACE
Urgency of Action	PRIORITY 3
Purpose of Action	LEVEL 2
Deficiency Photo1

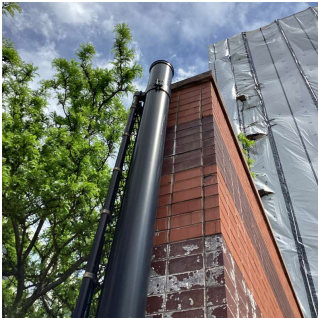
Question	Response
SITE	
SITE WALLS (NOT RETAINING WALLS)	
Deficiency Location/Instance	Containerization Area
Deficiency Quantity	10
Quantity Uom	S.F.
Potential Action	REPLACE
Urgency of Action	PRIORITY 3
Purpose of Action	LEVEL 2
Deficiency Photo1
