NYC Department of Education
Building Condition Assessment Survey 2023 - 2024

Architectural Inspection

Q453

Asset: LONG ISLAND CITY AF - QUEENS, 14-30 BROADWAY, New York, 11106

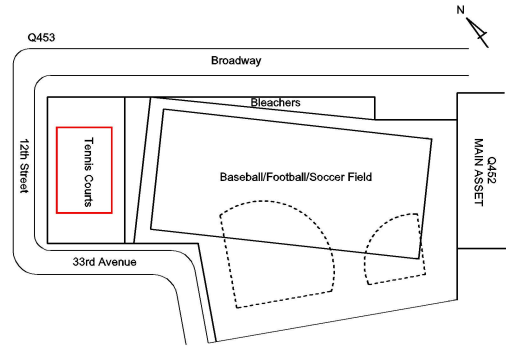
Roof Plan reference

Question	Response
Architectural	
EXTERIOR	Does not Exist
INTERIOR	Does not Exist
ATHLETIC FIELDS	Inspected
PLAYING SURFACE	Inspected
Synthetic Turf Field exists?	Yes
Year of Installation	2013
Replacement Quantity	129,000
Replacement Uom	S.F.
Instance on Football/Baseball/Soccer Field	Inspected
Instance Condition	2 - Between Good and Fair
Instance Quantity	105,000
Instance Quantity Uom	S.F.
Deficiency	No deficiencies recorded
Instance on Tennis Courts	Inspected
Instance Condition	3 - Fair
Instance Quantity	24,000
Instance Quantity Uom	S.F.
Deficiency	ASPHALT: DAMAGED/DETERIORATED
Deficiency Location/Instance	Tennis Courts

300
S.F.
REPAIR
PRIORITY 3
LEVEL 2
