**NYC Department of Education**  
**Building Condition Assessment Survey 2023 - 2024**

Architectural Inspection

Q454

**Asset:**        **PRE-K CENTER @ 123-07 22ND AVENUE - QUEENS, 123-07 22ND AVENUE, New York, 11356**

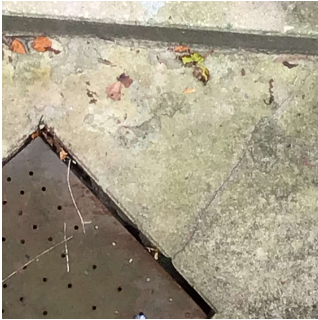
Question	Response
<b>Architectural</b>	
<b>EXTERIOR</b>	Inspected
<b>AREAWAY</b>	Inspected
Instance on AW1 - AW6	Inspected
Instance Condition	3 - Fair
Instance Quantity	6
Instance Quantity Uom	EACH
Deficiency	AREAWAY SLAB: CRACKS AND SPALLING
Roof Plan reference	
Deficiency Quantity	10
Quantity Uom	S.F.
Potential Action	REPLACE
Urgency of Action	PRIORITY 4
Purpose of Action	LEVEL 2

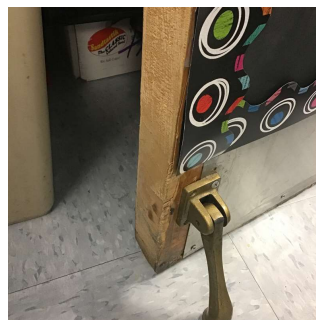
WOOD: DETERIORATED DOOR

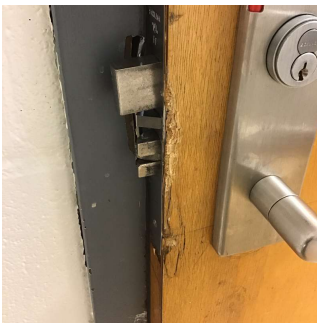
Question	Response
<b>INTERIOR</b>	
<b>TOILET ROOMS - STAFF</b>	
<b>Door(s)</b>	
Deficiency Photo1

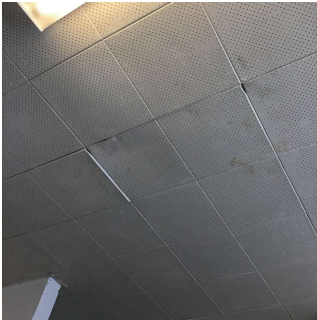
Room 204
Violations	No violations recorded.
<b>Floor Finish</b>	Inspected
Condition	2 - Between Good and Fair
Deficiency	No deficiencies recorded
<b>Stalls</b>	Does not Exist
<b>Walls</b>	Inspected
Condition	2 - Between Good and Fair
Deficiency	No deficiencies recorded
<b>TOILET ROOMS - STUDENTS</b>	Inspected
<b>Ceiling</b>	Inspected
Condition	2 - Between Good and Fair
Deficiency	METAL PAN: DAMAGED/MISSING
Deficiency Location/Instance	Rooms 202, 302
Deficiency Quantity	10
Quantity Uom	S.F.
Potential Action	REPLACE
Urgency of Action	PRIORITY 3
Purpose of Action	LEVEL 2
Deficiency Photo1

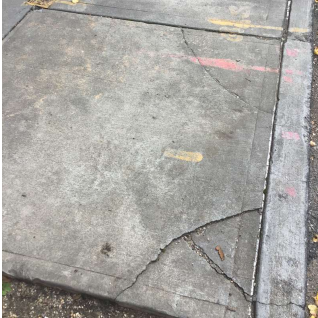
Question	Response
<b>SITE</b>	
<b>PAVING</b>	
<b>Site Sidewalks &amp; Walkways</b>	Inspected
<b>Asphalt</b>	Inspected
Deficiency	No deficiencies recorded
<b>Concrete</b>	Does not Exist
<b>Pavers</b>	Does not Exist
<b>DOT Sidewalk</b>	Inspected
<b>Asphalt</b>	Does not Exist
<b>Concrete</b>	Inspected
Condition	3 - Fair
Deficiency	DAMAGED/DETERIORATED/MISSING SECTIONS
Deficiency Location/Instance	22nd Avenue, 123rd Street
Deficiency Quantity	225
Quantity Uom	S.F.
Potential Action	REPLACE
Urgency of Action	PRIORITY 3
Purpose of Action	LEVEL 2
Deficiency Photo1

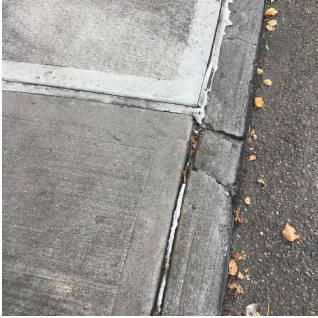
123rd Street
Violations	No violations recorded.
<b>Deficiency</b>	DAMAGED CURBS
Deficiency Location/Instance	22nd Avenue, 123rd Street
Deficiency Quantity	140
Quantity Uom	L.F.
Potential Action	REPLACE
Urgency of Action	PRIORITY 3
Purpose of Action	LEVEL 2
Deficiency Photo1
