**NYC Department of Education**  
**Building Condition Assessment Survey 2023 - 2024**

Architectural Inspection

Q457

**Asset:**        **NEWTOWN AF - QUEENS, 90-20 56TH AVENUE, New York, 11373**

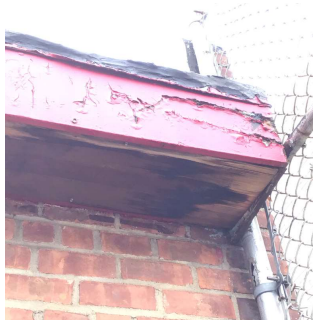
Facade E

Violations	Facade A No violations recorded.
<b>EXTERIOR SOFFITS</b>	
Condition	Inspected
Deficiency	3 - Fair
Deficiency	STUCCO/PLASTER: MAJOR CRACKS/SPALLING

REPLACE

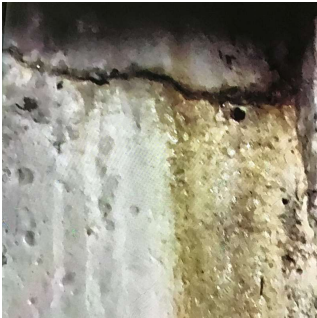
Question	Response
<b>INTERIOR</b>	
<b>STRUCTURAL</b>	
<b>FOUNDATION WALLS</b>	Inspected
Violations	No violations recorded.
<b>ROOF STRUCTURE</b>	Inspected
Condition	2 - Between Good and Fair
Deficiency	No deficiencies recorded
<b>VAULTS-BUNKERS</b>	Inspected
<b>Foundation Walls</b>	Inspected
Condition	3 - Fair
Deficiency	CRACKS, SPALLING
Deficiency Location/Instance	Basement - Ash Hoist Vault
Deficiency Quantity	20
Quantity Uom	S.F.
Potential Action	REPAIR
Urgency of Action	PRIORITY 4
Purpose of Action	LEVEL 5
Deficiency Photo1

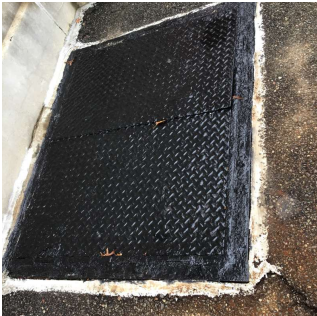
Violations	Basement - Ash Hoist Vault No violations recorded.
<b>Slab Structure</b>	Inspected
Condition	2 - Between Good and Fair
Deficiency	No deficiencies recorded
<b>Vault/Ash Hoist Doors and Framing</b>	Inspected
Condition	5 - Poor
Deficiency	DETERIORATED/DAMAGED VAULT/ASH HOIST DOORS AND FRAMING
Deficiency Location/Instance	Ash Hoist Doors
Deficiency Quantity	2
Quantity Uom	EACH
Potential Action	REPLACE

Urgency of Action	PRIORITY 4
Purpose of Action	LEVEL 2
Deficiency Photo1

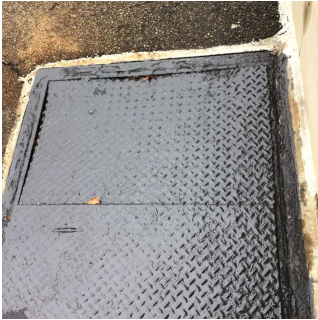
Question	Response
<b>INTERIOR</b>	
<b>STRUCTURAL</b>	
<b>VAULTS-BUNKERS</b>	
<b>Vault/Ash Hoist Doors and Framing</b>	
Violations	Ash Hoist Doors No violations recorded.
Deficiency	WATER INFILTRATION
Deficiency Location/Instance	Ash Hoist Doors
Deficiency Quantity	10
Quantity Uom	S.F.
Potential Action	REPAIR
Urgency of Action	PRIORITY 5
Purpose of Action	LEVEL 2
Deficiency Photo1

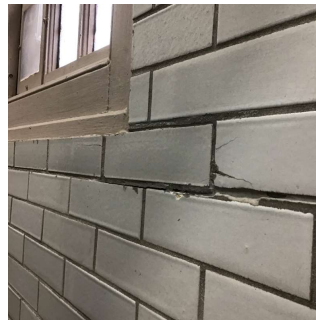
Boys Lockers room

Instance on 1st Floor - Boys (300 Lockers)	Inspected
Condition	2 - Between Good and Fair
Deficiency	PLASTER: CRACKS/SPALLING
Deficiency Location/Instance	Near Entrance
Deficiency Quantity	20
Quantity Uom	S.F.
Potential Action	REPLACE
Urgency of Action	PRIORITY 3
Purpose of Action	LEVEL 2

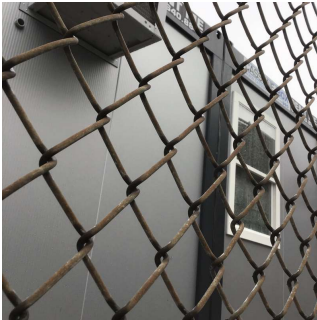
Question	Response
<b>SITE</b>	
<b>Drainage System for Asphalt</b>	
<b>Catch Basins/Manhole - Surrounded by asphalt</b>	Inspected
Condition	2 - Between Good and Fair
Deficiency	No deficiencies recorded
<b>Culverts - Asphalt Covering</b>	Does not Exist
<b>Drainage System for Concrete</b>	Inspected
<b>Catch Basins/Manhole - Surrounded by concrete</b>	Inspected
Condition	2 - Between Good and Fair
Deficiency	No deficiencies recorded
<b>Culverts - Concrete Covering</b>	Does not Exist
<b>Drainage System for Soil</b>	Does not Exist
<b>DRINKING FOUNTAINS</b>	Inspected
Condition	2 - Between Good and Fair
Deficiency	No deficiencies recorded
<b>FENCES</b>	Inspected
Condition	4 - Between Fair and Poor
Deficiency	CHAIN LINK: RUST - MAJOR
Deficiency Location/Instance	56th Avenue, 57th Avenue, 90th Street, 92nd Street.
Deficiency Quantity	2,700
Quantity Uom	S.F.
Potential Action	REPLACE
Urgency of Action	PRIORITY 3
Purpose of Action	LEVEL 2

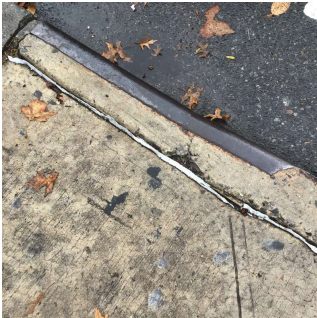
Question	Response
<b>SITE</b>	
<b>PAVING</b>	
<b>DOT Sidewalk</b>	
<b>Concrete</b>	
Violations	No violations recorded.
Deficiency	DAMAGED CURBS
Deficiency Location/Instance	56th Avenue, 57th Avenue, 90th Street, 92nd Street.
Deficiency Quantity	1,625
Quantity Uom	L.F.
Potential Action	REPLACE
Urgency of Action	PRIORITY 3
Purpose of Action	LEVEL 2
Deficiency Photo1

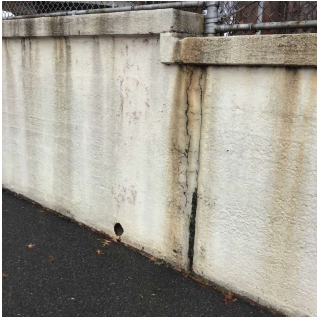
Violations	Near Volleyball Court 35657741L

Violations	57th Avenue No violations recorded.
<b>Pavers</b>	Does not Exist
<b>PLAYGROUNDS</b>	Does not Exist
<b>RETAINING WALLS</b>	Inspected
Are there any Retaining Walls 6' OR higher facing public street/sidewalk?	No
Condition	3 - Fair
Deficiency	CAST IN PLACE CONCRETE: CRACKS/SPALLING - MAJOR
Deficiency Location/Instance	Near Volleyball Court, Lockers room, Hanball Court.
Deficiency Quantity	100
Quantity Uom	S.F.
Potential Action	REPLACE
Urgency of Action	PRIORITY 4
Purpose of Action	LEVEL 4
Deficiency Photo1

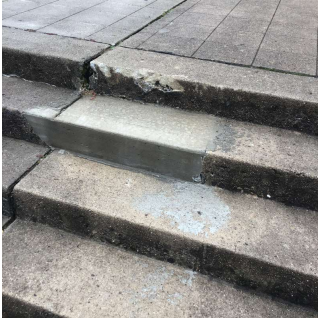
Violations	Near Lockers Area No violations recorded.

Violations	Handball Court No violations recorded.
<b>STAIRS/RAMPS: EXTERIOR</b>	
	Inspected
<b>Railings</b>	Inspected
Condition	2 - Between Good and Fair
Deficiency	No deficiencies recorded
<b>Site Cheek/flank Walls</b>	Inspected
Condition	2 - Between Good and Fair
Deficiency	No deficiencies recorded
<b>Stairs/ramps</b>	Inspected
Condition	3 - Fair
Deficiency	CAST IN PLACE CONCRETE: CRACKS/SPALLING - MAJOR
Deficiency Location/Instance	Near Lockers room Area
Deficiency Quantity	180
Quantity Uom	S.F.
Potential Action	REPLACE
Urgency of Action	PRIORITY 3
Purpose of Action	LEVEL 2
Deficiency Photo1
