NYC Department of Education
Building Condition Assessment Survey 2023 - 2024

Architectural Inspection

Q462

Asset: FLUSHING MEMORIAL AF - QUEENS, 27-01 149 STREET, New York, 11354

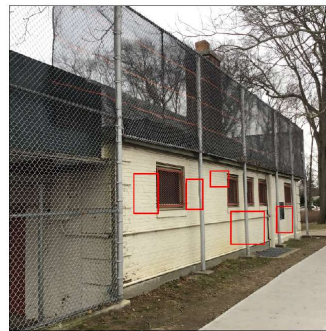
BRICK: MAJOR / THRU CRACKS

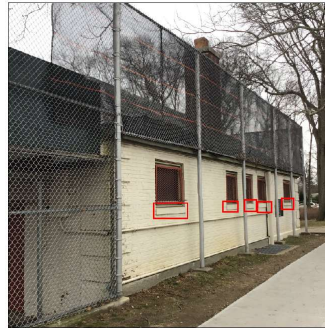
BRICK: DETERIORATED MASONRY SILLS - MINOR

REPAIR

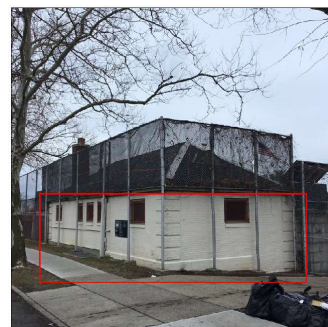
BRICK: DETERIORATED JOINTS

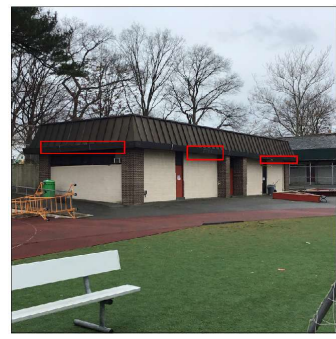
Question	Response
EXTERIOR	
EXTERIOR WALLS	
Urgency of Action	PRIORITY 3
Purpose of Action	LEVEL 2
Deficiency Photo1	 
Violations	Facade A No violations recorded.
<hr/>	
EXTERIOR SOFFITS	
Condition	Inspected
Deficiency	3 - Fair
Roof Plan reference	METAL: DETERIORATION/DAMAGED/MISSING PIECES
Elevation	 
Deficiency Quantity	40
Quantity Uom	S.F.
Potential Action	REPLACE
Urgency of Action	PRIORITY 4
Purpose of Action	LEVEL 2

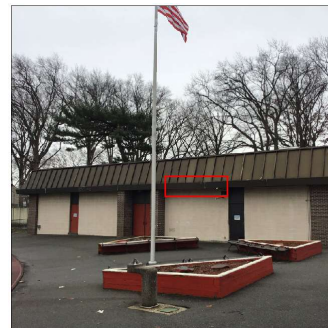
METAL: DETERIORATION/DAMAGED/MISSING PIECES

REPLACE

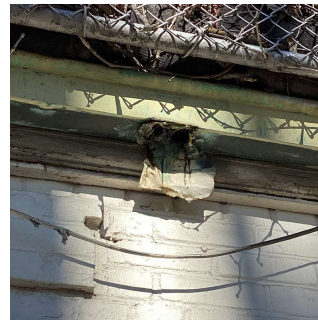
Field House 2 - Facade B

Violations	Roof 1 - RH No violations recorded.
LEADERS, GUTTERS, DOWNSPOUTS, SCUPPERS	Inspected
Condition	3 - Fair
Deficiency	DAMAGED/MISSING

20
L.F.
REPLACE
PRIORITY 4
LEVEL 2

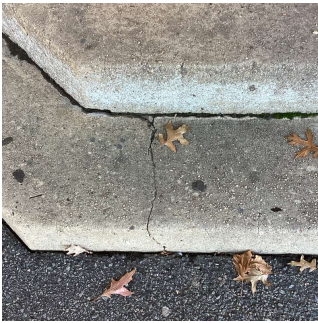
Violations	Roof 4 No violations recorded.
ROOFING DRAINS	Inspected
Condition	2 - Between Good and Fair
Deficiency	No deficiencies recorded
Specialties	Inspected
DUNNAGE STEEL	Does not Exist
SKYLIGHT/ROOF VENT	Does not Exist
STAIRS/RAMPS: EXTERIOR	Inspected
BUILDING CHEEK/FLANK WALLS	Does not Exist
RAILINGS	Does not Exist
STAIRS/RAMPS	Inspected
Condition	3 - Fair
Deficiency	CONCRETE: CRACKS/SPALLING - MINOR
Roof Plan reference

Deficiency Quantity	20
Quantity Uom	S.F.
Potential Action	REPAIR
Urgency of Action	PRIORITY 3
Purpose of Action	LEVEL 2

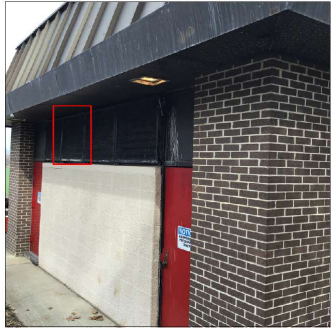
Violations	Field House 2 - Facade A No violations recorded.
WINDOWS	Inspected
Replacement Quantity	260
Replacement Uom	S.F.
EXTERIOR GUARDS	Inspected
Condition	3 - Fair
Deficiency	DETERIORATED/TORN-OUT/MISSING
Roof Plan reference

Deficiency Quantity	30
Quantity Uom	S.F.
Potential Action	REPLACE
Urgency of Action	PRIORITY 4
Purpose of Action	LEVEL 2

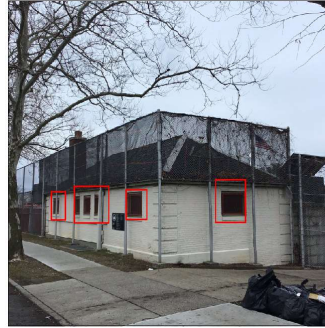
Question	Response
EXTERIOR	
WINDOWS	Inspected
EXTERIOR GUARDS	
Deficiency Photo1	 
Violations	Facade H No violations recorded.
LINTELS	Inspected
Condition	2 - Between Good and Fair
Deficiency	No deficiencies recorded
WINDOWS	Inspected
Material Type(s)	Aluminum
Instance on Aluminum - Other: Field House 1	Inspected
Instance Condition	3 - Fair
Instance Quantity	200
Instance Quantity Uom	S.F.
Are these windows insulated	No
Installation Year	1971
Source of Installation	Custodial Staff
Deficiency	No deficiencies recorded
Instance on Aluminum - Other: Field House 2	Inspected
Instance Condition	5 - Poor
Instance Quantity	60
Instance Quantity Uom	S.F.
Are these windows insulated	No
Installation Year	2011
Source of Installation	Custodial Staff
Deficiency	ALUMINUM - OTHER: AIR/WATER INFILTRATION
Roof Plan reference

60
L.F.
REPLACE TRIM, SILLS OR WEATHERSTRIPPING
PRIORITY 5
LEVEL 2

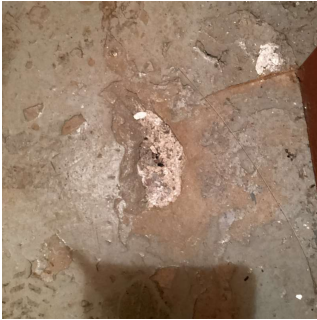
Question	Response
INTERIOR	
STRUCTURAL	
COLUMNS/BEAMS/BEARING WALLS	Inspected
Violations	No violations recorded.
FLOOR STRUCTURE	Inspected
Condition	3 - Fair
Deficiency	CONCRETE SLAB ON GRADE: THRU CRACKS
Deficiency Location/Instance	Field House 1 - Boiler Room, Field House 2 - Boys Locker Room
Deficiency Quantity	40
Quantity Uom	S.F.
Potential Action	REPAIR
Urgency of Action	PRIORITY 3
Purpose of Action	LEVEL 5
Deficiency Photo1

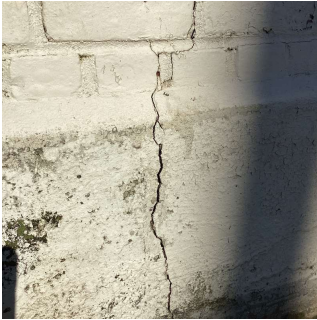
Violations	Field House 1 - Boiler Room No violations recorded.
FOUNDATION WALLS	Inspected
Material Type(s)	Concrete
Condition	4 - Between Fair and Poor
Deficiency	CONCRETE: CRACKED/SPALLED/REINFORCEMENT EXPOSED
Deficiency Location/Instance	Field House 2 - Facades A, B, C
Deficiency Quantity	40
Quantity Uom	S.F.
Potential Action	REPAIR
Urgency of Action	PRIORITY 3
Purpose of Action	LEVEL 5
Deficiency Photo1

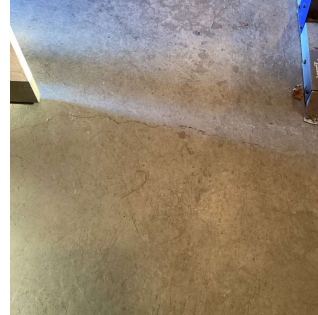
Left Side
Violations	No violations recorded.
Instance on Field House 1 Boys - (140 Lockers)	Inspected
Condition	3 - Fair
Deficiency	CONCRETE: CRACKS
Deficiency Location/Instance	Near Entrance
Deficiency Quantity	100

Quantity Uom	S.F.
Potential Action	REPLACE

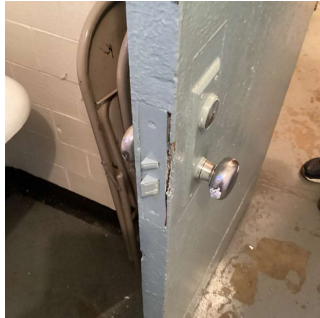
Question	Response
INTERIOR	
TOILET ROOMS - STAFF	
Door(s)	
Deficiency Quantity	2
Quantity Uom	EACH
Potential Action	MAINTENANCE
Urgency of Action	PRIORITY 3
Purpose of Action	LEVEL 2
Deficiency Photo1

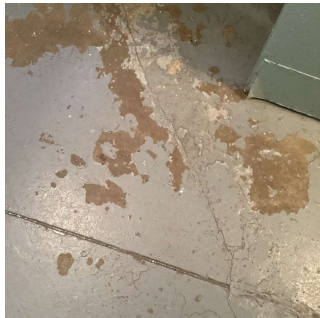
1st Floor - Men
Violations	No violations recorded.
Floor Finish	Inspected
Condition	5 - Poor
Deficiency	CONCRETE: CRACKS
Deficiency Location/Instance	1st Floor - Men, 1st Floor - Women
Deficiency Quantity	50
Quantity Uom	S.F.
Potential Action	REPLACE
Urgency of Action	PRIORITY 3
Purpose of Action	LEVEL 2
Deficiency Photo1

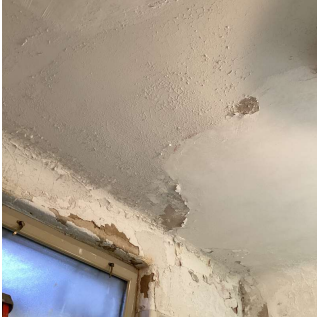
Question	Response
INTERIOR	
TOILET ROOMS - STAFF	Inspected
Walls	Inspected
Violations	1st Floor - Men No violations recorded.
TOILET ROOMS - STUDENTS	Inspected
Ceiling	Inspected
Condition	5 - Poor
Deficiency	PLASTER: CRACKS/SPALLING - ACTIVE LEAK
Deficiency Location/Instance	Inside Girls Locker room
Deficiency Quantity	40
Quantity Uom	S.F.
Potential Action	REPLACE
Urgency of Action	PRIORITY 5
Purpose of Action	LEVEL 2
Deficiency Photo1

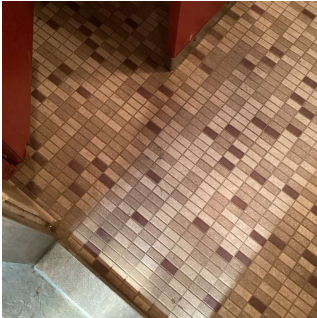
Violations	Inside Girls Locker room No violations recorded.
Door(s)	Inspected
Condition	2 - Between Good and Fair
Deficiency	No deficiencies recorded
Floor Finish	Inspected
Condition	2 - Between Good and Fair
Deficiency	CERAMIC TILE: BROKEN/MISSING TILES
Deficiency Location/Instance	Inside Boys Locker Room
Deficiency Quantity	10
Quantity Uom	S.F.
Potential Action	REPLACE
Urgency of Action	PRIORITY 3
Purpose of Action	LEVEL 2
Deficiency Photo1

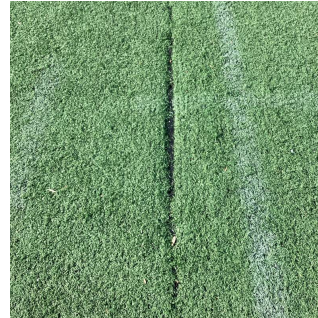
Yes	Tripping Hazard	Deteriorated synthetic turf is a potential tripping hazard.	ATHLETIC FIELDS PLAYING SURFACE	Baseball/Football Field	Lee Roebuck	Fireman

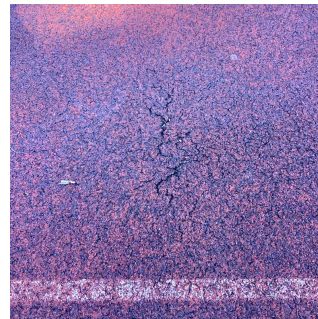
Yes	Tripping Hazard	Damaged and deteriorated athletic wearing surface is a potential tripping hazard.	ATHLETIC FIELDS PLAYING SURFACE	Running Track	Lee Roebuck	Fireman

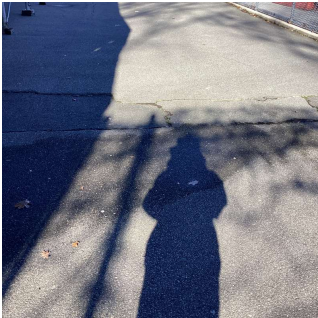
Question	Response
SITE	
PAVING	
Student Use	Inspected
Concrete	Does not Exist
Pavers	Does not Exist
Site Sidewalks & Walkways	Inspected
Asphalt	Inspected
Condition	3 - Fair
Deficiency	CRACKS - MAJOR
Deficiency Location/Instance	Near Main Entrance, Near field House, Near Bleachers
Deficiency Quantity	250
Quantity Uom	S.F.
Potential Action	REPLACE
Urgency of Action	PRIORITY 3
Purpose of Action	LEVEL 2
Deficiency Photo1

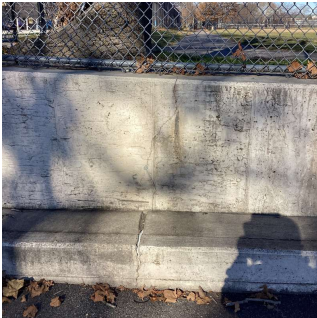
Violations	149th Street No violations recorded.
Pavers	Does not Exist
PLAYGROUNDS	Does not Exist
RETAINING WALLS	Inspected
Are there any Retaining Walls 6' OR higher facing public street/sidewalk?	No
Condition	3 - Fair
Deficiency	CAST IN PLACE CONCRETE: CRACKS/SPALLING - MAJOR
Deficiency Location/Instance	Near field house
Deficiency Quantity	80
Quantity Uom	S.F.
Potential Action	REPLACE
Urgency of Action	PRIORITY 3
Purpose of Action	LEVEL 2
Deficiency Photo1
