NYC Department of Education
Building Condition Assessment Survey 2023 - 2024

Architectural Inspection

Q463

Asset: FLUSHING AF (LEVITTS FIELD)-Q, 34-42 LEAVITT STREET, New York, 11355

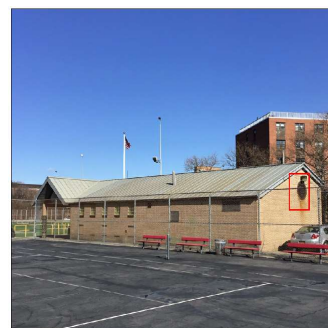
Violations	Facade D No violations recorded.
EXTERIOR SOFFITS	
LOUVER	Does not Exist
Condition	Inspected
Deficiency	3 - Fair
Roof Plan reference	MAJOR RUSTING
Elevation	 
Deficiency Quantity

Quantity Uom	10
Potential Action	S.F.
Urgency of Action	REPLACE
Purpose of Action	PRIORITY 4
	LEVEL 2

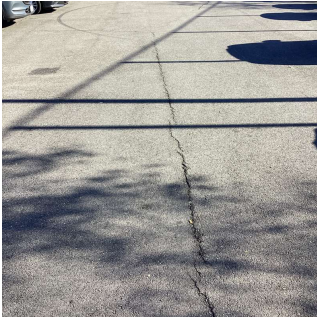
Near Parking lot	
Violations	No violations recorded.

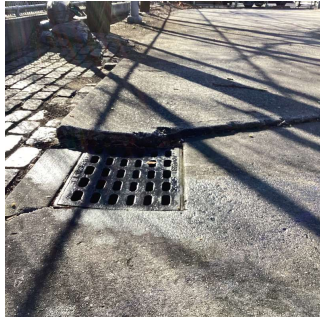
Violations	Parking lot No violations recorded.
Concrete	Inspected
Condition	3 - Fair
Deficiency	CRACKS - MAJOR
Deficiency Location/Instance	Rear of Field house
Deficiency Quantity	250
Quantity Uom	S.F.
Potential Action	REPLACE
Urgency of Action	PRIORITY 3
Purpose of Action	LEVEL 2
Deficiency Photo1

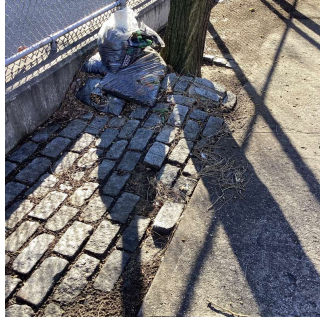
Violations	Rear of Field house No violations recorded.
Pavers	
Condition	Inspected 3 - Fair
Deficiency	DAMAGED/MISSING
Deficiency Location/Instance	Rear of Field house, Near Parking Lot
Deficiency Quantity	120
Quantity Uom	S.F.
Potential Action	REPLACE
Urgency of Action	PRIORITY 3
Purpose of Action	LEVEL 2
Deficiency Photo1

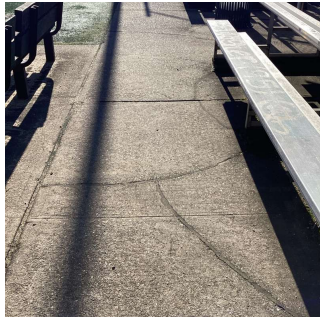
Violations	Rear of Field house No violations recorded.
Student Use	Inspected
Gravel Exists?	No
Asphalt	Inspected
Condition	4 - Between Fair and Poor
Deficiency	CRACKS - MAJOR
Deficiency Location/Instance	Along 137th Street, 32nd Avenue
Deficiency Quantity	800
Quantity Uom	S.F.
Potential Action	REPLACE
Urgency of Action	PRIORITY 3
Purpose of Action	LEVEL 2
Deficiency Photo1
