**NYC Department of Education**  
**Building Condition Assessment Survey 2023 - 2024**

Architectural Inspection

**Asset: 3K CENTER @ 185 BEACH 99TH STREET - QUEENS, 185 BEACH 99TH STREET, 11694**

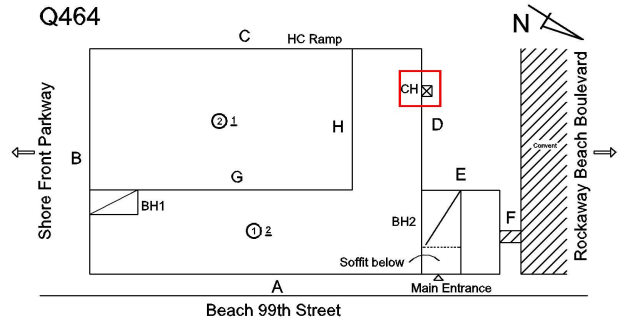
Roof Plan reference

Question	Response
<b>Architectural</b>	
<b>EXTERIOR</b>	Inspected
<b>AREAWAY</b>	Does not Exist
<b>AWNINGS AND CANOPIES</b>	Does not Exist
<b>CHIMNEY</b>	Inspected
Material Type(s)	Masonry
Condition	3 - Fair
Deficiency	BRICK: DETERIORATED JOINTS

200  
 S.F.  
 REPOINT  
 PRIORITY 3  
 LEVEL 2

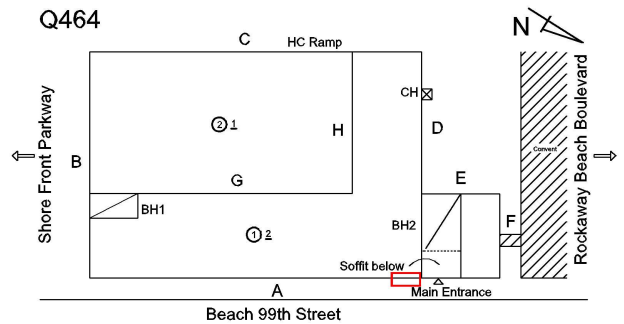
Roof Plan reference

CAST STONE: CRACKED/BROKEN PIECES

10  
 L.F.  
 REPLACE-IN-KIND  
 PRIORITY 4  
 LEVEL 2

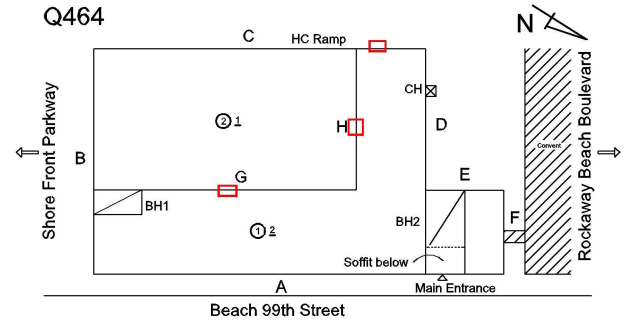
Roof Plan reference

TERRA COTTA: CRACKED/BROKEN PIECES

REPLACE-IN-KIND

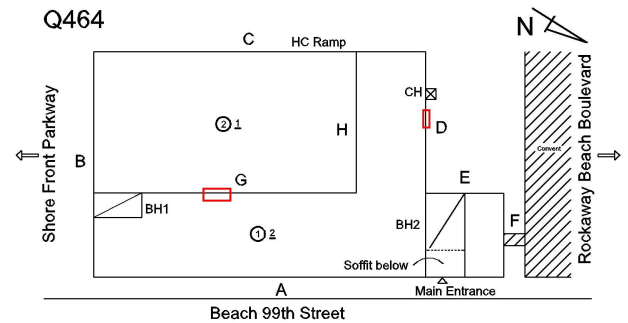
Roof Plan reference

TERRA COTTA: DETERIORATED TRANSVERSE JOINTS

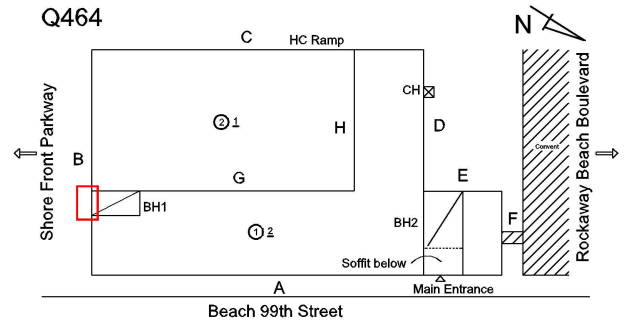
Roof Plan reference

METAL: DETERIORATED DOOR AND FRAME - MAJOR DETERIORATION

2  
EACH  
REPLACE  
PRIORITY 4  
LEVEL 2

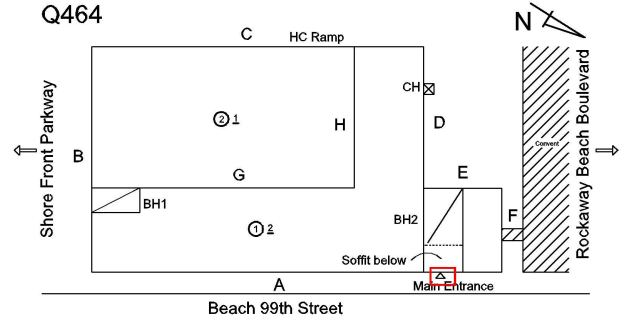
Roof Plan reference

METAL: DENTED, MAJOR RUSTING

REPLACE

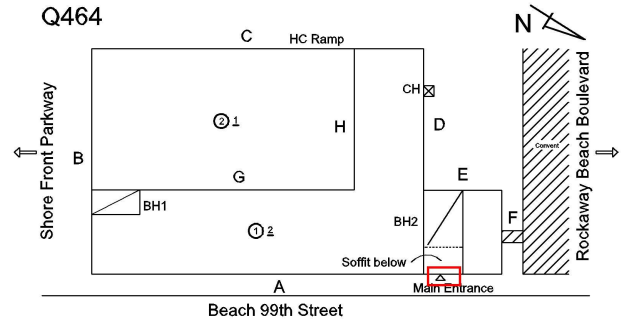
Roof Plan reference

METAL: BROKEN GLASS

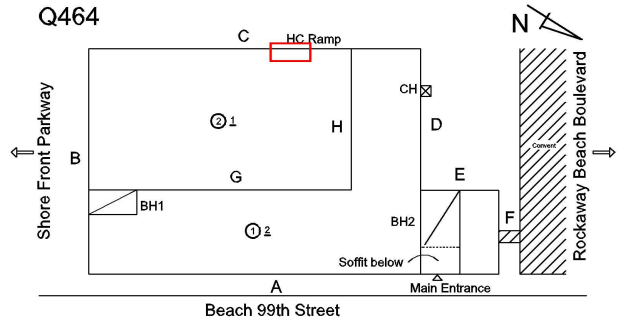
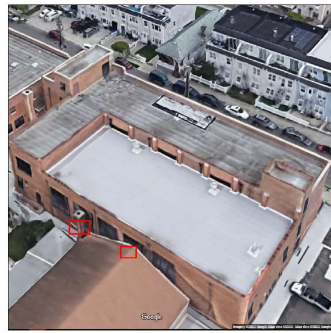
Violations	Facade A No violations recorded.
<b>EXTERIOR WALLS</b>	
Material Type(s)	Inspected Masonry
Replacement Quantity	8,000
Replacement Uom	S.F.
Instance on All Facades	Inspected
Instance Condition	3 - Fair
Instance Quantity	8,000
Instance Quantity Uom	S.F.
Deficiency	BRICK: DETERIORATED MASONRY SILLS - MINOR
Roof Plan reference	<p><b>Q464</b></p>

Deficiency Quantity	10
Quantity Uom	L.F.
Potential Action	REPAIR
Urgency of Action	PRIORITY 3
Purpose of Action	LEVEL 2

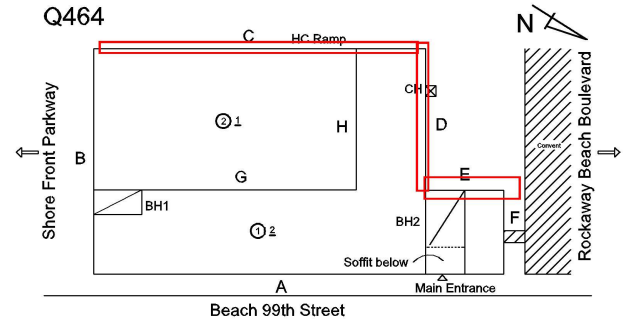
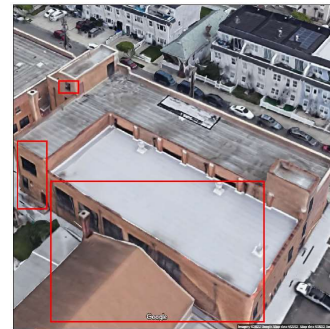
Roof Plan reference

**BRICK: DETERIORATED JOINTS**

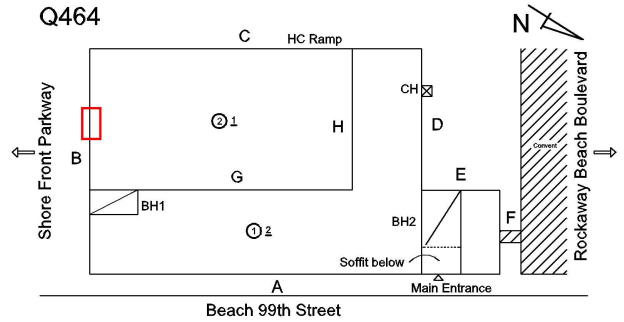
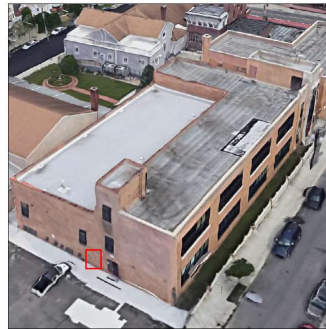
Roof Plan reference

**BRICK: DETERIORATED JOINTS**

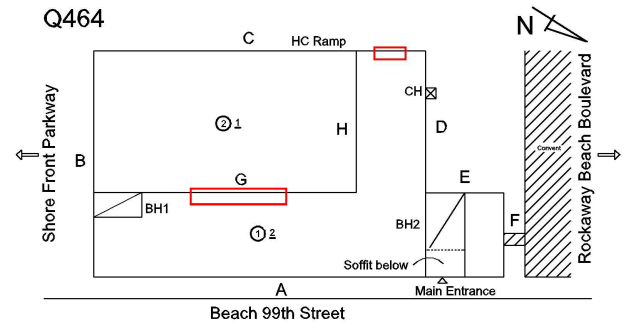
Roof Plan reference

Deficiency	BRICK: DETERIORATED JOINTS
------------	----------------------------

Deficiency Quantity	100
Quantity Uom	S.F.
Potential Action	REPOINT
Urgency of Action	PRIORITY 3
Purpose of Action	LEVEL 2

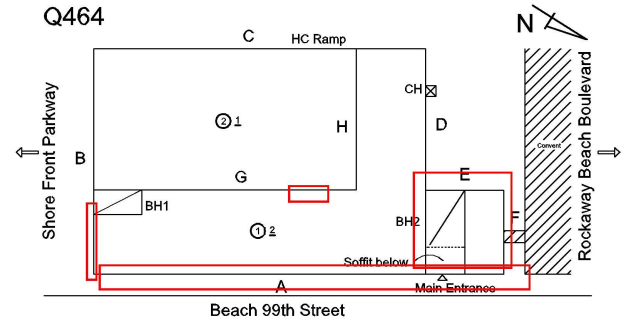
Roof Plan reference

BRICK: EFFLORESCENCE

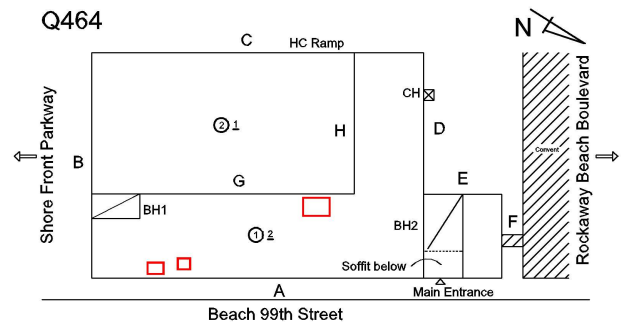
Roof Plan reference

Deficiency **MODIFIED BITUMEN: ROOFING: MAJOR ACTIVE ROOF LEAKS IN INSTRUCTIONAL SPACE**

Question	Response
<b>EXTERIOR</b>	
<b>ROOF</b>	
<b>Roofing</b>	
<b>ROOFING</b>	
Deficiency Quantity	300
Quantity Uom	S.F.
Potential Action	REPLACE ROOFING WITHOUT MAJOR EQUIPMENT REMOVAL
Urgency of Action	PRIORITY 5
Purpose of Action	LEVEL 2
Deficiency Photo1	 
	Roof 1 - Kitchen Room - 2nd Floor shown, Roof 1 - Rooms 202A, 205 similar
Violations	No violations recorded.
Instance on Modified Bitumen: Roof 2	Inspected
Instance Condition	5 - Poor
Instance Photo	 
	Roof 2
Instance Quantity	2,000
Instance Quantity Uom	S.F.
Does the roof have major mechanical equipment sitting on Dunnage Steel less than 18" above the Roofing?	No
Does this roof instance have a Sustainable Roof System?	Yes
Sustainable Roof Type	White Roof
Sustainable Roof Location (Roof Number)	Roof 2
Do solar panels exist on these roofs?	No
Is/Are the roof(s) suitable for Solar Panel installation?	No
Installation Year	2023
Source of Installation	Custodial Staff

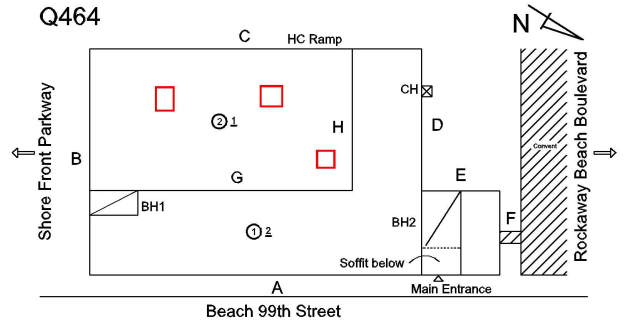
Roof Plan reference

Deficiency	MODIFIED BITUMEN; ROOFING; MAJOR ACTIVE ROOF LEAKS IN INSTRUCTIONAL SPACE

300  
S.F.  
REPLACE ROOFING WITHOUT MAJOR EQUIPMENT  
REMOVAL  
PRIORITY 5  
LEVEL 2

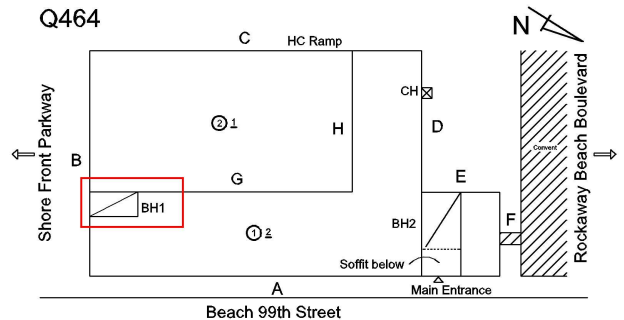
Roof Plan reference

BULKHEAD/PENTHOUSE WALLS/EXTERIOR: DETERIORATED JOINTS

10  
S.F.  
REPOINT  
PRIORITY 3  
LEVEL 2

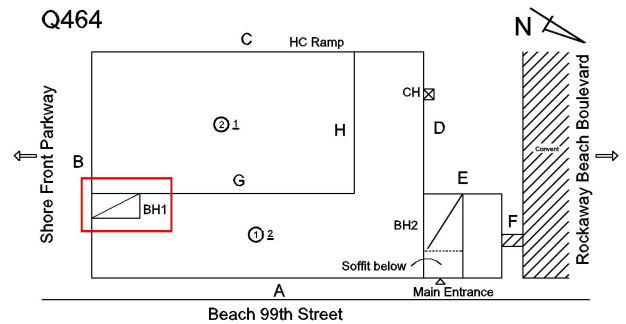
Roof Plan reference

**BULKHEAD/PENTHOUSE WALLS/EXTERIOR:  
CRACKS/SPALLING - MAJOR**

REPLACE

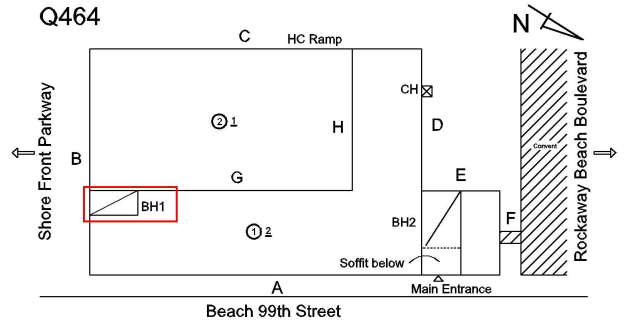
Roof Plan reference

**BULKHEAD/PENTHOUSE WALLS/INTERIOR: PLASTER  
CRACKS/SPALLING**

30  
S.F.  
REPLACE  
PRIORITY 3  
LEVEL 2

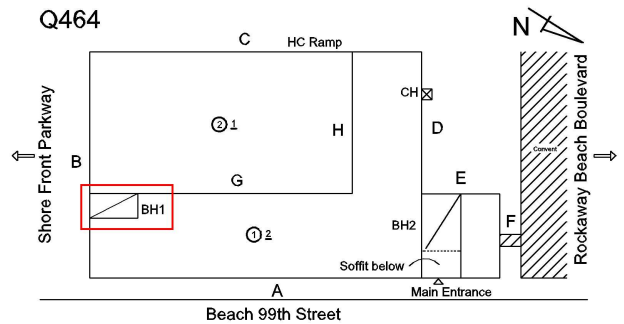
Deficiency	<b>BULKHEAD/PENTHOUSE ROOF: MAJOR LEAKAGE</b>
Roof Plan reference	Q464

100  
S.F.  
REPLACE  
PRIORITY 5  
LEVEL 2

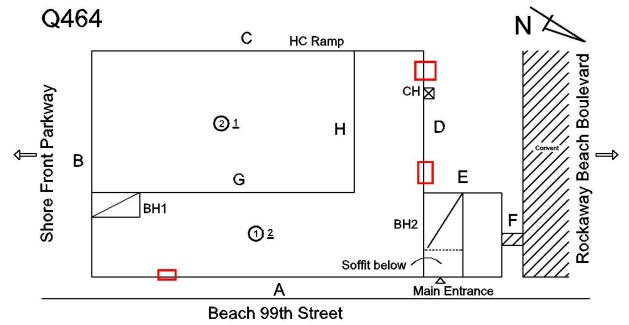
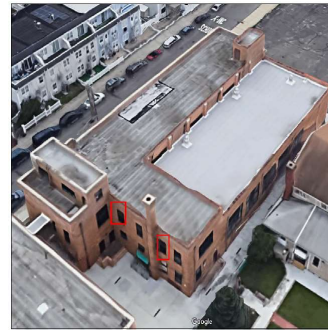
Roof Plan reference

Material Type(s)	Aluminum
Instance on Aluminum - Double Hung: All Facades	Inspected
Instance Condition	3 - Fair
Instance Quantity	2,600
Instance Quantity Uom	S.F.
Are these windows insulated	No
Installation Year	2005
Source of Installation	Custodial Staff
Deficiency	ALUMINUM - DOUBLE HUNG: AIR/WATER INFILTRATION

90  
L.F.  
REPLACE TRIM, SILLS OR WEATHERSTRIPPING  
PRIORITY 5  
LEVEL 2

Facade D - Room 210 (two locations) also Facade A - Room 206  
No violations recorded.

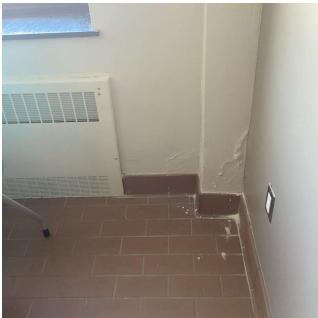
Question	Response
<b>INTERIOR</b>	
<b>KITCHEN</b>	
<b>Door(s)</b>	
Instance on 1st Floor	Inspected
Condition	1 - Good
Deficiency	No deficiencies recorded
Instance on 2nd Floor	Inspected
Condition	1 - Good
Deficiency	No deficiencies recorded
<b>Floor Finish</b>	
Instance on 1st Floor	Inspected
Condition	1 - Good
Deficiency	No deficiencies recorded
Instance on 2nd Floor	Inspected
Condition	1 - Good
Deficiency	No deficiencies recorded
<b>Walls</b>	
Instance on 2nd Floor	Inspected
Condition	2 - Between Good and Fair
Deficiency	PLASTER: CRACKS/SPALLING - ACTIVE LEAK
Deficiency Location/Instance	Near Windows
Deficiency Quantity	20
Quantity Uom	S.F.
Potential Action	REPLACE
Urgency of Action	PRIORITY 5
Purpose of Action	LEVEL 2
Deficiency Photo1

Near Windows
Violations	No violations recorded.
<b>LIBRARY</b>	Does not Exist
<b>LOCKER ROOM</b>	Does not Exist
<b>MULTI-PURPOSE ROOM</b>	Inspected
Instance on 1st Floor	Inspected

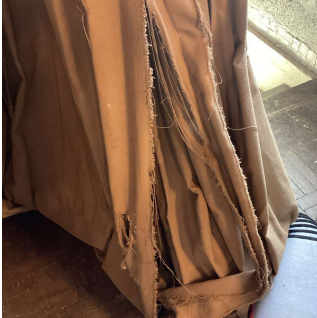
Violations	No violations recorded.
<b>Stage Curtain Rigging</b>	Inspected
Instance on 1st Floor	Inspected
Condition	2 - Between Good and Fair
Deficiency	No deficiencies recorded
<b>Stage Curtains</b>	Inspected
Instance on 1st Floor	Inspected
Condition	5 - Poor
Deficiency	WORN/DETERIORATED
Deficiency Location/Instance	Lateral Right and Left Side, Back Right Side
Deficiency Quantity	1,600
Quantity Uom	S.F.
Potential Action	REPLACE
Urgency of Action	PRIORITY 3
Purpose of Action	LEVEL 2
Deficiency Photo1

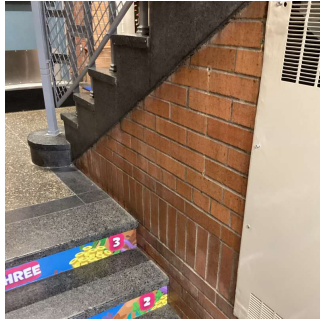
Question	Response
<b>INTERIOR</b>	
<b>STAIRS/RAMPS: INTERIOR</b>	
<b>Ceiling</b>	Inspected
Violations	Stair B/1 No violations recorded.
<b>Door(s)</b>	Inspected
Condition	2 - Between Good and Fair
Deficiency	No deficiencies recorded
<b>Partition</b>	Does not Exist
<b>Railings</b>	Inspected
Condition	3 - Fair
Deficiency	WOOD: MISSING
Deficiency Location/Instance	Stair A/1
Deficiency Quantity	10
Quantity Uom	L.F.
Potential Action	REPLACE
Urgency of Action	PRIORITY 5
Purpose of Action	LEVEL 6
Deficiency Photo1

Violations	Stair A/1 No violations recorded.
<b>Stairs and Landings</b>	Inspected
Condition	4 - Between Fair and Poor
Deficiency	TERRAZZO: CRACKS
Deficiency Location/Instance	Stairs A/1, 2, B/1, 2, Bulkhead
Deficiency Quantity	80
Quantity Uom	S.F.
Potential Action	REPLACE
Urgency of Action	PRIORITY 3
Purpose of Action	LEVEL 2
Deficiency Photo1

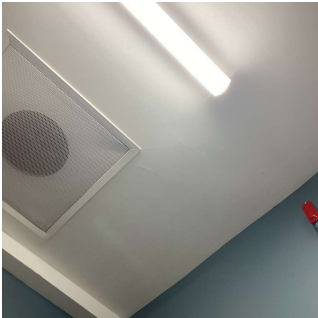
Question	Response
<b>INTERIOR</b>	
<b>STAIRS/RAMPS: INTERIOR</b>	Inspected
<b>Walls</b>	Inspected
Condition	2 - Between Good and Fair
Deficiency	No deficiencies recorded
<b>TOILET ROOMS - STAFF</b>	Inspected
<b>Ceiling</b>	Inspected
Condition	2 - Between Good and Fair
Deficiency	No deficiencies recorded
<b>Door(s)</b>	Inspected
Condition	2 - Between Good and Fair
Deficiency	No deficiencies recorded
<b>Floor Finish</b>	Inspected
Condition	2 - Between Good and Fair
Deficiency	No deficiencies recorded
<b>Stalls</b>	Does not Exist
<b>Walls</b>	Inspected
Condition	2 - Between Good and Fair
Deficiency	No deficiencies recorded
<b>TOILET ROOMS - STUDENTS</b>	Inspected
<b>Ceiling</b>	Inspected
Condition	2 - Between Good and Fair
Deficiency	PLASTER: CRACKS/SPALLING
Deficiency Location/Instance	Room 118
Deficiency Quantity	10
Quantity Uom	S.F.
Potential Action	REPLACE
Urgency of Action	PRIORITY 3
Purpose of Action	LEVEL 2
Deficiency Photo1

Room 118	
Violations	No violations recorded.
<b>Door(s)</b>	Inspected
Condition	5 - Poor
Deficiency	WOOD: DETERIORATED DOOR
Deficiency Location/Instance	Room 118
Deficiency Quantity	1
Quantity Uom	EACH
Potential Action	MAINTENANCE
Urgency of Action	PRIORITY 3
Purpose of Action	LEVEL 2
