NYC Department of Education
Building Condition Assessment Survey 2023 - 2024

Architectural Inspection

Q471

Asset: JAMAICA AF - QUEENS, 167-01 GOTHIC DRIVE, New York, 11432

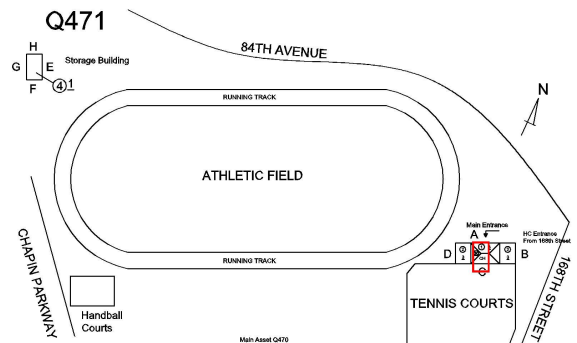
Deficiency: BRICK: DETERIORATED JOINTS
 Roof Plan reference

Deficiency Quantity	30
Quantity Uom	S.F.
Potential Action	REPOINT
Urgency of Action	PRIORITY 3
Purpose of Action	LEVEL 2
Deficiency Photo1

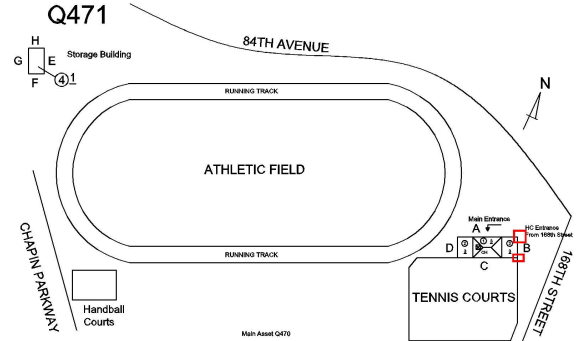
CAST STONE: CRACKED/BROKEN PIECES

Deficiency Quantity	10
Quantity Uom	L.F.
Potential Action	REPLACE-IN-KIND
Urgency of Action	PRIORITY 4
Purpose of Action	LEVEL 2
Deficiency Photo1

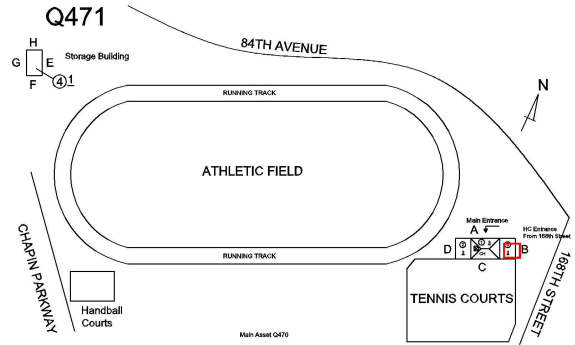
STONE: DETERIORATED JOINTS

10
L.F.
REPOINT
PRIORITY 4
LEVEL 2

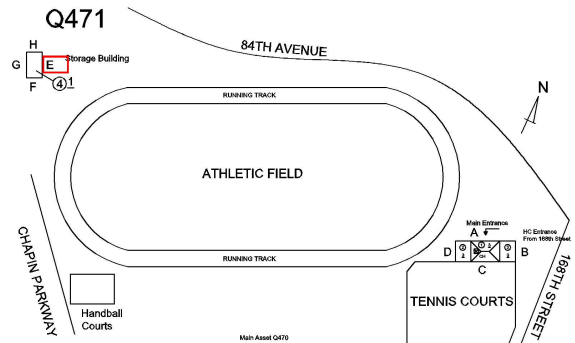
ROLL-UP DOOR: DETERIORATED DOOR AND FRAME - MAJOR DETERIORATION

300
S.F.
REPLACE
PRIORITY 4
LEVEL 2

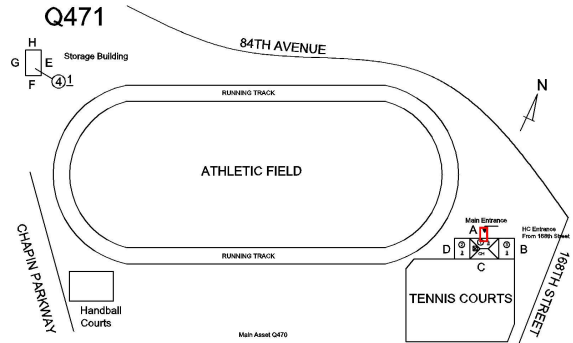
Violations	Facade E No violations recorded.
Deficiency	METAL CLAD: DETERIORATED DOOR AND FRAME - MAJOR DETERIORATION
Roof Plan reference

Deficiency Quantity	2
Quantity Uom	EACH
Potential Action	REPLACE
Urgency of Action	PRIORITY 4
Purpose of Action	LEVEL 2
Deficiency Photo1

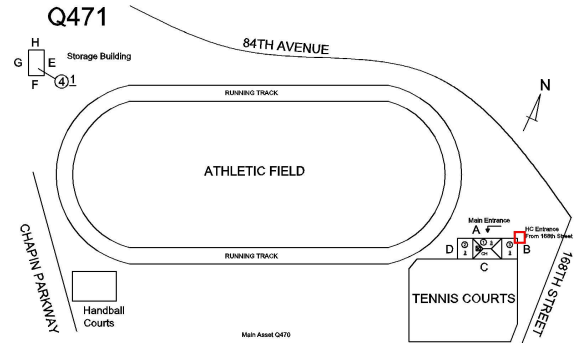
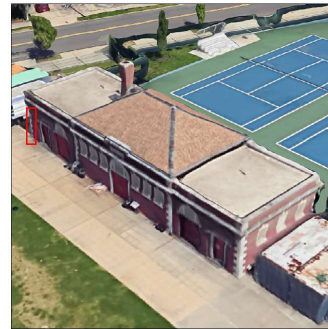
Question	Response
EXTERIOR	
EXTERIOR WALLS	Inspected
Material Type(s)	Masonry
Replacement Quantity	3,500
Replacement Uom	S.F.
Instance on All Facades	Inspected
Instance Condition	3 - Fair
Instance Quantity	3,500
Instance Quantity Uom	S.F.
Deficiency	BRICK: MINOR CRACKS AND SPALLING
Roof Plan reference	<p>Q471</p>  
Elevation	 
Deficiency Quantity	10
Quantity Uom	S.F.
Potential Action	RESTITCH
Urgency of Action	PRIORITY 3
Purpose of Action	LEVEL 2
Deficiency Photo1	 
Violations	Facade E No violations recorded.
Deficiency	STONE: CRACKS AT BUILDING CORNERS

REPLACE

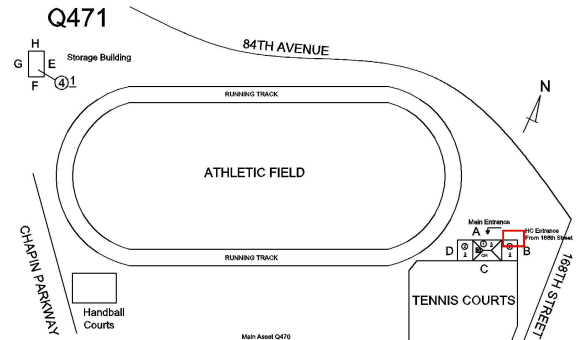
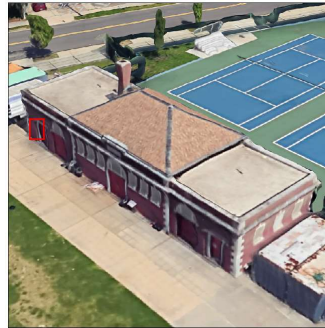
BRICK: DETERIORATED JOINTS

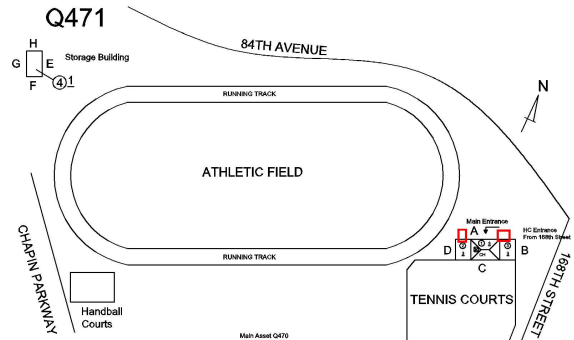
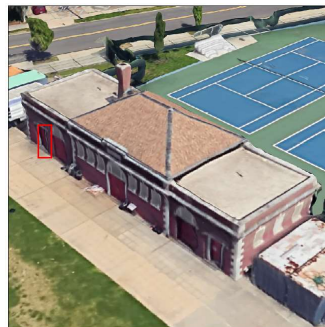
STONE: CHIPPED/SPALLED/BROKEN PIECES - MINOR

REPAIR

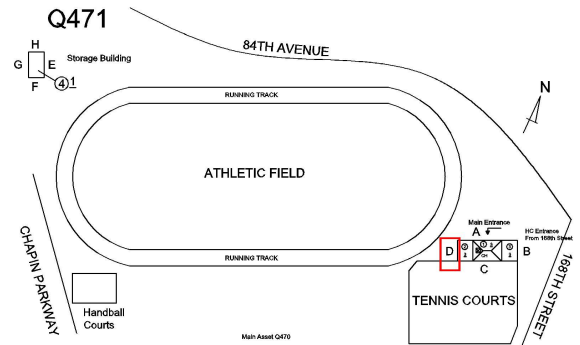
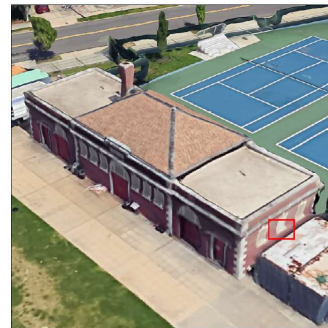
BRICK: DETERIORATED MASONRY SILLS - MINOR

REPAIR

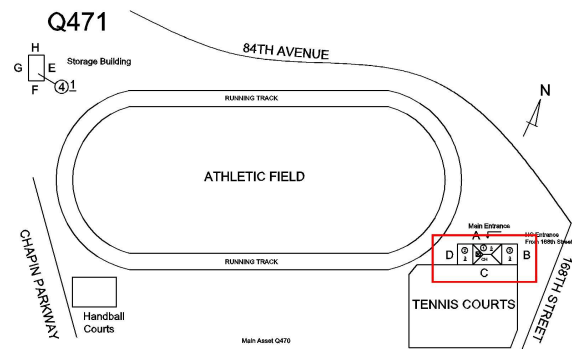
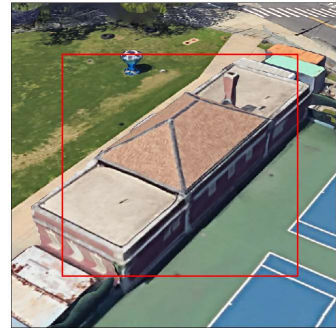
Question	Response
EXTERIOR	
EXTERIOR WALLS	
Violations	No violations recorded.
Deficiency	BRICK: DETERIORATED JOINTS
Roof Plan reference	<p>Q471</p>

Deficiency Quantity	200
Quantity Uom	S.F.
Potential Action	REPOINT
Urgency of Action	PRIORITY 3
Purpose of Action	LEVEL 2
Deficiency Photo1

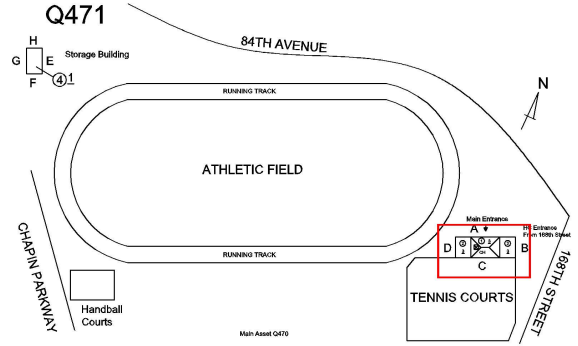
Deficiency BRICK: DETERIORATED JOINTS

Deficiency Quantity	100
Quantity Uom	S.F.
Potential Action	REPOINT
Urgency of Action	PRIORITY 3
Purpose of Action	LEVEL 2
Deficiency Photo1

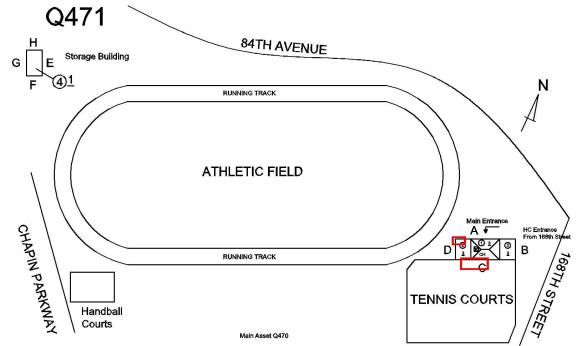
Deficiency	STONE: DETERIORATED JOINTS
------------	----------------------------

Deficiency Quantity	30
Quantity Uom	S.F.
Potential Action	REPOINT
Urgency of Action	PRIORITY 4
Purpose of Action	LEVEL 2

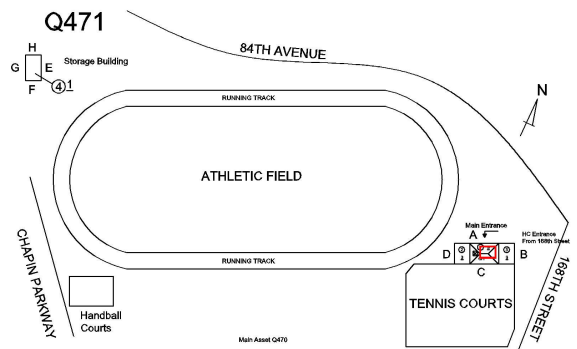
Violations	Roof 2 No violations recorded.
PLAZA DECK	Does not Exist
ROOF	Inspected
Roofing	Inspected
Replacement Quantity	2,800
Replacement Uom	S.F.
ROOF HATCH/SMOKE HATCH	Does not Exist
LEADERS, GUTTERS, DOWNSPOUTS, SCUPPERS	Inspected
Condition	2 - Between Good and Fair
Deficiency	No deficiencies recorded
ROOFING	Inspected
Instance on Asphalt Shingle: Roof 1	Inspected
Instance Condition	4 - Between Fair and Poor
Instance Quantity	800
Instance Quantity Uom	S.F.
Does the roof have major mechanical equipment sitting on Dunnage Steel less than 18" above the Roofing?	No
Does this roof instance have a Sustainable Roof System?	No
Do solar panels exist on these roofs?	No
Is/Are the roof(s) suitable for Solar Panel installation?	No
Installation Year	2000
Source of Installation	Custodial Staff
Deficiency	ASPHALT SHINGLE: ROOFING: DAMAGED, WORN-OUT OR MISSING SHINGLES CURLING UP

Deficiency Quantity	10
Quantity Uom	S.F.
Potential Action	REPLACE
Urgency of Action	PRIORITY 4
Purpose of Action	LEVEL 2

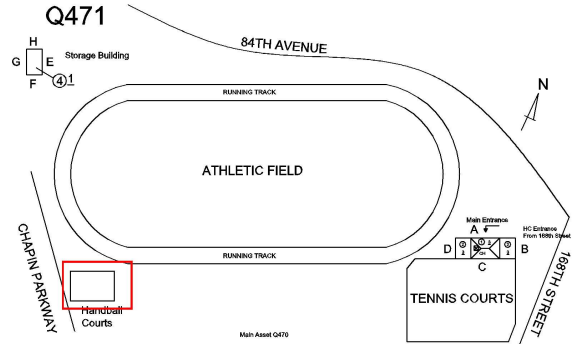
Deficiency ASPHALT: DAMAGED/DETERIORATED
 Deficiency Location/Instance Handball Courts

Deficiency Quantity	200
Quantity Uom	S.F.
Potential Action	REPLACE
Urgency of Action	PRIORITY 4
Purpose of Action	LEVEL 2
Deficiency Photo1
