NYC Department of Education
Building Condition Assessment Survey 2023 - 2024

Architectural Inspection

Q474

Asset: **3K CENTER @ 104-06 101 AVENUE - QUEENS, 104-06 101 AVENUE, New York, 11416**

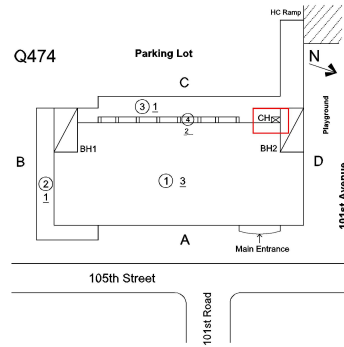
Roof Plan reference

Question	Response
Architectural	
EXTERIOR	Inspected
AREAWAY	Does not Exist
AWNINGS AND CANOPIES	Inspected
Condition	2 - Between Good and Fair
Deficiency	No deficiencies recorded
CHIMNEY	Inspected
Material Type(s)	Masonry
Condition	3 - Fair
Deficiency	BRICK: DETERIORATED JOINTS

CHIMNEY

100
 S.F.
 REPOINT
 PRIORITY 3
 LEVEL 2

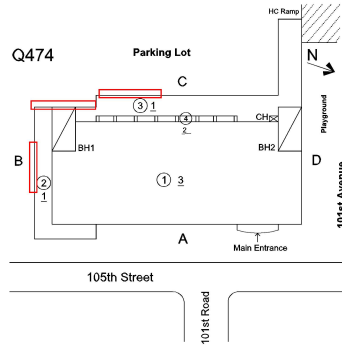
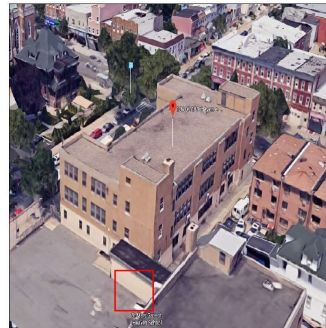
Instance Condition 3 - Fair
 Instance Quantity 16,000
 Instance Quantity Uom S.F.
 Deficiency
 Roof Plan reference

BRICK: DETERIORATED JOINTS

Deficiency Quantity 100
 Quantity Uom S.F.
 Potential Action REPOINT
 Urgency of Action PRIORITY 4
 Purpose of Action LEVEL 2

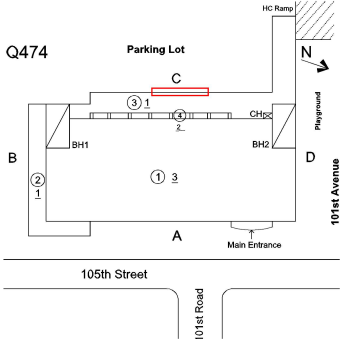
Question	Response
EXTERIOR	
PARAPETS	
Instance on All Facades	Inspected
Instance Condition	2 - Between Good and Fair
Instance Quantity	3,000
Instance Quantity Uom	C.F.
Deficiency	No deficiencies recorded
PLAZA DECK	Does not Exist
ROOF	Inspected
Roofing	Inspected
Replacement Quantity	12,000
Replacement Uom	S.F.
ROOF HATCH/SMOKE HATCH	Does not Exist
LEADERS, GUTTERS, DOWNSPOUTS, SCUPPERS	Inspected
Condition	3 - Fair
Deficiency	DAMAGED/MISSING
Roof Plan reference

Deficiency Quantity	40
Quantity Uom	L.F.
Potential Action	REPLACE
Urgency of Action	PRIORITY 4
Purpose of Action	LEVEL 2
Deficiency Photo1

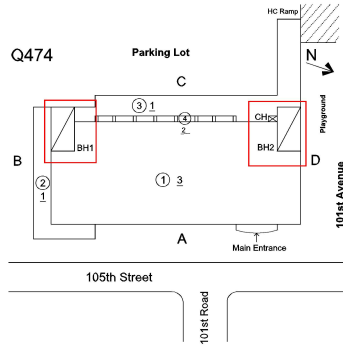
Roof 1
Instance Quantity	12,000
Instance Quantity Uom	S.F.
Does the roof have major mechanical equipment sitting on Dunnage Steel less than 18" above the Roofing?	No
Does this roof instance have a Sustainable Roof System?	Yes
Sustainable Roof Type	White Roof
Sustainable Roof Location (Roof Number)	All Roofs
Do solar panels exist on these roofs?	No
Is/Are the roof(s) suitable for Solar Panel installation?	Yes
Installation Year	2023
Source of Installation	Custodial Staff
Deficiency	No deficiencies recorded
ROOFING DRAINS	Does not Exist
Specialties	Inspected
BULKHEAD/PENTHOUSE	Inspected
Condition	3 - Fair
Deficiency	BULKHEAD/PENTHOUSE WALLS/EXTERIOR: DETERIORATED JOINTS
Roof Plan reference

Deficiency Quantity	200
Quantity Uom	S.F.
Potential Action	REPOINT
Urgency of Action	PRIORITY 3
Purpose of Action	LEVEL 2

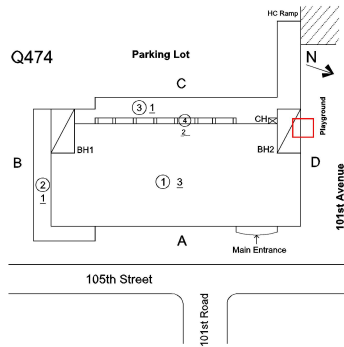
Violations	Roof 1 - Bulkhead 2 No violations recorded.
CUPOLA/ SPIRES/ TOWERS	Does not Exist
DORMER	Does not Exist
DUNNAGE STEEL	Does not Exist
SKYLIGHT/ROOF VENT	Does not Exist
ROOF/GRAVITY TANK	Does not Exist
STAIRS/RAMPS: EXTERIOR	Inspected
BUILDING CHEEK/FLANK WALLS	Inspected
Condition	2 - Between Good and Fair
Deficiency	No deficiencies recorded
RAILINGS	Inspected
Condition	3 - Fair
Deficiency	DAMAGED
Roof Plan reference

Deficiency Quantity	10
Quantity Uom	L.F.
Potential Action	REPLACE
Urgency of Action	PRIORITY 4
Purpose of Action	LEVEL 2

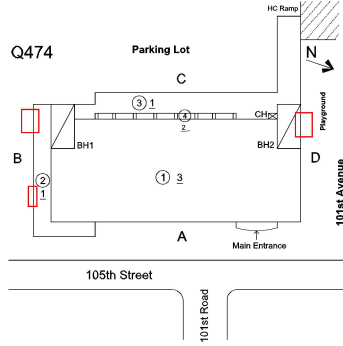
Violations	Facade D No violations recorded.
STAIRS/RAMPS	
Condition	Inspected 4 - Between Fair and Poor
Deficiency	STONE: DETERIORATED JOINTS
Roof Plan reference

Deficiency Quantity	20
Quantity Uom	L.F.
Potential Action	REPOINT
Urgency of Action	PRIORITY 4
Purpose of Action	LEVEL 2
Deficiency Photo1
