NYC Department of Education
Building Condition Assessment Survey 2023 - 2024

Architectural Inspection

Q503

Asset: 3K CENTER @ 47-09 36TH STREET - QUEENS, 47-09 36TH STREET, 11101

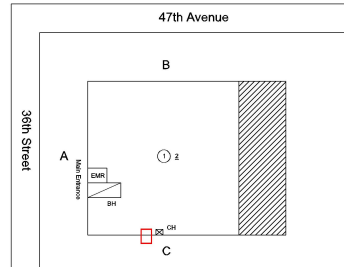
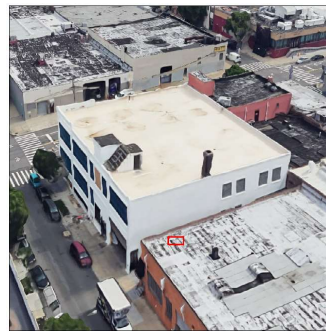
Question	Response
EXTERIOR	
EXTERIOR WALLS	
Instance Condition	3 - Fair
Instance Quantity	4,000
Instance Quantity Uom	S.F.
Deficiency	CAST IN PLACE / PRE-CAST CONCRETE: MINOR CRACKS/SPALLING
Roof Plan reference	<p>Q503</p>  
Elevation	 
Deficiency Quantity	10
Quantity Uom	S.F.
Potential Action	REPAIR
Urgency of Action	PRIORITY 3
Purpose of Action	LEVEL 2
Deficiency Photo1	  <p>Facade C</p>
Violations	No violations recorded.
Deficiency	CAST IN PLACE / PRE-CAST CONCRETE: MAJOR CRACKS/SPALLING

10

REPLACE

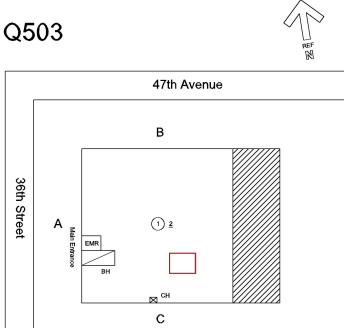
Question	Response
EXTERIOR	
ROOF	
Roofing	
ROOFING DRAINS	
Roof Plan reference

Do solar panels exist on these roofs?	No
Is/Are the roof(s) suitable for Solar Panel installation?	No
Installation Year	2024
Source of Installation	Custodial Staff
Deficiency	No deficiencies recorded
ROOFING DRAINS	Inspected
Condition	3 - Fair
Deficiency	DETERIORATED

<p>Q503</p> <p>1 EACH REPLACE PRIORITY 4 LEVEL 2</p>

Deficiency Quantity	1
Quantity Uom	EACH
Potential Action	REPLACE
Urgency of Action	PRIORITY 4
Purpose of Action	LEVEL 2
Deficiency Photo1
