NYC Department of Education
Building Condition Assessment Survey 2023 - 2024

Architectural Inspection

Q506

Asset: HILLCREST AF - QUEENS, 160-05 HIGHLAND AVENUE, New York, 11437

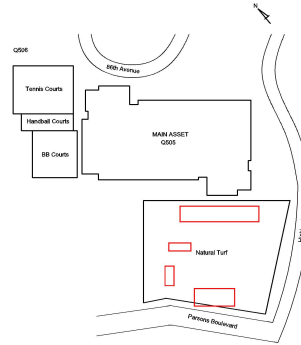
Roof Plan reference

Question	Response
Architectural	
EXTERIOR	Does not Exist
INTERIOR	Does not Exist
ATHLETIC FIELDS	Inspected
PLAYING SURFACE	Inspected
Synthetic Turf Field exists?	No
Replacement Quantity	136,000
Replacement Uom	S.F.
Instance on Baseball/Soccer Field	Inspected
Instance Condition	5 - Poor
Instance Quantity	105,000
Instance Quantity Uom	S.F.
Deficiency	NATURAL TURF: DAMAGED/WORN OUT
Deficiency Location/Instance	Baseball/Soccer Field

Deficiency Quantity

5,000

REPLACE

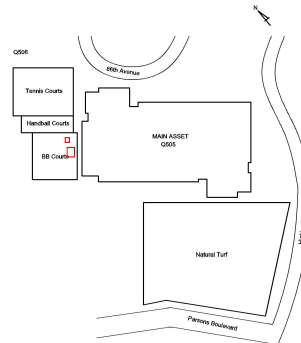
Roof Plan reference

ASPHALT: DAMAGED/DETERIORATED

Deficiency Location/Instance

Basketball Courts

Deficiency Quantity

30

REPLACE

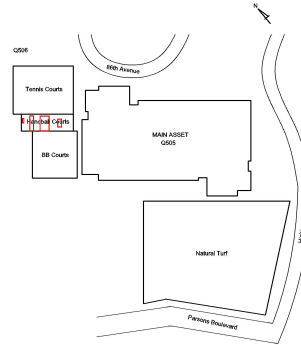
Roof Plan reference

ASPHALT: DAMAGED/DETERIORATED

Deficiency Location/Instance

Handball Courts

Deficiency Quantity

500

REPLACE
