NYC Department of Education
Building Condition Assessment Survey 2023 - 2024

Architectural Inspection

Asset: MIDDLE COLLEGE CAMPUS - QUEENS, 45-35 VAN DAM STREET, New York, 11101

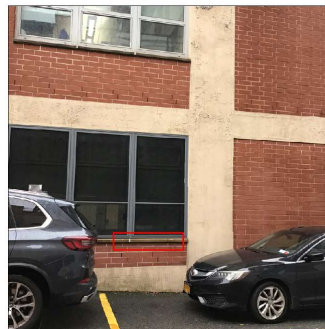
BRICK: DETERIORATED MASONRY SILLS - MINOR

REPAIR

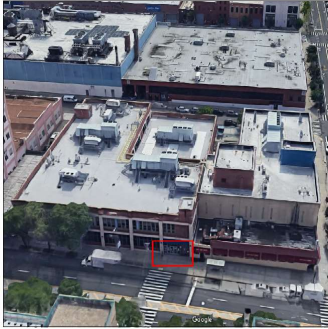
Question	Response
EXTERIOR	
EXTERIOR SOFFITS	
Condition	3 - Fair
Deficiency	METAL: WATER PENETRATION
Roof Plan reference

Deficiency Quantity	10
Quantity Uom	S.F.
Potential Action	REPAIR
Urgency of Action	PRIORITY 5
Purpose of Action	LEVEL 2
Deficiency Photo1

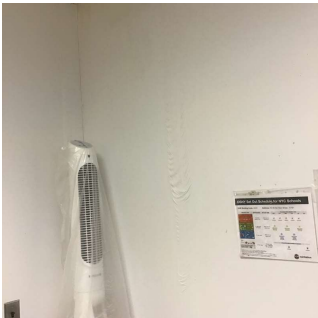
Question	Response
INTERIOR	
KITCHEN	Inspected
Floor Finish	
Violations	Near fridge No violations recorded.
Walls	
Instance on 1st Floor	Inspected
Condition	2 - Between Good and Fair
Deficiency	GYP SUM BOARD: DETERIORATED
Deficiency Location/Instance	Room 143B
Deficiency Quantity	20
Quantity Uom	S.F.
Potential Action	REPLACE
Urgency of Action	PRIORITY 3
Purpose of Action	LEVEL 2
Deficiency Photo1

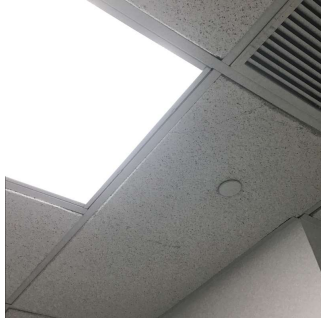
Question	Response
INTERIOR	
STAIRS/RAMPS: INTERIOR	Inspected
Walls	Inspected
Violations	Stair C/1 No violations recorded.
TOILET ROOMS - STAFF	Inspected
Ceiling	Inspected
Condition	2 - Between Good and Fair
Deficiency	ACOUSTIC TILES: DAMAGED/MISSING
Deficiency Location/Instance	Rooms 215,125
Deficiency Quantity	20
Quantity Uom	S.F.
Potential Action	REPLACE
Urgency of Action	PRIORITY 3
Purpose of Action	LEVEL 2
Deficiency Photo1

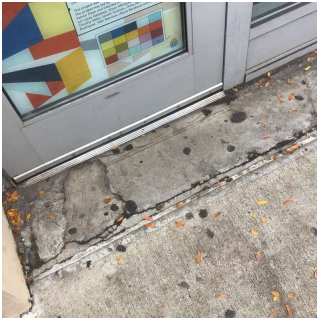
Violations	Courtyard No violations recorded.
Pavers	Does not Exist
Site Sidewalks & Walkways	Inspected
Asphalt	Does not Exist
Concrete	Inspected
Condition	2 - Between Good and Fair
Deficiency	CRACKS - MAJOR
Deficiency Location/Instance	Main Entrance
Deficiency Quantity	20
Quantity Uom	S.F.
Potential Action	REPLACE
Urgency of Action	PRIORITY 3
Purpose of Action	LEVEL 2
Deficiency Photo1
