NYC Department of Education
Building Condition Assessment Survey 2023 - 2024

Architectural Inspection

Q593

Asset: P.S. @ 140 BEACH 112 STREET - QUEENS, 140 BEACH 112 STREET, New York, 11694

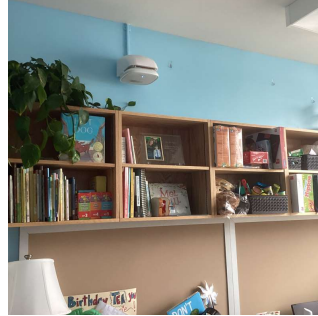
BRICK: WATER INFILTRATION IN INSTRUCTIONAL SPACE

Facade B - Room 302, also Room 202

REPAIR
PRIORITY 5
LEVEL 2

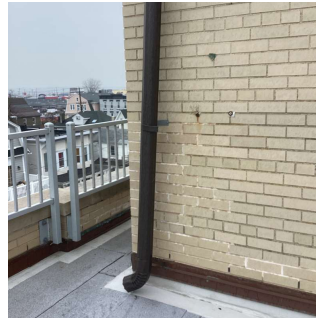
Roof 1

LEADERS, GUTTERS, DOWNSPOUTS, SCUPPERS

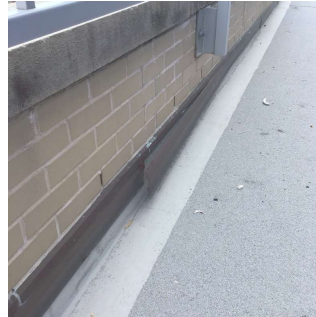
Roof 1

MODIFIED BITUMEN: FLASHING: BASE FLASHING DETERIORATED

Deficiency Quantity	20
Quantity Uom	S.F.
Potential Action	REPAIR
Urgency of Action	PRIORITY 3
Purpose of Action	LEVEL 2
Deficiency Photo1

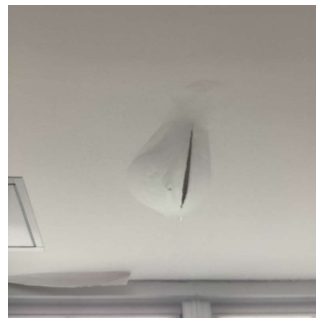
Deficiency	MODIFIED BITUMEN: ROOFING: MAJOR ACTIVE ROOF LEAKS IN INSTRUCTIONAL SPACE
------------	--

Roof 4 - 1st Floor Kitchen Storage, also Roof 1 - Stair D/3, Corridor near Stair D/3, Corridor near Room 319, Corridor near Room 313, Corridor near Room 301, Roof 2 - Gymnasium

Deficiency Quantity	600
Quantity Uom	S.F.
Potential Action	REPLACE ROOFING WITHOUT MAJOR EQUIPMENT REMOVAL
Urgency of Action	PRIORITY 5
Purpose of Action	LEVEL 2
Deficiency Photo1

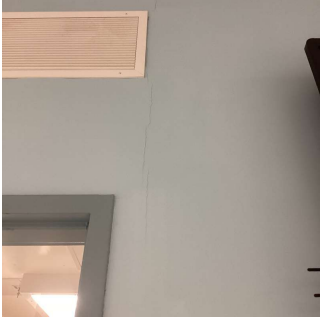
Question	Response
INTERIOR	
CAFETERIA	
Door(s)	
Deficiency	No deficiencies recorded
Fixed Equipment	
Instance on 1st Floor	Does not Exist
Floor Finish	
Instance on 1st Floor	Inspected
Condition	1 - Good
Deficiency	No deficiencies recorded
Sliding-folding Partition	
Instance on 1st Floor	Does not Exist
Stage	
Instance on 1st Floor	Does not Exist
Walls	
Instance on 1st Floor	Inspected
Condition	2 - Between Good and Fair
Deficiency	GYPSUM BOARD: DETERIORATED
Deficiency Location/Instance	Near Serving Area
Deficiency Quantity	10
Quantity Uom	S.F.
Potential Action	REPLACE
Urgency of Action	PRIORITY 3
Purpose of Action	LEVEL 2
Deficiency Photo1

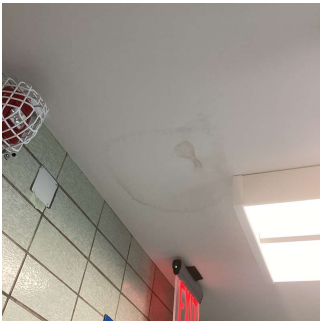
Near Serving Area
Violations	No violations recorded.
Window Curtains/Shades/Blinds	
Instance on 1st Floor	Does not Exist
CLASSROOMS/CORRIDORS/ADMIN SPACES	
Ceiling	Inspected
Condition	2 - Between Good and Fair
Deficiency	GYPSUM BOARD: DAMAGED/DETERIORATED - ACTIVE LEAK
Deficiency Location/Instance	Room 301, Corridor near Rooms 301, 313, 319, Corridor near Stair D/3

Deficiency Quantity	60
Quantity Uom	S.F.
Potential Action	REPLACE
Urgency of Action	PRIORITY 5
Purpose of Action	LEVEL 2

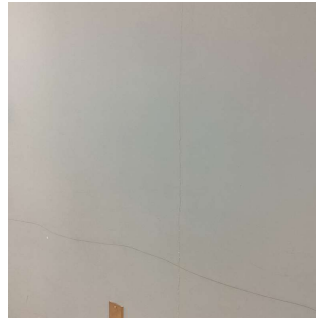
Corridor near Room 304

GYPSON BOARD: DETERIORATED

REPLACE

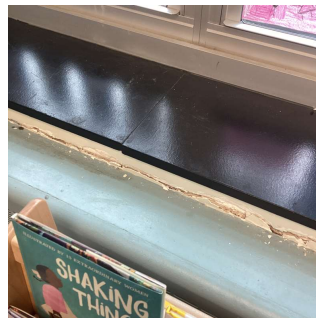
PLASTER: CRACKS/SPALLING

REPLACE

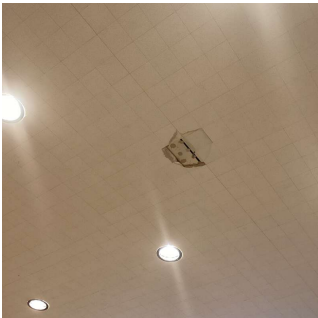
Instance on 1st Floor	Inspected
Condition	2 - Between Good and Fair
Deficiency	ACOUSTIC TILES ON PLASTER: DAMAGED/MISSING - ACTIVE LEAK
Deficiency Location/Instance	Near center
Deficiency Quantity	10
Quantity Uom	S.F.
Potential Action	REPLACE
Urgency of Action	PRIORITY 5
Purpose of Action	LEVEL 2
Deficiency Photo1

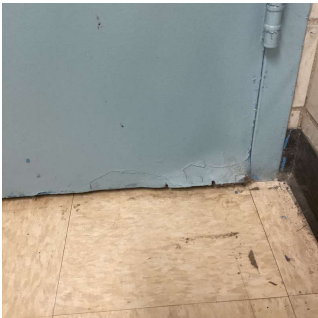
Question	Response
INTERIOR	
GYMNASIUM	
Ceiling	
Violations	Near center No violations recorded.
Door(s)	
Instance on 1st Floor	Inspected
Condition	5 - Poor
Deficiency	METAL: DETERIORATED DOOR
Deficiency Location/Instance	Exits Right and Left Side
Deficiency Quantity	4
Quantity Uom	EACH
Potential Action	MAINTENANCE
Urgency of Action	PRIORITY 3
Purpose of Action	LEVEL 2
Deficiency Photo1

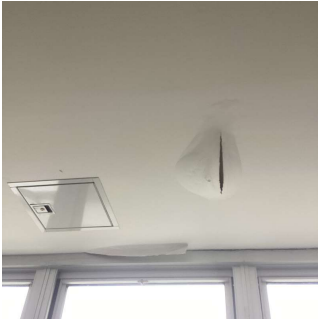
Question	Response
INTERIOR	
GYMNASIUM	
Stage	
Stage Curtains	
Condition	1 - Good
Deficiency	No deficiencies recorded
Walls	
Instance on 1st Floor	Inspected
Condition	2 - Between Good and Fair
Deficiency	No deficiencies recorded
Window Curtains/Shades/Blinds	
Instance on 1st Floor	Inspected
Condition	2 - Between Good and Fair
Deficiency	No deficiencies recorded
INTERIOR DOOR HARDWARE	
Condition	1 - Good
Deficiency	No deficiencies recorded
INTERIOR GUARDS	
Condition	1 - Good
Deficiency	No deficiencies recorded
KITCHEN	
Instance on 1st Floor	Inspected
Ceiling	
Instance on 1st Floor	Inspected
Condition	2 - Between Good and Fair
Deficiency	GYPSUM BOARD: DAMAGED/DETERIORATED
Deficiency Location/Instance	Room 051B
Deficiency Quantity	10
Quantity Uom	S.F.
Potential Action	REPLACE
Urgency of Action	PRIORITY 3
Purpose of Action	LEVEL 2
Deficiency Photo1

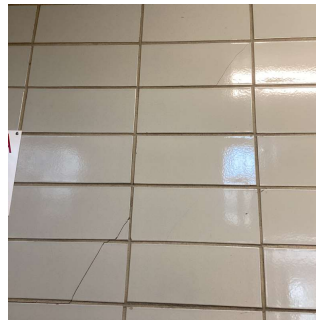
Stair A/1

GLAZED BLOCK: CRACKS/SPALLING

REPLACE

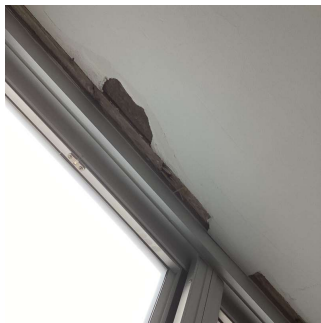
PLASTER: CRACKS/SPALLING - ACTIVE LEAK

REPLACE

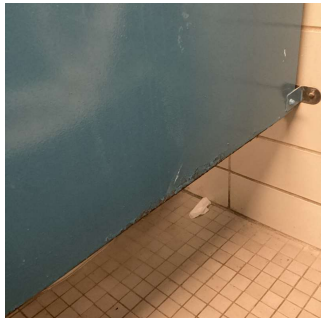
Room 102
Violations	No violations recorded.
Door(s)	Inspected
Condition	2 - Between Good and Fair
Deficiency	No deficiencies recorded
Floor Finish	Inspected
Condition	2 - Between Good and Fair
Deficiency	No deficiencies recorded
Stalls	Inspected
Condition	5 - Poor
Deficiency	RUST - MAJOR
Deficiency Location/Instance	Room 046
Deficiency Quantity	1
Quantity Uom	EACH
Potential Action	REPLACE
Urgency of Action	PRIORITY 3
Purpose of Action	LEVEL 2
Deficiency Photo1

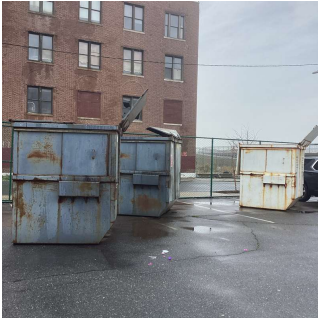
Question	Response
SITE	
CONTAINERIZATION	
Deficiency Photo1

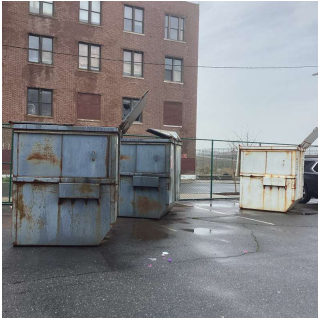
Violations	Parking Lot Area No violations recorded.
Deficiency	CONTAINER DAMAGED
Deficiency Location/Instance	Parking Lot Area
Deficiency Quantity	1
Quantity Uom	EACH
Potential Action	REPLACE
Urgency of Action	PRIORITY 3
Purpose of Action	LEVEL 2
Deficiency Photo1

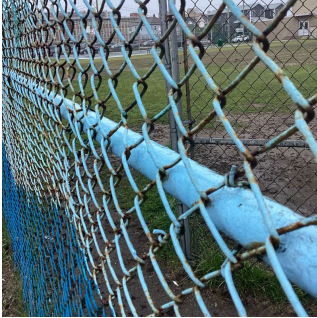
Question	Response
SITE	
Drainage System for Soil	Inspected
Catch Basins/Manhole - Surrounded by Soil	Inspected
Condition	2 - Between Good and Fair
Deficiency	No deficiencies recorded
Culverts - Soil Covering	Does not Exist
DRINKING FOUNTAINS	Does not Exist
FENCES	Inspected
Condition	4 - Between Fair and Poor
Deficiency	CHAIN LINK: RUST - MAJOR
Deficiency Location/Instance	Rockaway Beach
Deficiency Quantity	1,950
Quantity Uom	S.F.
Potential Action	REPLACE
Urgency of Action	PRIORITY 3
Purpose of Action	LEVEL 2
Deficiency Photo1

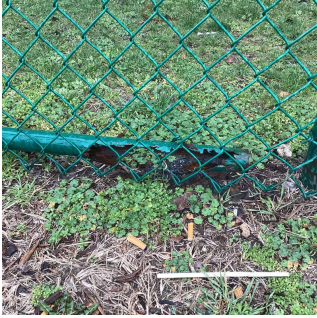
Violations	Rockaway Beach No violations recorded.
Deficiency	CHAIN LINK: DAMAGED POST/RAIL
Deficiency Location/Instance	Beach 111st Street, Beach 112nd Street, Rockaway Beach
Deficiency Quantity	200
Quantity Uom	L.F.
Potential Action	REPLACE
Urgency of Action	PRIORITY 3
Purpose of Action	LEVEL 2
Deficiency Photo1

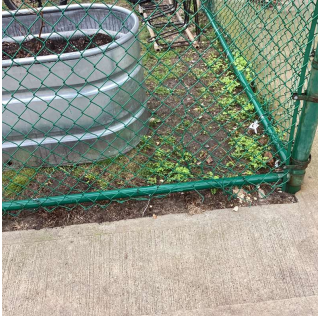
Violations	Beach 111st Street No violations recorded.
Deficiency	CHAIN LINK: DAMAGED/DETERIORATED

Deficiency Location/Instance	B112nd Street
Deficiency Quantity	200
Quantity Uom	S.F.
Potential Action	REPLACE

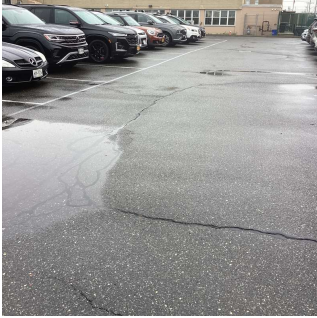
Violations	Near Center Parking Lot No violations recorded.
Deficiency	CRACKS - MAJOR
Deficiency Location/Instance	Parking Area, Near Playground
Deficiency Quantity	2,000
Quantity Uom	S.F.
Potential Action	REPLACE
Urgency of Action	PRIORITY 3
Purpose of Action	LEVEL 2

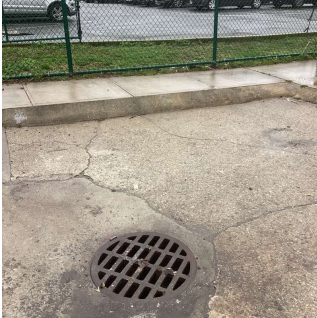
Violations	Parking Area No violations recorded.
Concrete	Inspected
Condition	3 - Fair
Deficiency	DAMAGED/DETERIORATED/MISSING SECTIONS
Deficiency Location/Instance	Near Parking Lot
Deficiency Quantity	200
Quantity Uom	S.F.
Potential Action	REPLACE
Urgency of Action	PRIORITY 3
Purpose of Action	LEVEL 2
Deficiency Photo1

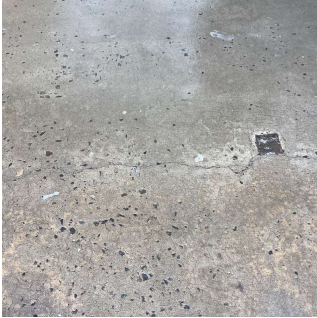
Violations	Near Parking Lot No violations recorded.
Pavers	Does not Exist
Student Use	Inspected
Gravel Exists?	No
Asphalt	Inspected
Condition	1 - Good
Deficiency	No deficiencies recorded
Concrete	Does not Exist
Pavers	Does not Exist
Site Sidewalks & Walkways	Inspected
Asphalt	Does not Exist
Concrete	Inspected
Condition	3 - Fair
Deficiency	DAMAGED/DETERIORATED/MISSING SECTIONS
Deficiency Location/Instance	Near Cafeteria Exit, Student Use, Playground

Question	Response
SITE	
PAVING	
Site Sidewalks & Walkways	
Concrete	
Deficiency Quantity	300
Quantity Uom	S.F.
Potential Action	REPLACE
Urgency of Action	PRIORITY 3
Purpose of Action	LEVEL 2
Deficiency Photo1

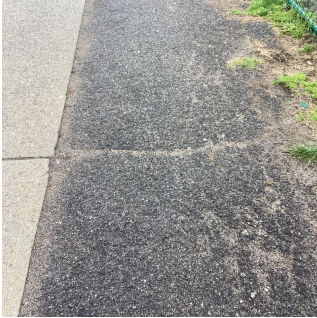
Near Cafeteria Exit
Violations	No violations recorded.
Pavers	Does not Exist
DOT Sidewalk	Inspected
Asphalt	Inspected
Condition	3 - Fair
Deficiency	CRACKS - MAJOR
Deficiency Location/Instance	Beach 112nd Street, Beach 111st Street, Rockaway Beach
Deficiency Quantity	300
Quantity Uom	S.F.
Potential Action	REPLACE
Urgency of Action	PRIORITY 3
Purpose of Action	LEVEL 2
Deficiency Photo1

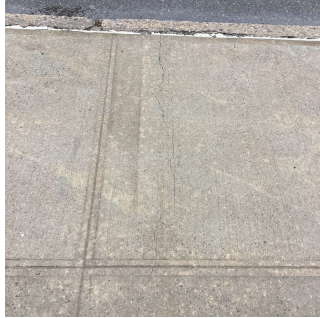
B112nd Street
Violations	No violations recorded.
Concrete	Inspected
Condition	4 - Between Fair and Poor
Deficiency	DAMAGED/DETERIORATED/MISSING SECTIONS
Deficiency Location/Instance	Beach 112nd Street, Beach 111st Street, Rockaway Beach
Deficiency Quantity	850
Quantity Uom	S.F.
Potential Action	REPLACE
Urgency of Action	PRIORITY 3

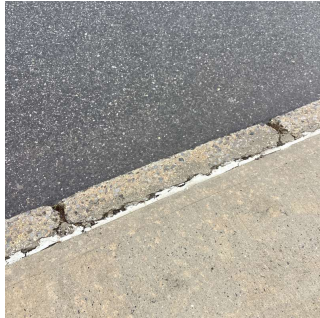
B112nd Street
Violations	No violations recorded.
Damaged Curbs	
Deficiency	DAMAGED CURBS
Deficiency Location/Instance	Beach 112nd Street, Beach 111st Street, Rockaway Beach
Deficiency Quantity	300
Quantity Uom	L.F.
Potential Action	REPLACE
Urgency of Action	PRIORITY 3
Purpose of Action	LEVEL 2
Deficiency Photo1
