**NYC Department of Education**  
**Building Condition Assessment Survey 2023 - 2024**

Architectural Inspection

**Q600**

**Asset:** QUEENS VOC HS - Q, 37-02 47 AVENUE, New York, 11101

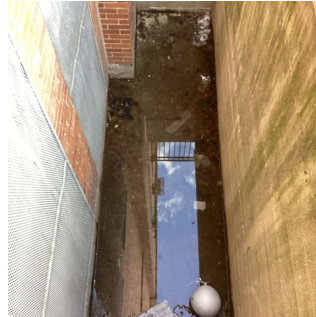
AW5

Question	Response
<b>Architectural</b>	
<b>EXTERIOR</b>	Inspected
<b>AREAWAY</b>	Inspected
Instance on AW1-AW9	Inspected
Instance Condition	4 - Between Fair and Poor
Instance Quantity	9
Instance Quantity Uom	EACH
Deficiency	AREAWAY WALLS: CRACKS AND SPALLING
Roof Plan reference	
Deficiency Quantity	10
Quantity Uom	S.F.
Potential Action	REPAIR
Urgency of Action	PRIORITY 3
Purpose of Action	LEVEL 2

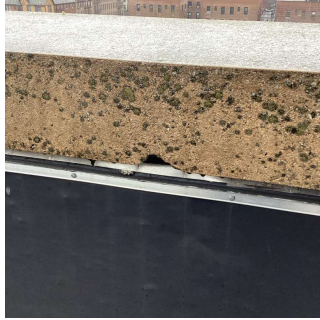
Violations	Roof 1 No violations recorded.
<b>CORNICE</b>	Inspected
Condition	2 - Between Good and Fair
Deficiency	No deficiencies recorded
<b>DOORS</b>	Inspected
<b>DOORS AND FRAMES</b>	Inspected
Condition	2 - Between Good and Fair
Deficiency	No deficiencies recorded
<b>DOOR HARDWARE</b>	Inspected
Condition	3 - Fair
Deficiency	No deficiencies recorded
<b>LINTELS</b>	Inspected
Condition	2 - Between Good and Fair
Deficiency	No deficiencies recorded
<b>TRANSOM/SIDE LIGHT</b>	Inspected
Condition	3 - Fair
Deficiency	WOOD: BROKEN GLASS
Roof Plan reference

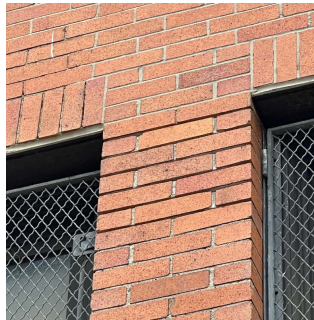
Facade K

BRICK: MAJOR / THRU CRACKS

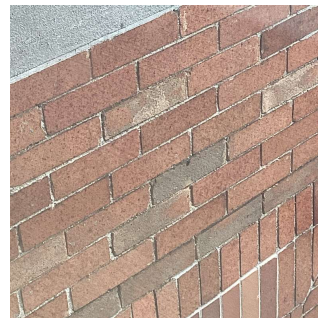
Facade E

Question	Response
<b>EXTERIOR</b>	
<b>EXTERIOR WALLS</b>	
Violations	No violations recorded.
Deficiency	STONE: CHIPPED/SPALLED/BROKEN PIECES - MINOR
Roof Plan reference

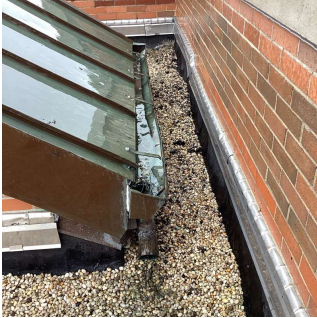
Violations	Roof 2 No violations recorded.
<b>PLAZA DECK</b>	Does not Exist
<b>ROOF</b>	Inspected
<b>Roofing</b>	Inspected
Replacement Quantity	35,200
Replacement Uom	S.F.
<b>ROOF HATCH/SMOKE HATCH</b>	Inspected
Condition	2 - Between Good and Fair
Deficiency	No deficiencies recorded
<b>LEADERS, GUTTERS, DOWNSPOUTS, SCUPPERS</b>	Inspected
Condition	3 - Fair
Deficiency	DAMAGED/MISSING
Roof Plan reference

Deficiency Quantity	10
Quantity Uom	L.F.
Potential Action	REPLACE
Urgency of Action	PRIORITY 4
Purpose of Action	LEVEL 2
Deficiency Photo1

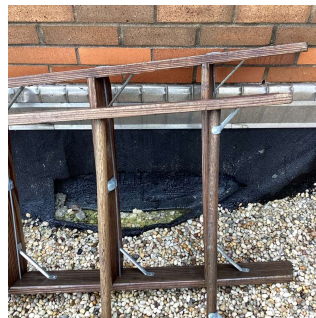
BUILT-UP: FLASHING: BASE FLASHING DETERIORATED

REMOVE AND REPLACE

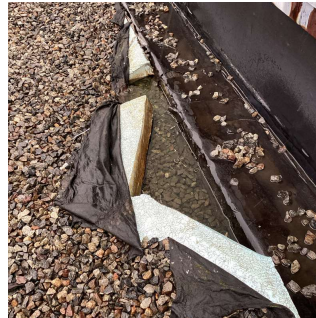
Roof 1

Do solar panels exist on these roofs?	No
Is/Are the roof(s) suitable for Solar Panel installation?	Yes
Installation Year	2005
Source of Installation	Custodial Staff
Deficiency	IRMA: ROOFING: MAJOR ACTIVE ROOF LEAKS IN INSTRUCTIONAL SPACE

400  
S.F.  
REPLACE ROOFING WITHOUT MAJOR EQUIPMENT  
REMOVAL  
PRIORITY 5  
LEVEL 2

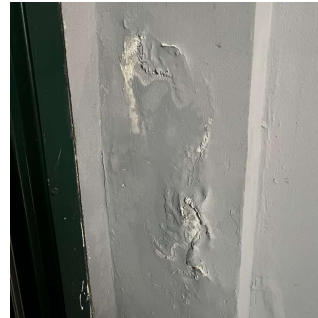
BH2

**BULKHEAD/PENTHOUSE WALLS/EXTERIOR:  
CRACKS/SPALLING - MINOR**

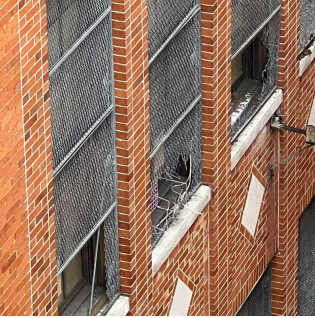
Question	Response
<b>EXTERIOR</b>	
<b>WINDOWS</b>	
<b>EXTERIOR GUARDS</b>	
Elevation

Deficiency Quantity	60
Quantity Uom	S.F.
Potential Action	REPLACE
Urgency of Action	PRIORITY 4
Purpose of Action	LEVEL 2
Deficiency Photo1

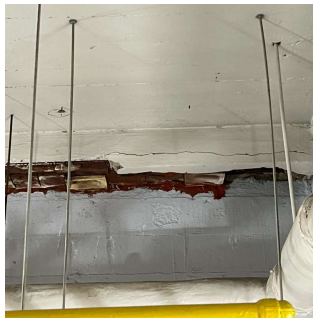
Yes	Potential Falling Debris	Deteriorated concrete fireproofing is a potential falling debris hazard.	INTERIOR   STRUCTURAL   COLUMNS/BEARING WALLS	Basement - Oil Tank Room	Frank Ruggiero	Fireman

Inspected  
Does not Exist  
Inspected  
Inspected  
3 - Fair  
STEEL COLUMNS/BEAMS: DETERIORATED CONCRETE  
FIREPROOFING  
Basement - Oil Tank Room  
20  
S.F.  
REPLACE  
PRIORITY 5  
LEVEL 6

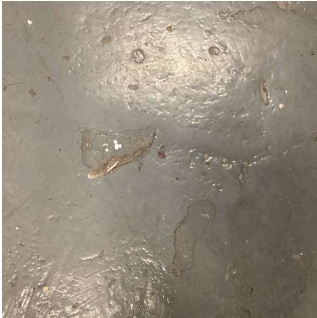
Question	Response
<b>INTERIOR</b>	
<b>STRUCTURAL</b>	
<b>COLUMNS/BEAMS/BEARING WALLS</b>	Inspected
	Basement - Oil Tank Room
Violations	No violations recorded.
<b>FLOOR STRUCTURE</b>	Inspected
Condition	3 - Fair
Deficiency	CONCRETE: CRACKS/SPALLED/REINFORCEMENT EXPOSED
Deficiency Location/Instance	Basement - Rooms B51, B54A, Boiler Room
Deficiency Quantity	80
Quantity Uom	S.F.
Potential Action	REPAIR
Urgency of Action	PRIORITY 3
Purpose of Action	LEVEL 5
Deficiency Photo1

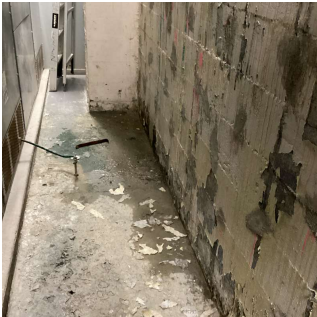
Violations	Boiler Room No violations recorded.
<b>FOUNDATION WALLS</b>	Inspected
Material Type(s)	Concrete
Condition	4 - Between Fair and Poor
Deficiency	CONCRETE: WATER INFILTRATION IN ELECTRICAL PANEL ROOM
Deficiency Location/Instance	Electrical Panel Room
Deficiency Quantity	100
Quantity Uom	S.F.
Potential Action	INSTALL WATERPROOFING
Urgency of Action	PRIORITY 5
Purpose of Action	LEVEL 6
Deficiency Photo1

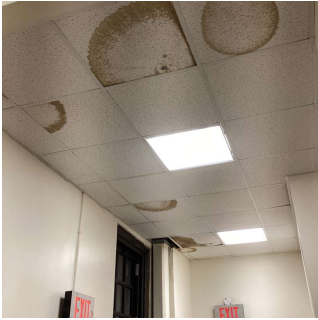
Question	Response
<b>INTERIOR</b>	
<b>STRUCTURAL</b>	Inspected
<b>VAULTS-BUNKERS</b>	Does not Exist
<b>AUDITORIUM</b>	Inspected
Instance on 1st Floor (534 Seats)	Inspected
<b>Ceiling</b>	
Instance on 1st Floor (534 Seats)	Inspected
Condition	2 - Between Good and Fair
Deficiency	ACOUSTIC TILES: DAMAGED/MISSING - ACTIVE LEAK
Deficiency Location/Instance	Back stage Right Side
Deficiency Quantity	40
Quantity Uom	S.F.
Potential Action	REPLACE
Urgency of Action	PRIORITY 5
Purpose of Action	LEVEL 2
Deficiency Photo1

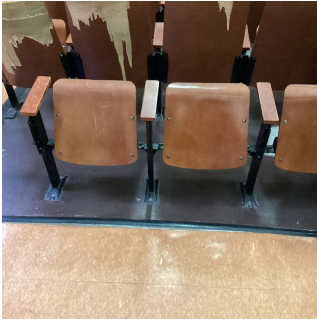
Question	Response
<b>INTERIOR</b>	
<b>AUDITORIUM</b>	Inspected
<b>Fixed H/C Lift</b>	
Condition	2 - Between Good and Fair
Deficiency	No deficiencies recorded
<b>Fixed Seating</b>	
Instance on 1st Floor (534 Seats)	Inspected
Condition	5 - Poor
Deficiency	DAMAGED/BROKEN/INOPERABLE
Deficiency Location/Instance	Seats V/19, 21, 23, 25
Deficiency Quantity	4
Quantity Uom	EACH
Potential Action	REPLACE
Urgency of Action	PRIORITY 5
Purpose of Action	LEVEL 6
Deficiency Photo1

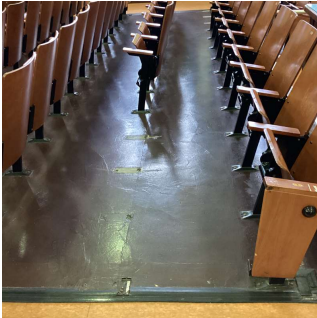
Seat V/25
Violations	No violations recorded.
Deficiency	DAMAGED/BROKEN/INOPERABLE
Deficiency Location/Instance	Seat Q/1, S/2, 4, 6, 8 and others
Deficiency Quantity	52
Quantity Uom	EACH
Potential Action	REPLACE
Urgency of Action	PRIORITY 3
Purpose of Action	LEVEL 2
Deficiency Photo1

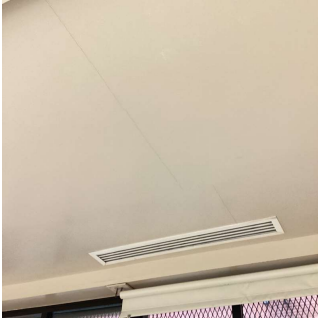
Question	Response
<b>INTERIOR</b>	
<b>CAFETERIA</b>	
<b>Ceiling</b>	
Instance on 2nd Floor	Inspected
Condition	2 - Between Good and Fair
Deficiency	GYPSUM BOARD: DAMAGED/DETERIORATED
Deficiency Location/Instance	Near Windows, Near Entrance, near Serving area
Deficiency Quantity	30
Quantity Uom	S.F.
Potential Action	REPLACE
Urgency of Action	PRIORITY 3
Purpose of Action	LEVEL 2
Deficiency Photo1

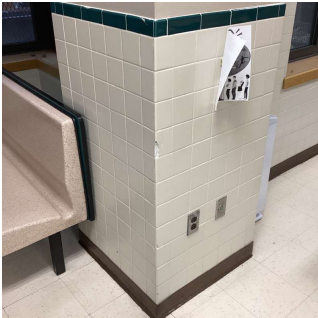
Violations	Near Entrance No violations recorded.
<b>Sliding-folding Partition</b>	
Instance on 2nd Floor	Does not Exist
<b>Stage</b>	
Instance on 2nd Floor	Does not Exist
<b>Walls</b>	
Instance on 2nd Floor	Inspected
Condition	2 - Between Good and Fair
Deficiency	CERAMIC TILE: BROKEN/ MISSING
Deficiency Location/Instance	Near Windows, Near Entrance
Deficiency Quantity	20
Quantity Uom	S.F.
Potential Action	REPLACE
Urgency of Action	PRIORITY 3
Purpose of Action	LEVEL 2
Deficiency Photo1

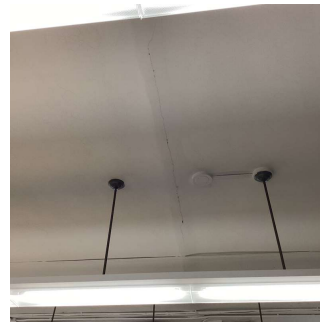
Room 307

**Ceiling**

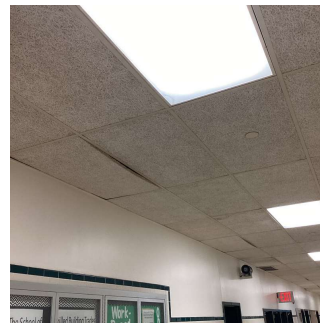
Corridor near Room 447

TECTUM: DAMAGED/MISSING

REPLACE

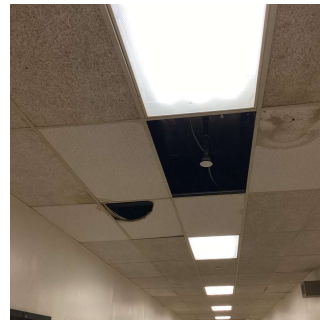
Corridor near Room 439

TECTUM: DAMAGED/MISSING - ACTIVE LEAK

REPLACE

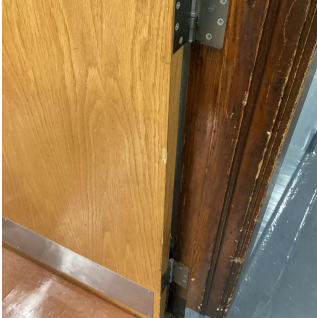
Question	Response
<b>INTERIOR</b>	
<b>CLASSROOMS/CORRIDORS/ADMIN SPACES</b>	
<b>Door(s)</b>	Inspected
Condition	5 - Poor
Deficiency	WOOD: DETERIORATED DOOR
Deficiency Location/Instance	Rooms 423, 404, 309, 303, 302 and others
Deficiency Quantity	17
Quantity Uom	EACH
Potential Action	MAINTENANCE
Urgency of Action	PRIORITY 3
Purpose of Action	LEVEL 2
Deficiency Photo1

Room 404
Violations	No violations recorded.
<b>Floor Finish</b>	Inspected
Condition	3 - Fair
Deficiency	TERRAZZO: CRACKS
Deficiency Location/Instance	Corridor near Rooms 109, 107A, 106, 104, Corridor near Auditorium and others
Deficiency Quantity	80
Quantity Uom	S.F.
Potential Action	REPLACE
Urgency of Action	PRIORITY 3
Purpose of Action	LEVEL 2
Deficiency Photo1

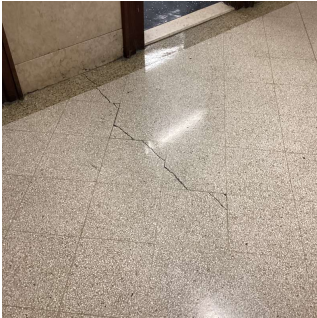
Corridor near Room 104
Violations	No violations recorded.
Deficiency	VINYL TILES: TRIPPING HAZARD - ELECTRICAL OUTLET
Deficiency Location/Instance	Room 411
Deficiency Quantity	10
Quantity Uom	S.F.

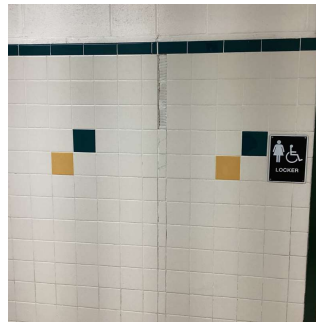
Corridor near Room B39

Question	Response
<b>INTERIOR</b>	
<b>CLASSROOMS/CORRIDORS/ADMIN SPACES</b>	
<b>Floor Finish</b>	
Deficiency	VINYL TILES: BROKEN/DETERIORATED/MISSING TILES
Deficiency Location/Instance	Rooms 411, 406, 404, 323, 103 and others
Deficiency Quantity	1,700
Quantity Uom	S.F.
Potential Action	REPLACE
Urgency of Action	PRIORITY 3
Purpose of Action	LEVEL 2
Deficiency Photo1	 
	Room 406
Violations	No violations recorded.
Deficiency	CERAMIC TILE: BROKEN/MISSING TILES
Deficiency Location/Instance	Main Entrance Lobby
Deficiency Quantity	20
Quantity Uom	S.F.
Potential Action	REPLACE
Urgency of Action	PRIORITY 3
Purpose of Action	LEVEL 2
Deficiency Photo1	 
	Main Entrance Lobby
Violations	No violations recorded.
<b>Walls</b>	<b>Inspected</b>
Condition	2 - Between Good and Fair
Deficiency	CERAMIC TILE: BROKEN/ MISSING
Deficiency Location/Instance	Corridor near Room B39, Corridor near Stair B/ Basement
Deficiency Quantity	20
Quantity Uom	S.F.

Potential Action	REPLACE
Urgency of Action	PRIORITY 3
Purpose of Action	LEVEL 2

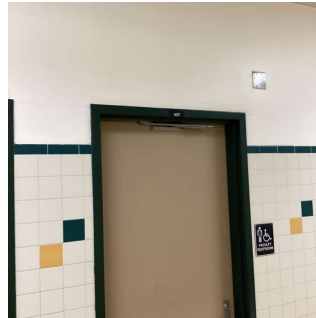
Corridor near Room 437

**GYPSUM BOARD: DETERIORATED**

REPLACE

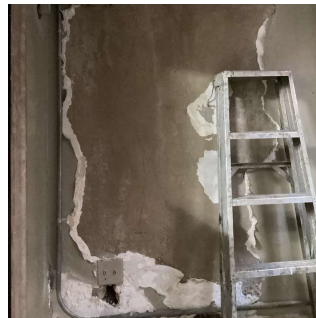
Exit Vestibule near Auditorium

**PLASTER: CRACKS/SPALLING**

REPLACE

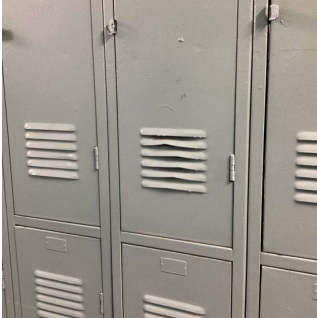
Question	Response
<b>INTERIOR</b>	
<b>CLASSROOMS/CORRIDORS/ADMIN SPACES</b>	
<b>Walls</b>	Inspected
Violations	No violations recorded.
<b>Specialties</b>	Inspected
<b>Classroom Locker(s)</b>	Inspected
Condition	2 - Between Good and Fair
Deficiency	DAMAGED UNITS
Deficiency Location/Instance	Corridor near Room 416
Deficiency Quantity	1
Quantity Uom	EACH
Potential Action	REPLACE
Urgency of Action	PRIORITY 3
Purpose of Action	LEVEL 2
Deficiency Photo1

Violations	Corridor near Room 416 No violations recorded.
<b>Fixed Seating</b>	Does not Exist
<b>GYMNASIUM</b>	
Instance on Basement	Inspected
<b>Ceiling</b>	Inspected
Instance on Basement	Inspected
Condition	2 - Between Good and Fair
Deficiency	No deficiencies recorded
<b>Door(s)</b>	Inspected
Instance on Basement	Inspected
Condition	2 - Between Good and Fair
Deficiency	No deficiencies recorded
<b>Fixed Equipment</b>	Inspected
Instance on Basement	Inspected
Condition	2 - Between Good and Fair

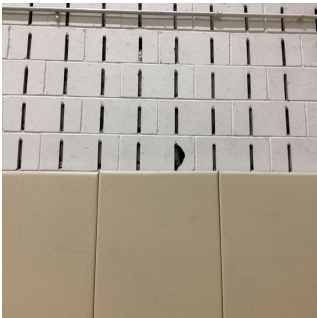
Question	Response
<b>INTERIOR</b>	
<b>GYMNASIUM</b>	
<b>Sliding-folding Partition</b>	
Condition	2 - Between Good and Fair
Deficiency	No deficiencies recorded
<b>Stage</b>	
Instance on Basement	Does not Exist
<b>Walls</b>	
Instance on Basement	Inspected
Condition	2 - Between Good and Fair
Deficiency	MASONRY: CRACKS/SPALLING
Deficiency Location/Instance	Near Exit 16
Deficiency Quantity	10
Quantity Uom	S.F.
Potential Action	REPLACE
Urgency of Action	PRIORITY 3
Purpose of Action	LEVEL 2
Deficiency Photo1

Near Exit 16
Violations	No violations recorded.
Deficiency	WALL PADDING: DETERIORATED
Deficiency Location/Instance	Near Exit 16, Near Windows, Near Entrance
Deficiency Quantity	120
Quantity Uom	S.F.
Potential Action	REPLACE
Urgency of Action	PRIORITY 3
Purpose of Action	LEVEL 2
Deficiency Photo1

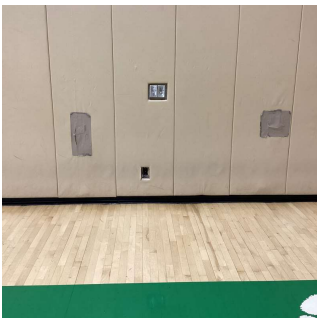
Near Exit 16
Violations	No violations recorded.
<b>Window Curtains/Shades/Blinds</b>	
Instance on Basement	Does not Exist

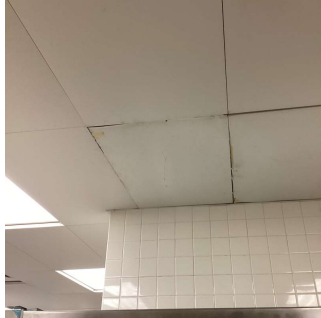
Question	Response
<b>INTERIOR</b>	
<b>INTERIOR DOOR HARDWARE</b>	Inspected
Deficiency	No deficiencies recorded
<b>INTERIOR GUARDS</b>	Inspected
Condition	3 - Fair
Deficiency	DETERIORATED/TORN-OUT/MISSING
Deficiency Location/Instance	Stairs X/3, Y/2, 1, Z/4, 2 and others
Deficiency Quantity	200
Quantity Uom	S.F.
Potential Action	REPLACE
Urgency of Action	PRIORITY 3
Purpose of Action	LEVEL 2
Deficiency Photo1	 
Violations	Stair Z/4 No violations recorded.
<b>KITCHEN</b>	Inspected
Instance on 2nd Floor	Inspected
<b>Ceiling</b>	Inspected
Instance on 2nd Floor	Inspected
Condition	3 - Fair
Deficiency	GYPSON BOARD: DAMAGED/DETERIORATED
Deficiency Location/Instance	Serving area
Deficiency Quantity	20
Quantity Uom	S.F.
Potential Action	REPLACE
Urgency of Action	PRIORITY 3
Purpose of Action	LEVEL 2
Deficiency Photo1	 
Violations	Serving area No violations recorded.
Deficiency	METAL PAN: DAMAGED/MISSING
Deficiency Location/Instance	Near Room 250A

Deficiency Quantity	10
Quantity Uom	S.F.

Potential Action	REPLACE
Urgency of Action	PRIORITY 3
Purpose of Action	LEVEL 2
Deficiency Photo1

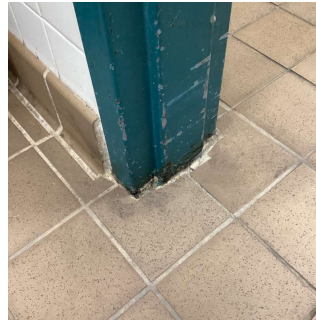
Instance on 2nd Floor	Inspected
Condition	3 - Fair
Deficiency	METAL: DETERIORATED DOOR AND FRAME
Deficiency Location/Instance	Serving area
Deficiency Quantity	1
Quantity Uom	EACH
Potential Action	MAINTENANCE
Urgency of Action	PRIORITY 3
Purpose of Action	LEVEL 2

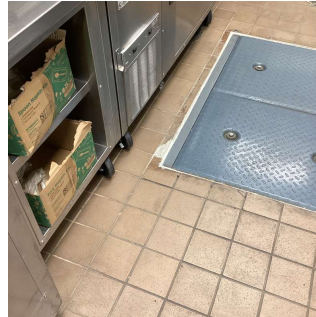
Serving area

QUARRY TILE: BROKEN/MISSING TILES

REPLACE

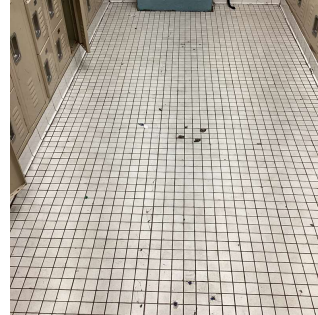
Near Locker 524

Near Locker 4
Violations	No violations recorded.
Instance on Room B45 (828 Lockers)	Inspected
Condition	2 - Between Good and Fair
Deficiency	CERAMIC TILE: BROKEN/MISSING TILES
Deficiency Location/Instance	Near Lockers 562, 524, 486, 435, 76 and others
Deficiency Quantity	40
Quantity Uom	S.F.
Potential Action	REPLACE

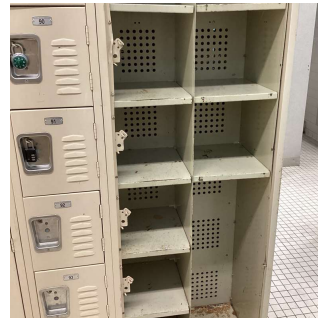
Locker 95

DAMAGED UNITS

REPLACE

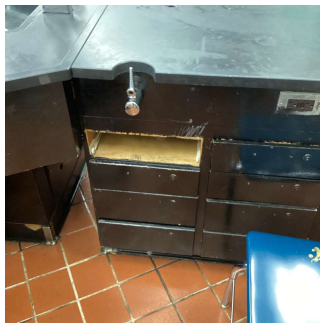
Violations	Near Locker 668 No violations recorded.
<b>MULTI-PURPOSE ROOM</b>	Does not Exist
<b>SCIENCE DEMO ROOM</b>	Inspected
Instance on Room 204	Inaccessible
Instance on Rooms 207, 202	Inspected
Alternative use	No
<b>Fixed Equipment</b>	
Instance on Rooms 207, 202	Inspected
Condition	2 - Between Good and Fair
Deficiency	No deficiencies recorded
<b>SCIENCE LAB</b>	Inspected
Instance on Room 203	Inaccessible
Instance on Room 211	Inspected
Alternative use	No
<b>Fixed Equipment</b>	
Instance on Room 211	Inspected
Condition	4 - Between Fair and Poor
Deficiency	CABINETRY: MISSING/DAMAGED
Deficiency Location/Instance	Room 211
Deficiency Quantity	16
Quantity Uom	L.F.
Potential Action	REPLACE
Urgency of Action	PRIORITY 3
Purpose of Action	LEVEL 2
Deficiency Photo1

Violations	Room 211 No violations recorded.
<b>SCIENCE PREP ROOM</b>	Inspected

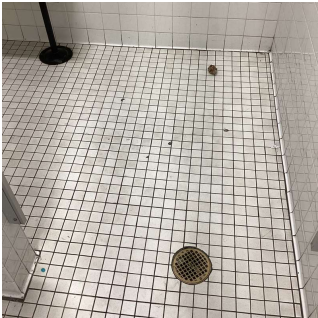
Question	Response
<b>INTERIOR</b>	
<b>SCIENCE PREP ROOM</b>	Inspected
<b>SHOWER ROOM</b>	Inspected
Instance on Room B34P	Inaccessible
Instance on Room B34S	Inaccessible
Instance on Room B39	Inspected
Alternative use	Yes
Instance on Room B45	Inspected
Alternative use	Yes
<b>Ceiling</b>	
Instance on Room B39	Inspected
Condition	2 - Between Good and Fair
Deficiency	No deficiencies recorded
Instance on Room B45	Inspected
Condition	2 - Between Good and Fair
Deficiency	No deficiencies recorded
<b>Door(s)</b>	
Instance on Room B39	Does not Exist
Instance on Room B45	Does not Exist
<b>Floor Finish</b>	
Instance on Room B45	Inspected
Condition	3 - Fair
Deficiency	CERAMIC TILE: BROKEN/MISSING TILES
Deficiency Location/Instance	Rear
Deficiency Quantity	10
Quantity Uom	S.F.
Potential Action	REPLACE
Urgency of Action	PRIORITY 3
Purpose of Action	LEVEL 2
Deficiency Photo1

Violations	Rear No violations recorded.
<b>Walls</b>	
Instance on Room B39	Inspected

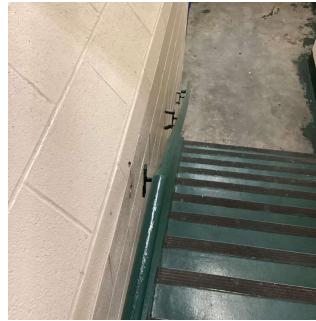
Stair D/Basement

**Railings**

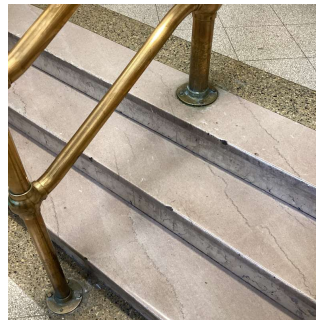
Exit 0 Vestibule

STONE: BROKEN/MISSING

REPLACE

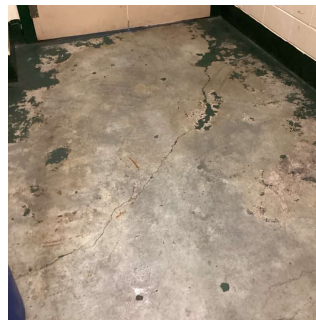
CONCRETE: CRACKS/SPALLING - MAJOR

Question	Response
<b>INTERIOR</b>	
<b>STAIRS/RAMPS: INTERIOR</b>	
<b>Stairs and Landings</b>	Inspected
	Stair D/Basement
Violations	No violations recorded.
<b>Walls</b>	Inspected
Condition	2 - Between Good and Fair
Deficiency	PLASTER: CRACKS/SPALLING
Deficiency Location/Instance	Stairs A/Basement, X/Basement, 4, Y/3
Deficiency Quantity	80
Quantity Uom	S.F.
Potential Action	REPLACE
Urgency of Action	PRIORITY 3
Purpose of Action	LEVEL 2
Deficiency Photo1

REPLACE

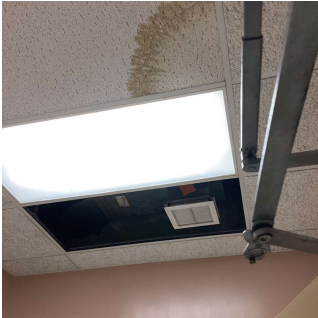
Violations	Stair X/Basement No violations recorded.
<b>TOILET ROOMS - STAFF</b>	
	Inspected
<b>Ceiling</b>	Inspected
Condition	2 - Between Good and Fair
Deficiency	ACOUSTIC TILES: DAMAGED/MISSING
Deficiency Location/Instance	Rooms 339
Deficiency Quantity	10
Quantity Uom	S.F.
Potential Action	REPLACE
Urgency of Action	PRIORITY 3
Purpose of Action	LEVEL 2
Deficiency Photo1

Violations	Room 339 No violations recorded.
<b>Door(s)</b>	Inspected
Condition	5 - Poor
Deficiency	METAL: DAMAGED LOUVER

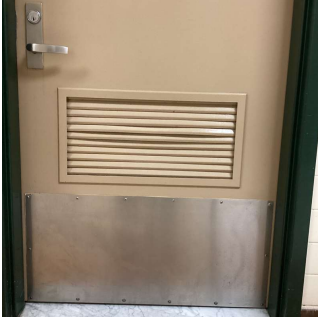
Question	Response
<b>INTERIOR</b>	
<b>TOILET ROOMS - STAFF</b>	
<b>Door(s)</b>	
Deficiency Location/Instance	Rooms 339, 337, 237
Deficiency Quantity	3
Quantity Uom	EACH
Potential Action	MAINTENANCE
Urgency of Action	PRIORITY 3
Purpose of Action	LEVEL 2
Deficiency Photo1

Room 339
Violations	No violations recorded.
Deficiency	WOOD: DETERIORATED DOOR
Deficiency Location/Instance	Rooms 415, 315, 215, 201
Deficiency Quantity	4
Quantity Uom	EACH
Potential Action	MAINTENANCE
Urgency of Action	PRIORITY 3
Purpose of Action	LEVEL 2
Deficiency Photo1

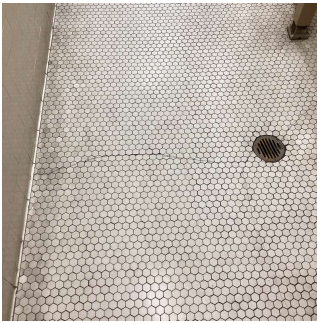
Room 415
Violations	No violations recorded.
<b>Floor Finish</b>	Inspected
Condition	3 - Fair
Deficiency	CERAMIC TILE: BROKEN/MISSING TILES
Deficiency Location/Instance	Rooms 315, 215, inside Gymnasium
Deficiency Quantity	30
Quantity Uom	S.F.
Potential Action	REPLACE
Urgency of Action	PRIORITY 3
Purpose of Action	LEVEL 2

Room 215
Violations	No violations recorded.
<b>Stalls</b>	
Condition	Inspected
	5 - Poor
Deficiency	RUST - MAJOR
Deficiency Location/Instance	Rooms 415, 315
Deficiency Quantity	2
Quantity Uom	EACH
Potential Action	REPLACE
Urgency of Action	PRIORITY 3
Purpose of Action	LEVEL 2
Deficiency Photo1

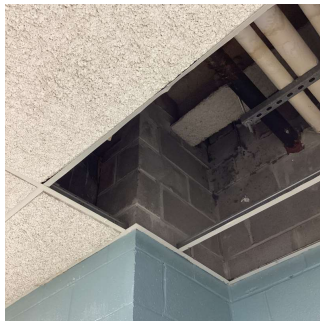
Question	Response
<b>INTERIOR</b>	
<b>TOILET ROOMS - STAFF</b>	
<b>Walls</b>	
Deficiency Photo1	 
Violations	Room 415 No violations recorded.
<b>TOILET ROOMS - STUDENTS</b>	
<b>Ceiling</b>	Inspected
Condition	2 - Between Good and Fair
Deficiency	ACOUSTIC TILES: DAMAGED/MISSING
Deficiency Location/Instance	Rooms B34C, Room 135
Deficiency Quantity	20
Quantity Uom	S.F.
Potential Action	REPLACE
Urgency of Action	PRIORITY 3
Purpose of Action	LEVEL 2
Deficiency Photo1

Violations	Room B34C No violations recorded.
<b>Door(s)</b>	
<b>Condition</b>	Inspected
Condition	5 - Poor
Deficiency	METAL: DAMAGED LOUVER
Deficiency Location/Instance	Rooms 341, 335, 235, 135, 107A
Deficiency Quantity	5
Quantity Uom	EACH
Potential Action	MAINTENANCE
Urgency of Action	PRIORITY 3
Purpose of Action	LEVEL 2

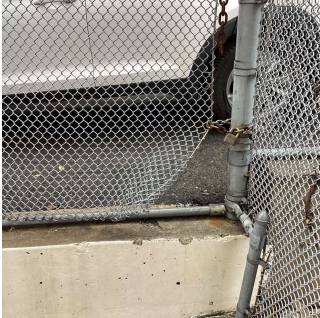
Question	Response
<b>SITE</b>	
<b>Drainage System for Concrete</b>	
<b>Catch Basins/Manhole - Surrounded by concrete</b>	
Deficiency	DAMAGED COVER
Deficiency Location/Instance	Near Exit 6
Deficiency Quantity	1
Quantity Uom	EACH
Potential Action	REPLACE
Urgency of Action	PRIORITY 3
Purpose of Action	LEVEL 2
Deficiency Photo1	 
Violations	Near Exit 6 No violations recorded.
<b>Culverts - Concrete Covering</b>	
	Does not Exist
<b>Drainage System for Soil</b>	
	Does not Exist
<b>DRINKING FOUNTAINS</b>	
Condition	Inspected
	2 - Between Good and Fair
Deficiency	No deficiencies recorded
<b>FENCES</b>	
Condition	Inspected
	3 - Fair
Deficiency	WROUGHT IRON: DAMAGED/DETERIORATED
Deficiency Location/Instance	47th Avenue, 37th Street
Deficiency Quantity	240
Quantity Uom	S.F.
Potential Action	REPLACE
Urgency of Action	PRIORITY 3
Purpose of Action	LEVEL 2
Deficiency Photo1	 
Violations	47th Avenue No violations recorded.
Deficiency	CHAIN LINK: DAMAGED/DETERIORATED

Deficiency Location/Instance	handball court, 38th Street
Deficiency Quantity	100
Quantity Uom	S.F.

Question	Response
<b>SITE</b>	
<b>FENCES</b>	
Potential Action	REPLACE
Urgency of Action	PRIORITY 3
Purpose of Action	LEVEL 2
Deficiency Photo1

handball court
Violations	No violations recorded.
Deficiency	CHAIN LINK: DAMAGED POST/RAIL
Deficiency Location/Instance	Near handball court
Deficiency Quantity	10
Quantity Uom	L.F.
Potential Action	REPLACE
Urgency of Action	PRIORITY 3
Purpose of Action	LEVEL 2
Deficiency Photo1

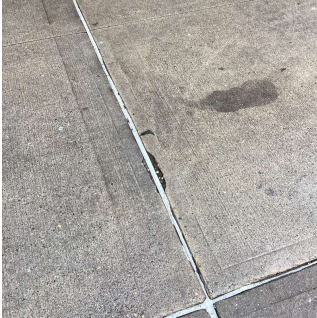
Near handball court
Violations	No violations recorded.
<b>IRRIGATION SYSTEM</b>	Does not Exist
<b>PAVING</b>	Inspected
<b>Student Non-Use</b>	Inspected
Gravel Exists?	No
<b>Asphalt</b>	Does not Exist
<b>Concrete</b>	Inspected
Condition	2 - Between Good and Fair
Deficiency	CRACKS - MAJOR
Deficiency Location/Instance	Near Exit 6
Deficiency Quantity	25
Quantity Uom	S.F.
Potential Action	REPLACE
Urgency of Action	PRIORITY 3
Purpose of Action	LEVEL 2

Near Exit 6
Violations	No violations recorded.
<b>Pavers</b>	Does not Exist
<b>Student Use</b>	Inspected
Gravel Exists?	No
<b>Asphalt</b>	Does not Exist
<b>Concrete</b>	Inspected
Condition	2 - Between Good and Fair
Deficiency	CRACKS - MAJOR
Deficiency Location/Instance	Near handball court
Deficiency Quantity	25
Quantity Uom	S.F.
Potential Action	REPLACE
Urgency of Action	PRIORITY 3
Purpose of Action	LEVEL 2
Deficiency Photo1

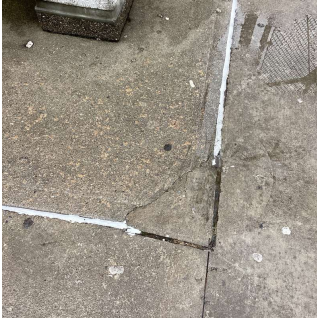
Near handball court
Violations	No violations recorded.
<b>Pavers</b>	Does not Exist
<b>Site Sidewalks &amp; Walkways</b>	Inspected
<b>Asphalt</b>	Does not Exist
<b>Concrete</b>	Inspected
Condition	3 - Fair
Deficiency	CRACKS - MAJOR
Deficiency Location/Instance	Exits 1, 5
Deficiency Quantity	75
Quantity Uom	S.F.
Potential Action	REPLACE

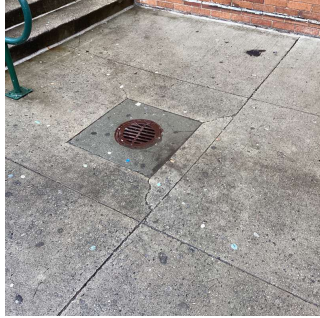
Question	Response
<b>SITE</b>	
<b>PAVING</b>	
<b>Site Sidewalks &amp; Walkways</b>	
<b>Concrete</b>	
Urgency of Action	PRIORITY 3
Purpose of Action	LEVEL 2
Deficiency Photo1

Violations	Exit 1 No violations recorded.
<b>Pavers</b>	Does not Exist
<b>DOT Sidewalk</b>	Inspected
<b>Asphalt</b>	Does not Exist
<b>Concrete</b>	Inspected
Condition	4 - Between Fair and Poor
Deficiency	DAMAGED/DETERIORATED/MISSING SECTIONS
Deficiency Location/Instance	47th Avenue
Deficiency Quantity	25
Quantity Uom	S.F.
Potential Action	REPLACE
Urgency of Action	PRIORITY 5
Purpose of Action	LEVEL 6
Deficiency Photo1

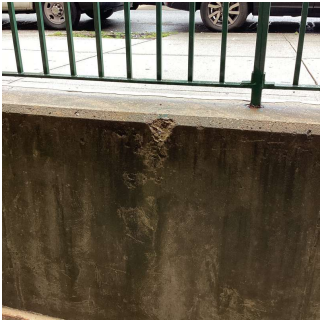
Question	Response
<b>SITE</b>	
<b>PAVING</b>	
<b>DOT Sidewalk</b>	
<b>Concrete</b>	
Deficiency	HEAVING
Deficiency Location/Instance	38th Street, 37th Street
Deficiency Quantity	175
Quantity Uom	S.F.
Potential Action	REPLACE
Urgency of Action	PRIORITY 4
Purpose of Action	LEVEL 4
Deficiency Photo1	 
Violations	38th Street 89765
<b>Pavers</b>	Does not Exist
<b>PLAYGROUNDS</b>	Does not Exist
<b>PLAYING SURFACE</b>	Does not Exist
<b>RETAINING WALLS</b>	Inspected
Are there any Retaining Walls 6' OR higher facing public street/sidewalk?	No
Condition	2 - Between Good and Fair
Deficiency	CAST IN PLACE CONCRETE: CRACKS/SPALLING - MAJOR
Deficiency Location/Instance	38th Street
Deficiency Quantity	10
Quantity Uom	S.F.
Potential Action	REPLACE
Urgency of Action	PRIORITY 3
Purpose of Action	LEVEL 2
Deficiency Photo1

Violations	38th Street No violations recorded.
<b>SEATING</b>	Inspected
<b>Benches</b>	Does not Exist
<b>Bleachers</b>	Inspected
