**NYC Department of Education**  
**Building Condition Assessment Survey 2023 - 2024**

Architectural Inspection

Q633

**Asset:** EAGLE ACADEMY - QUEENS, 171-10 LINDEN BOULEVARD, New York, 11434

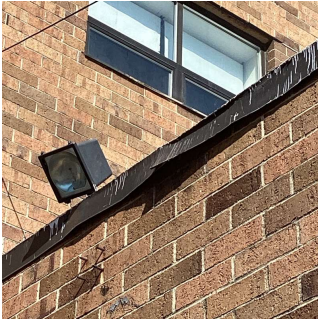
Question	Response
<b>EXTERIOR</b>	
<b>COPING</b>	
Deficiency Photo1

Violations	Roof 2 No violations recorded.
<b>CORNICE</b>	Does not Exist
<b>DOORS</b>	Inspected
<b>DOORS AND FRAMES</b>	Inspected
Condition	3 - Fair
Deficiency	METAL: DETERIORATED DOOR AND FRAME - MINOR DETERIORATION
Roof Plan reference	Q633

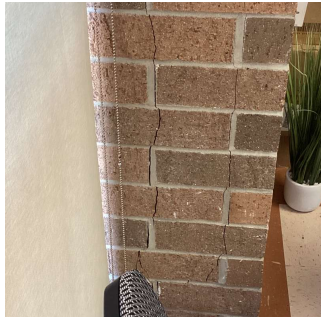
Question	Response
<b>INTERIOR</b>	
<b>STRUCTURAL</b>	
<b>COLUMNS/BEAMS/BEARING WALLS</b>	
Purpose of Action	LEVEL 5
Deficiency Photo1

Violations	Room 318 No violations recorded.
<b>FLOOR STRUCTURE</b>	
Condition	Inspected
Deficiency	2 - Between Good and Fair
Deficiency	No deficiencies recorded
<b>FOUNDATION WALLS</b>	
Material Type(s)	Inspected
Condition	Concrete
Condition	4 - Between Fair and Poor
Deficiency	CONCRETE: WATER INFILTRATION IN INSTRUCTIONAL SPACE
Deficiency Location/Instance	Basement - Stair B/Basement
Deficiency Quantity	100
Quantity Uom	S.F.
Potential Action	INSTALL WATERPROOFING
Urgency of Action	PRIORITY 5
Purpose of Action	LEVEL 5
Deficiency Photo1

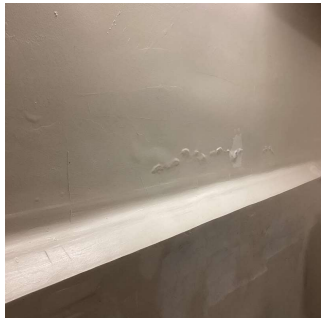
Violations	Basement - Stair B/Basement No violations recorded.
<b>ROOF STRUCTURE</b>	
Condition	Inspected
Deficiency	2 - Between Good and Fair
Deficiency	No deficiencies recorded
<b>VAULTS-BUNKERS</b>	
	Does not Exist
<b>AUDITORIUM</b>	
	Does not Exist

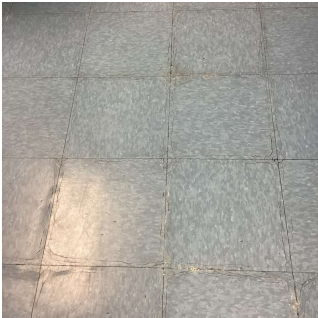
Question	Response
<b>INTERIOR</b>	
<b>CAFETERIA</b>	
<b>Ceiling</b>	
Deficiency	No deficiencies recorded
<b>Door(s)</b>	
Instance on Basement	Inspected
Condition	2 - Between Good and Fair
Deficiency	No deficiencies recorded
<b>Fixed Equipment</b>	
Instance on Basement	Does not Exist
<b>Floor Finish</b>	
Instance on Basement	Inspected
Condition	3 - Fair
Deficiency	VINYL TILES: DETERIORATED SUBSTRATE
Deficiency Location/Instance	Near Entrance
Deficiency Quantity	50
Quantity Uom	S.F.
Potential Action	REPLACE
Urgency of Action	PRIORITY 3
Purpose of Action	LEVEL 2
Deficiency Photo1

Violations	Near Entrance No violations recorded.
Deficiency	VINYL TILES: BROKEN/DETERIORATED/MISSING TILES
Deficiency Location/Instance	Near Serving Area, Entrances
Deficiency Quantity	150
Quantity Uom	S.F.
Potential Action	REPLACE
Urgency of Action	PRIORITY 3
Purpose of Action	LEVEL 2
Deficiency Photo1

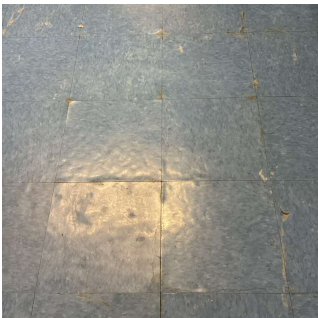
Violations	Near Serving Area No violations recorded.

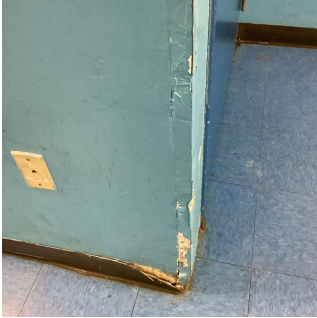
Question	Response
<b>INTERIOR</b>	
<b>CAFETERIA</b>	
<b>Sliding-folding Partition</b>	
Instance on Basement	Inspected
Condition	2 - Between Good and Fair
Deficiency	No deficiencies recorded
<b>Stage</b>	
Instance on Basement	Does not Exist
<b>Walls</b>	
Instance on Basement	Inspected
Condition	2 - Between Good and Fair
Deficiency	GYP SUM BOARD: DETERIORATED
Deficiency Location/Instance	Near Entrance, Center, Drinking Fountain, Serving Area
Deficiency Quantity	100
Quantity Uom	S.F.
Potential Action	REPLACE
Urgency of Action	PRIORITY 3
Purpose of Action	LEVEL 2
Deficiency Photo1

Violations	Near Serving Area No violations recorded.
<b>Window Curtains/Shades/Blinds</b>	
Instance on Basement	Does not Exist
<b>CLASSROOMS/CORRIDORS/ADMIN SPACES</b>	
<b>Ceiling</b>	
Condition	Inspected
Condition	2 - Between Good and Fair
Deficiency	GYP SUM BOARD: DAMAGED/DETERIORATED - ACTIVE LEAK
Deficiency Location/Instance	Room 318
Deficiency Quantity	20

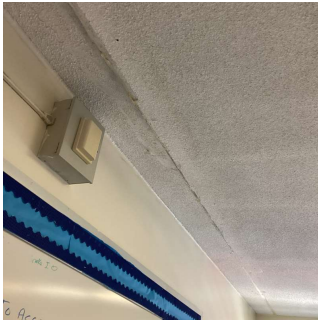
Room 310
Violations	No violations recorded.

Room 318
Violations	35655449P
Deficiency	TECTUM: DAMAGED/MISSING - ACTIVE LEAK
Deficiency Location/Instance	Corridor near Room 321A/B
Deficiency Quantity	20
Quantity Uom	S.F.
Potential Action	REPLACE
Urgency of Action	PRIORITY 5
Purpose of Action	LEVEL 4
Deficiency Photo1	 
	Corridor near Room 321A
Violations	35655449P
Deficiency	PLASTER: CRACKS/SPALLING
Deficiency Location/Instance	Rooms 107, 310, 311A, 312, 316, and others
Deficiency Quantity	180
Quantity Uom	S.F.
Potential Action	REPLACE
Urgency of Action	PRIORITY 3
Purpose of Action	LEVEL 2
Deficiency Photo1

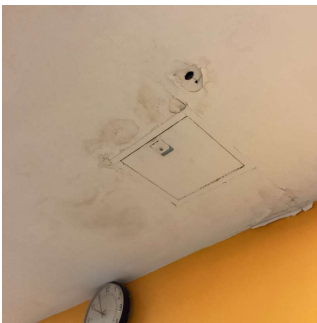
Question	Response
<b>INTERIOR</b>	
<b>CLASSROOMS/CORRIDORS/ADMIN SPACES</b>	
<b>Ceiling</b>	
Deficiency	TECTUM: DAMAGED/MISSING - ACTIVE LEAK
Deficiency Location/Instance	Corridor near Room 303
Deficiency Quantity	10
Quantity Uom	S.F.
Potential Action	REPLACE
Urgency of Action	PRIORITY 5
Purpose of Action	LEVEL 2
Deficiency Photo1	 
Violations	Corridor near Room 303 No violations recorded.
Deficiency	PLASTER: CRACKS/SPALLING - ACTIVE LEAK
Deficiency Location/Instance	Room 306
Deficiency Quantity	40
Quantity Uom	S.F.
Potential Action	REPLACE
Urgency of Action	PRIORITY 5
Purpose of Action	LEVEL 2
Deficiency Photo1	 
Violations	Room 306 No violations recorded.
Deficiency	GYPSUM BOARD: DAMAGED/DETERIORATED
Deficiency Location/Instance	Corridor near Rooms C09, 214, Stair A/Basement
Deficiency Quantity	40
Quantity Uom	S.F.
Potential Action	REPLACE
Urgency of Action	PRIORITY 3
Purpose of Action	LEVEL 2

Corridor near Room C09
Violations	No violations recorded.
<b>Door(s)</b>	Inspected
Condition	2 - Between Good and Fair
Deficiency	No deficiencies recorded
<b>Floor Finish</b>	Inspected
Condition	3 - Fair
Deficiency	EPOXY FLOORING: CRACKS/SPALLING
Deficiency Location/Instance	Rooms 304, 306, 309, 311A/B
Deficiency Quantity	100
Quantity Uom	S.F.
Potential Action	REPLACE
Urgency of Action	PRIORITY 3
Purpose of Action	LEVEL 2
Deficiency Photo1

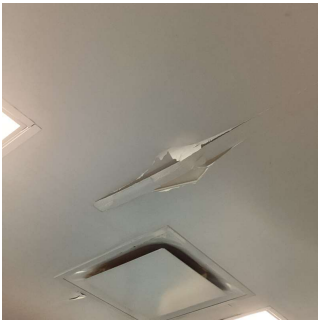
Question	Response
<b>INTERIOR</b>	
<b>LOCKER ROOM</b>	Inspected
Instance on Basement - Students (391 Lockers)	Inspected
Alternative use	No
Instance on Basement - Visitors (244 Lockers)	Inaccessible
<b>Ceiling</b>	
Instance on Basement - Students (391 Lockers)	Inspected
Condition	3 - Fair
Deficiency	GYPSUM BOARD: DAMAGED/DETERIORATED
Deficiency Location/Instance	Near Entrance, Center
Deficiency Quantity	50
Quantity Uom	S.F.
Potential Action	REPLACE
Urgency of Action	PRIORITY 3
Purpose of Action	LEVEL 2
Deficiency Photo1

Near center
Violations	No violations recorded.
Deficiency	PLASTER: CRACKS/SPALLING
Deficiency Location/Instance	Near Entrance
Deficiency Quantity	10
Quantity Uom	S.F.
Potential Action	REPLACE
Urgency of Action	PRIORITY 3
Purpose of Action	LEVEL 2
Deficiency Photo1

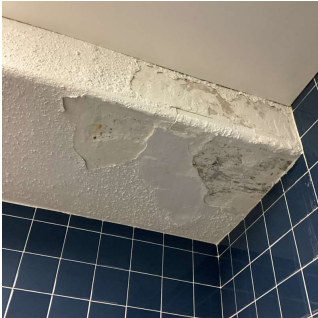
Near Entrance
Violations	No violations recorded.
<b>Door(s)</b>	
Instance on Basement - Students (391 Lockers)	Inspected
Condition	2 - Between Good and Fair

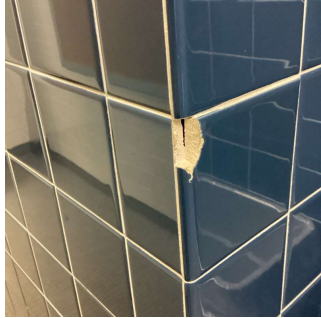
Question	Response
<b>INTERIOR</b>	
<b>LOCKER ROOM</b>	
<b>Floor Finish</b>	
Condition	2 - Between Good and Fair
Deficiency	No deficiencies recorded
<b>Locker Room Lockers</b>	
Instance on Basement - Students (391 Lockers)	Inspected
Condition	2 - Between Good and Fair
Deficiency	No deficiencies recorded
<b>Walls</b>	
Instance on Basement - Students (391 Lockers)	Inspected
Condition	2 - Between Good and Fair
Deficiency	CERAMIC TILE: BROKEN/ MISSING
Deficiency Location/Instance	Near Entrance, Toilet Room
Deficiency Quantity	10
Quantity Uom	S.F.
Potential Action	REPLACE
Urgency of Action	PRIORITY 3
Purpose of Action	LEVEL 2
Deficiency Photo1

Violations	Near Entrance No violations recorded.
<b>MULTI-PURPOSE ROOM</b>	Does not Exist
<b>SCIENCE DEMO ROOM</b>	Does not Exist
<b>SCIENCE LAB</b>	Inspected
Instance on Rooms 311A/B, 306	Inspected
Alternative use	No
<b>Fixed Equipment</b>	
Instance on Rooms 311A/B, 306	Inspected

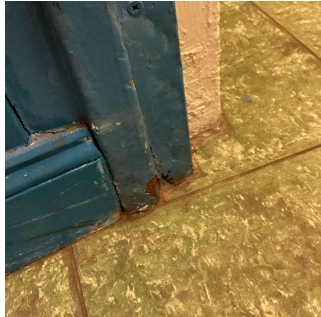
Question	Response
<b>INTERIOR</b>	
<b>STAIRS/RAMPS: INTERIOR</b>	
<b>Ceiling</b>	
Deficiency Photo1	 
Violations	Stair B/1 No violations recorded.
<b>Door(s)</b>	Inspected
Condition	4 - Between Fair and Poor
Deficiency	METAL: DETERIORATED DOOR AND FRAME
Deficiency Location/Instance	Stair A/Basement, 2
Deficiency Quantity	2
Quantity Uom	EACH
Potential Action	MAINTENANCE
Urgency of Action	PRIORITY 3
Purpose of Action	LEVEL 2
Deficiency Photo1

Violations	Stair A/Basement No violations recorded.
<b>Partition</b>	Does not Exist
<b>Railings</b>	Inspected
Condition	2 - Between Good and Fair
Deficiency	No deficiencies recorded
<b>Stairs and Landings</b>	Inspected
Condition	3 - Fair
Deficiency	SHEET VINYL: BROKEN/DETERIORATED
Deficiency Location/Instance	Stair A/Basement, Gymnasium Stair
Deficiency Quantity	10
Quantity Uom	S.F.
Potential Action	REPLACE
Urgency of Action	PRIORITY 3
Purpose of Action	LEVEL 2

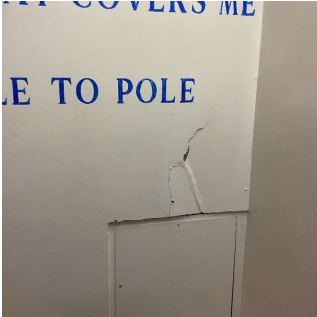
Question	Response
<b>INTERIOR</b>	
<b>STAIRS/RAMPS: INTERIOR</b>	
<b>Walls</b>	
Violations	Stair C/3 No violations recorded.
Deficiency	GYPSUM BOARD: DETERIORATED
Deficiency Location/Instance	Stairs B/2, C/1
Deficiency Quantity	30
Quantity Uom	S.F.
Potential Action	REPLACE
Urgency of Action	PRIORITY 3
Purpose of Action	LEVEL 2
Deficiency Photo1

Violations	Stair C/1 No violations recorded.
Deficiency	MASONRY: CRACKS/SPALLING
Deficiency Location/Instance	Stair A/1
Deficiency Quantity	10
Quantity Uom	S.F.
Potential Action	REPLACE
Urgency of Action	PRIORITY 3
Purpose of Action	LEVEL 2
Deficiency Photo1

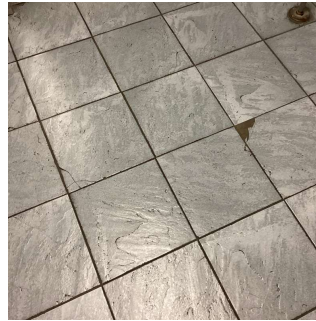
Room 221A

BROKEN/MISSING

REPLACE

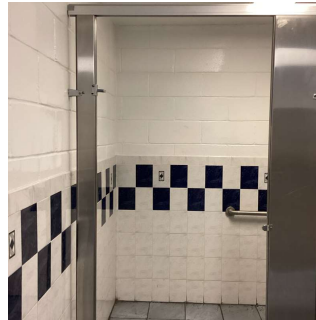
Room 221B

CERAMIC TILE: BROKEN/ MISSING

REPLACE

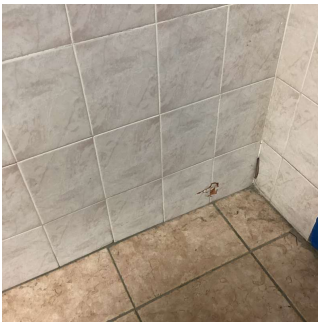
Question	Response
<b>INTERIOR</b>	
<b>TOILET ROOMS - STUDENTS</b>	
<b>Walls</b>	
Deficiency Photo1

Violations	Room 321A No violations recorded.
<b>LIFE SAFETY</b>	Inspected
<b>F.D. HOLDING AREA</b>	Does not Exist
<b>STEEL STAIRS</b>	Does not Exist
<b>SITE</b>	Inspected
<b>CONTAINERIZATION</b>	Does not Exist
<b>Drainage System for Asphalt</b>	Inspected
<b>Catch Basins/Manhole - Surrounded by asphalt</b>	Inspected
Condition	2 - Between Good and Fair
Deficiency	No deficiencies recorded
<b>Culverts - Asphalt Covering</b>	Does not Exist
<b>Drainage System for Concrete</b>	Inspected
<b>Catch Basins/Manhole - Surrounded by concrete</b>	Inspected
Condition	2 - Between Good and Fair
Deficiency	No deficiencies recorded
<b>Culverts - Concrete Covering</b>	Does not Exist
<b>Drainage System for Soil</b>	Does not Exist
<b>DRINKING FOUNTAINS</b>	Does not Exist
<b>FENCES</b>	Inspected
Condition	3 - Fair
Deficiency	CHAIN LINK: DAMAGED/DETERIORATED

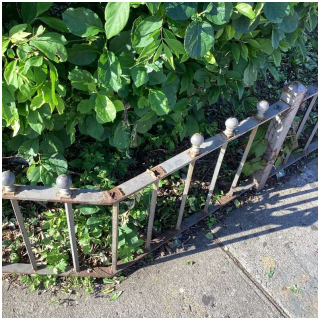
Question	Response
<b>SITE</b>	
<b>FENCES</b>	
Violations	Parking Lot Area No violations recorded.
Deficiency	WROUGHT IRON: DAMAGED/DETERIORATED
Deficiency Location/Instance	Linden Boulevard
Deficiency Quantity	120
Quantity Uom	S.F.
Potential Action	REPLACE
Urgency of Action	PRIORITY 3
Purpose of Action	LEVEL 2
Deficiency Photo1

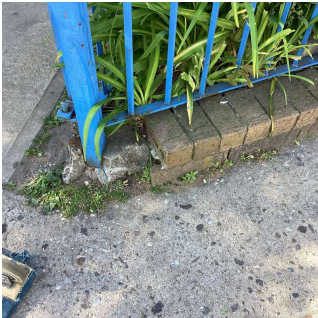
Violations	Linden Boulevard No violations recorded.
Deficiency	CONCRETE CURB: DAMAGED/DETERIORATED
Deficiency Location/Instance	Linden Boulevard
Deficiency Quantity	10
Quantity Uom	S.F.
Potential Action	REPLACE
Urgency of Action	PRIORITY 3
Purpose of Action	LEVEL 2
Deficiency Photo1

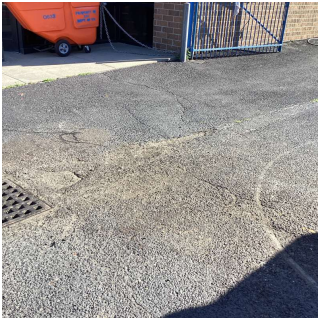
Violations	Linden Boulevard No violations recorded.
<b>IRRIGATION SYSTEM</b>	
	Does not Exist
<b>PAVING</b>	
	Inspected
<b>Student Non-Use</b>	
Gravel Exists?	Inspected No
<b>Asphalt</b>	
Condition	Inspected 4 - Between Fair and Poor
Deficiency	CRACKS - MAJOR
Deficiency Location/Instance	Parking Lot Area
Deficiency Quantity	1,800

Question	Response
<b>SITE</b>	
<b>PAVING</b>	
<b>Student Non-Use</b>	
<b>Asphalt</b>	
Quantity Uom	S.F.
Potential Action	REPLACE
Urgency of Action	PRIORITY 3
Purpose of Action	LEVEL 2
Deficiency Photo1

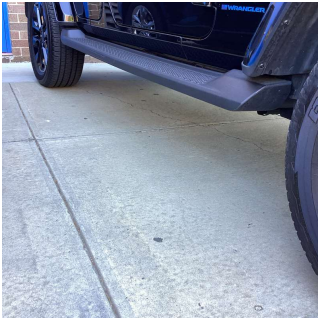
Near Exit 4
Violations	No violations recorded.
<b>Pavers</b>	Does not Exist
<b>DOT Sidewalk</b>	Inspected
<b>Asphalt</b>	Does not Exist

Merrick Boulevard
Violations	No violations recorded.
<b>Concrete</b>	Inspected
Condition	2 - Between Good and Fair
Deficiency	No deficiencies recorded
<b>Pavers</b>	Does not Exist
<b>Student Use</b>	Does not Exist
<b>Site Sidewalks &amp; Walkways</b>	Inspected
<b>Asphalt</b>	Does not Exist
<b>Concrete</b>	Inspected
Condition	3 - Fair
Deficiency	DAMAGED/DETERIORATED/MISSING SECTIONS
Deficiency Location/Instance	Near Exits 2, 4
Deficiency Quantity	75
Quantity Uom	S.F.
Potential Action	REPLACE
Urgency of Action	PRIORITY 3
Purpose of Action	LEVEL 2
Deficiency Photo1

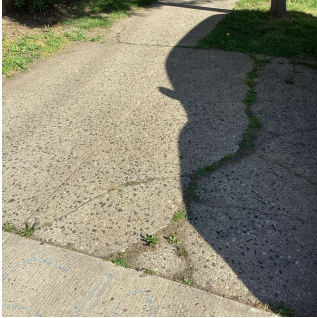
172nd Street
Violations	No violations recorded.
Deficiency	DAMAGED CURBS
Deficiency Location/Instance	172nd Street, Linden Boulevard, Merrick Boulevard
Deficiency Quantity	105
Quantity Uom	L.F.
Potential Action	REPLACE
Urgency of Action	PRIORITY 3
Purpose of Action	LEVEL 2
Deficiency Photo1

Question	Response
<b>SITE</b>	
<b>PAVING</b>	
<b>DOT Sidewalk</b>	
<b>Concrete</b>	Inspected
Condition	4 - Between Fair and Poor
Deficiency	DAMAGED/DETERIORATED/MISSING SECTIONS
Deficiency Location/Instance	172nd Street, Linden Boulevard, Merrick Boulevard
Deficiency Quantity	1,675
Quantity Uom	S.F.
Potential Action	REPLACE
Urgency of Action	PRIORITY 3
Purpose of Action	LEVEL 2
Deficiency Photo1

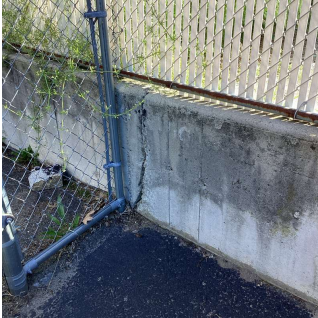
Condition	3 - Fair
Deficiency	CAST IN PLACE CONCRETE: CRACKS/SPALLING - MAJOR
Deficiency Location/Instance	Parking Lot Area

Question	Response
<b>SITE</b>	
<b>RETAINING WALLS</b>	
Deficiency Quantity	30
Quantity Uom	S.F.
Potential Action	REPLACE
Urgency of Action	PRIORITY 3
Purpose of Action	LEVEL 2
Deficiency Photo1
