NYC Department of Education
Building Condition Assessment Survey 2023 - 2024

Architectural Inspection

Asset: HS FOR CONST.TRADES,ENGG.,& ARCH-Q, 94-06 104TH STREET, New York, 11416

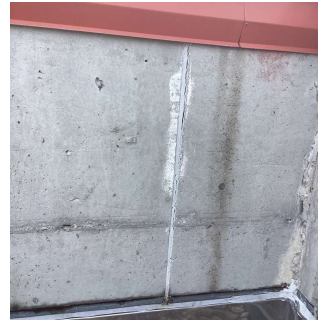
Roof 1 - Facade E

Facade B
Violations	No violations recorded.
EXTERIOR SOFFITS	
Condition	Inspected
Deficiency	2 - Between Good and Fair
	No deficiencies recorded
LOADING DOCK	
	Does not Exist
LOUVER	
Condition	Inspected
Deficiency	2 - Between Good and Fair
	No deficiencies recorded
PARAPETS	
Material Type(s)	Inspected
Replacement Quantity	Concrete, Masonry, Metal
Replacement Uom	12,000
	C.F.
Instance on All Facades	Inspected
Instance Condition	2 - Between Good and Fair
Instance Quantity	12,000
Instance Quantity Uom	C.F.
Deficiency	CONCRETE: DETERIORATED CONTROL/EXPANSION JOINT
Roof Plan reference	Q650

Deficiency Quantity	10
Quantity Uom	L.F.
Potential Action	MAINTENANCE
Urgency of Action	PRIORITY 3
Purpose of Action	LEVEL 2

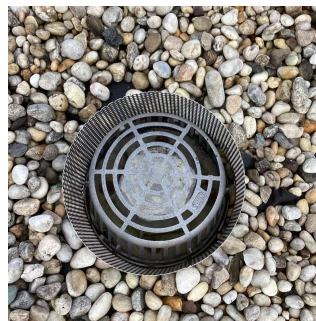
Roof 2

DETERIORATED

REPLACE

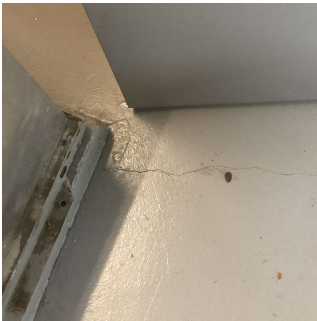
Question	Response
INTERIOR	
STRUCTURAL	
COLUMNS/BEAMS/BEARING WALLS	
Condition	3 - Fair
Deficiency	CONCRETE COLUMNS/BEAMS: CRACKED/SPALLED/REINFORCEMENT EXPOSED
Deficiency Location/Instance	Facade A - Column by Exit 1
Deficiency Quantity	20
Quantity Uom	S.F.
Potential Action	REPAIR
Urgency of Action	PRIORITY 3
Purpose of Action	LEVEL 5
Deficiency Photo1	 
Violations	Facade A - Column by Exit 1 No violations recorded.
Deficiency	STEEL COLUMNS/BEAMS: DETERIORATED CONCRETE FIREPROOFING
Deficiency Location/Instance	Basement - Room B24B
Deficiency Quantity	10
Quantity Uom	S.F.
Potential Action	REPLACE
Urgency of Action	PRIORITY 4
Purpose of Action	LEVEL 5
Deficiency Photo1	 
Violations	Basement - Room B24B No violations recorded.
FLOOR STRUCTURE	
Condition	Inspected
Condition	3 - Fair
Deficiency	CONCRETE SLAB ON GRADE: THRU CRACKS
Deficiency Location/Instance	Basement - Rooms B10B, B60I
Deficiency Quantity	30
Quantity Uom	S.F.

Violations	Basement - Room B60I No violations recorded.
FOUNDATION WALLS	
Material Type(s)	Inspected Concrete
Condition	2 - Between Good and Fair
Deficiency	CONCRETE: CRACKED/SPALLED/REINFORCEMENT EXPOSED
Deficiency Location/Instance	Basement - Room B24B
Deficiency Quantity	20
Quantity Uom	S.F.
Potential Action	REPAIR
Urgency of Action	PRIORITY 3
Purpose of Action	LEVEL 5
Deficiency Photo1

Potential Action	REPAIR
Urgency of Action	PRIORITY 3
Purpose of Action	LEVEL 5

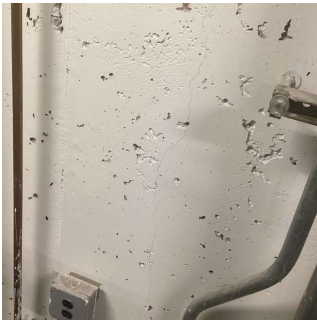
Violations	Basement - Room B24B No violations recorded.
ROOF STRUCTURE	
Condition	Inspected 2 - Between Good and Fair
Deficiency	No deficiencies recorded
VAULTS-BUNKERS	
	Does not Exist
AUDITORIUM	
Instance on 1st Floor (363 Seats)	Inspected Inspected
Ceiling	
Instance on 1st Floor (363 Seats)	Inspected Inspected
Condition	2 - Between Good and Fair
Deficiency	No deficiencies recorded
Door(s)	
Instance on 1st Floor (363 Seats)	Inspected Inspected
Condition	2 - Between Good and Fair

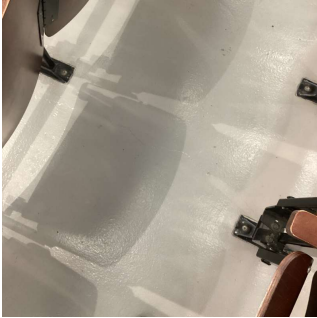
Question	Response
INTERIOR	
AUDITORIUM	
Fixed H/C Lift	
Instance on 1st Floor (363 Seats)	Does not Exist
Fixed Seating	
Instance on 1st Floor (363 Seats)	Inspected
Condition	2 - Between Good and Fair
Deficiency	No deficiencies recorded
Floor Finish	
Instance on 1st Floor (363 Seats)	Inspected
Condition	2 - Between Good and Fair
Deficiency	CONCRETE: CRACKS
Deficiency Location/Instance	Near Seat J/113
Deficiency Quantity	25
Quantity Uom	S.F.
Potential Action	REPLACE
Urgency of Action	PRIORITY 3
Purpose of Action	LEVEL 2
Deficiency Photo1

Near Seat J/113
Violations	No violations recorded.
Sliding-folding Partition	
Instance on 1st Floor (363 Seats)	Does not Exist
Stage	
Instance on 1st Floor (363 Seats)	Inspected
Stage	
Instance on 1st Floor (363 Seats)	Inspected
Condition	2 - Between Good and Fair
Deficiency	No deficiencies recorded
Stage Curtain Rigging	
Instance on 1st Floor (363 Seats)	Inspected
Condition	2 - Between Good and Fair

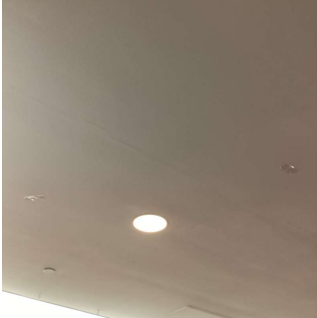
Question	Response
INTERIOR	
AUDITORIUM	
Walls	
Deficiency Quantity	40
Quantity Uom	S.F.
Potential Action	REPLACE
Urgency of Action	PRIORITY 3
Purpose of Action	LEVEL 2
Deficiency Photo1	 
Violations	Left Side of Stage No violations recorded.
Window Curtains/Shades/Blinds	
Instance on 1st Floor (363 Seats)	Does not Exist
CAFETERIA	
Instance on Basement - Staff (600 SF)	Inspected
Instance on Basement - Students	Inspected
Ceiling	
Instance on Basement - Students	Inspected
Condition	2 - Between Good and Fair
Deficiency	ACOUSTIC TILES: DAMAGED/MISSING
Deficiency Location/Instance	Center, Near Serving Area
Deficiency Quantity	20
Quantity Uom	S.F.
Potential Action	REPLACE
Urgency of Action	PRIORITY 3
Purpose of Action	LEVEL 2
Deficiency Photo1	 
Violations	Center No violations recorded.
Deficiency	GYPSUM BOARD: DAMAGED/DETERIORATED
Deficiency Location/Instance	Near Serving area, Near Entrance
Deficiency Quantity	20
Quantity Uom	S.F.

Question	Response
INTERIOR	
CAFETERIA	
Ceiling	
Urgency of Action	PRIORITY 3
Purpose of Action	LEVEL 2
Deficiency Photo1

Violations	Near Serving area No violations recorded.
Door(s)	
Instance on Basement - Students	Inspected
Condition	2 - Between Good and Fair
Deficiency	No deficiencies recorded
Instance on Basement - Staff (600 SF)	Inspected
Condition	2 - Between Good and Fair
Deficiency	No deficiencies recorded
Fixed Equipment	
Instance on Basement - Staff (600 SF)	Does not Exist
Instance on Basement - Students	Does not Exist
Floor Finish	
Instance on Basement - Staff (600 SF)	Inspected
Condition	2 - Between Good and Fair
Deficiency	No deficiencies recorded
Instance on Basement - Students	Inspected
Condition	2 - Between Good and Fair
Deficiency	No deficiencies recorded
Sliding-folding Partition	
Instance on Basement - Students	Does not Exist
Instance on Basement - Staff (600 SF)	Does not Exist
Stage	
Instance on Basement - Staff (600 SF)	Does not Exist

Potential Action	REPLACE

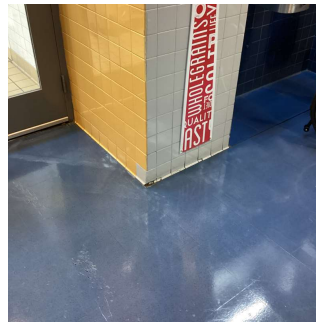
Instance on Basement - Students	Does not Exist
Walls	
Instance on Basement - Students	Inspected
Condition	2 - Between Good and Fair
Deficiency	CERAMIC TILE: BROKEN/ MISSING
Deficiency Location/Instance	Near Serving area
Deficiency Quantity	10
Quantity Uom	S.F.
Potential Action	REPLACE
Urgency of Action	PRIORITY 3
Purpose of Action	LEVEL 2

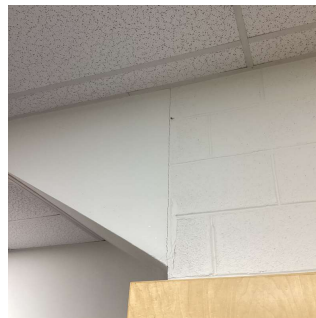
GYPSUM BOARD: DETERIORATED

Question	Response
INTERIOR	
CAFETERIA	
Walls	
Violations	Right Side No violations recorded.
Window Curtains/Shades/Blinds	
Instance on Basement - Staff (600 SF)	Does not Exist
Instance on Basement - Students	Does not Exist
CLASSROOMS/CORRIDORS/ADMIN SPACES	
Ceiling	Inspected
Condition	2 - Between Good and Fair
Deficiency	GYPSUM BOARD: DAMAGED/DETERIORATED
Deficiency Location/Instance	Corridor near Library, Corridor near Gymnasium
Deficiency Quantity	60
Quantity Uom	S.F.
Potential Action	REPLACE
Urgency of Action	PRIORITY 3
Purpose of Action	LEVEL 2
Deficiency Photo1

REPLACE

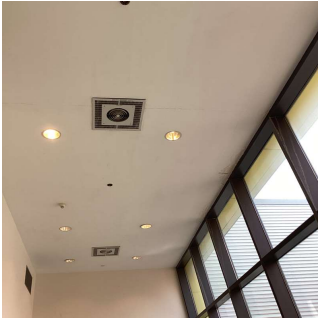
Violations	Corridor near Library No violations recorded.
Deficiency	ACOUSTIC TILES: DAMAGED/MISSING - ACTIVE LEAK
Deficiency Location/Instance	Rooms 432, 430, 424, 408, 405
Deficiency Quantity	200
Quantity Uom	S.F.
Potential Action	REPLACE
Urgency of Action	PRIORITY 5
Purpose of Action	LEVEL 2
Deficiency Photo1

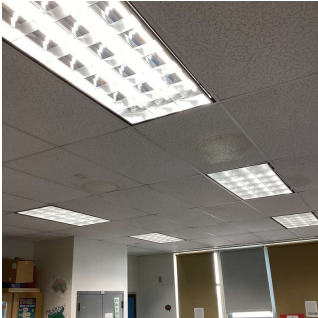
Violations	Room 430 No violations recorded.

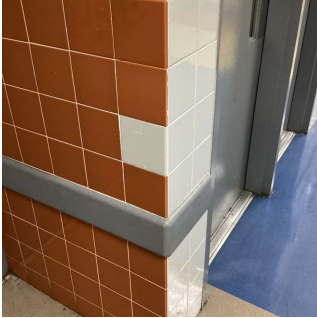
Question	Response
INTERIOR	
CLASSROOMS/CORRIDORS/ADMIN SPACES	
Walls	Inspected
Condition	2 - Between Good and Fair
Deficiency	CERAMIC TILE: BROKEN/ MISSING
Deficiency Location/Instance	Corridor near Gymnasium
Deficiency Quantity	10
Quantity Uom	S.F.
Potential Action	REPLACE
Urgency of Action	PRIORITY 3
Purpose of Action	LEVEL 2
Deficiency Photo1

Violations	Corridor near Gymnasium No violations recorded.
Deficiency	BRICK: CRACKS/SPALLING
Deficiency Location/Instance	Main Entrance Lobby
Deficiency Quantity	10
Quantity Uom	S.F.
Potential Action	REPLACE
Urgency of Action	PRIORITY 3
Purpose of Action	LEVEL 2
Deficiency Photo1

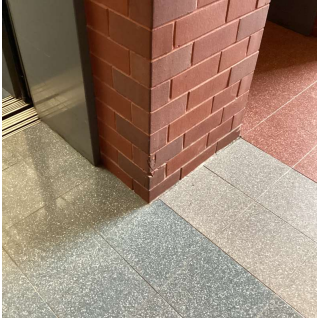
Violations	Main Entrance Lobby No violations recorded.
Deficiency	GYPSUM BOARD: DETERIORATED - ACTIVE LEAK
Deficiency Location/Instance	Room 443B
Deficiency Quantity	10
Quantity Uom	S.F.
Potential Action	REPLACE
Urgency of Action	PRIORITY 5
Purpose of Action	LEVEL 2

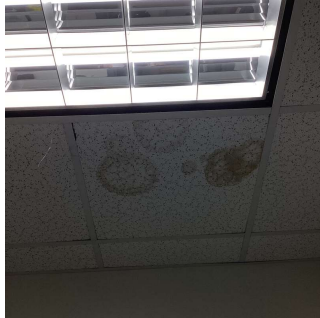
Question	Response
INTERIOR	
KITCHEN	
Ceiling	
Urgency of Action	PRIORITY 3
Purpose of Action	LEVEL 2
Deficiency Photo1

Violations	Room B60A No violations recorded.
Door(s)	
Instance on Basement	Inspected
Condition	2 - Between Good and Fair
Deficiency	No deficiencies recorded
Floor Finish	
Instance on Basement	Inspected
Condition	2 - Between Good and Fair
Deficiency	No deficiencies recorded
Walls	
Instance on Basement	Inspected
Condition	2 - Between Good and Fair
Deficiency	No deficiencies recorded
LIBRARY	
Instance on Room 305	Inspected
Built-in Furnishing	
Instance on Room 305	Inspected
Condition	2 - Between Good and Fair
Deficiency	No deficiencies recorded
Ceiling	
Instance on Room 305	Inspected
Condition	2 - Between Good and Fair
Deficiency	No deficiencies recorded
Door(s)	
Instance on Room 305	Inspected
Condition	2 - Between Good and Fair
Deficiency	No deficiencies recorded
Floor Finish	
Instance on Room 305	Inspected

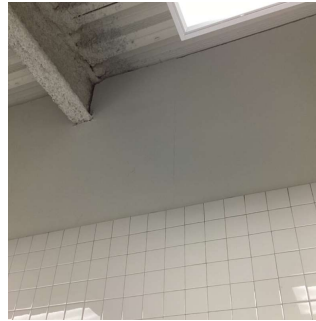
Left Side

Locker Room Lockers	
Instance on Basement - Visitors (31 Lockers)	Inspected
Condition	2 - Between Good and Fair
Deficiency	No deficiencies recorded
Instance on Basement - Boys (490 Lockers)	Inspected
Condition	2 - Between Good and Fair
Deficiency	No deficiencies recorded
Instance on Basement - Girls (485 Lockers)	Inspected
Condition	2 - Between Good and Fair
Deficiency	No deficiencies recorded
Walls	
Instance on Basement - Girls (485 Lockers)	Inspected
Condition	2 - Between Good and Fair
Deficiency	GYPSUM BOARD: DETERIORATED
Deficiency Location/Instance	Left Side, Near Toilet Room
Deficiency Quantity	20
Quantity Uom	S.F.
Potential Action	REPLACE
Urgency of Action	PRIORITY 3
Purpose of Action	LEVEL 2

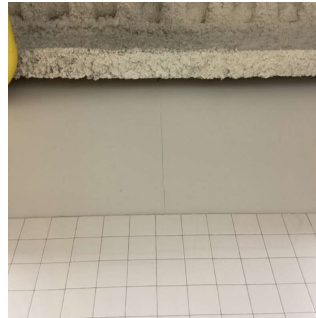
Near Toilet Room

GYP SUM BOARD: DETERIORATED

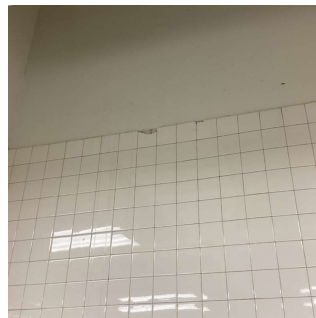
Deficiency Quantity

REPLACE

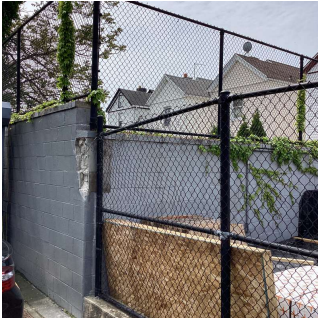
Violations	94th Street No violations recorded.
Deficiency	CHAIN LINK: DAMAGED POST/RAIL
Deficiency Location/Instance	Schoolyard
Deficiency Quantity	30
Quantity Uom	L.F.
Potential Action	REPLACE
Urgency of Action	PRIORITY 3
Purpose of Action	LEVEL 2
Deficiency Photo1

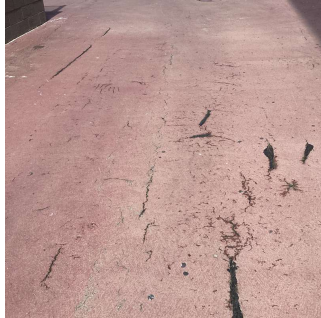
Exit 4
Violations	No violations recorded.
Concrete	Inspected
Condition	3 - Fair
Deficiency	CRACKS - MAJOR
Deficiency Location/Instance	Exits 2, 3, 5
Deficiency Quantity	150
Quantity Uom	S.F.
Potential Action	REPLACE
Urgency of Action	PRIORITY 3
Purpose of Action	LEVEL 2
Deficiency Photo1

Question	Response
SITE	
PAVING	
Site Sidewalks & Walkways	
Asphalt	
Purpose of Action	LEVEL 2
Deficiency Photo1

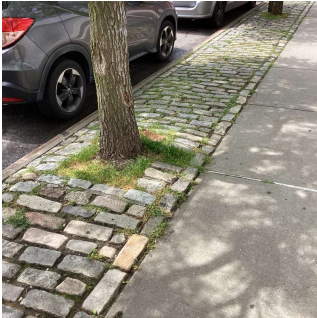
Question	Response
SITE	
PAVING	
DOT Sidewalk	
Concrete	Inspected
Violations	No violations recorded.
Pavers	Inspected
Condition	2 - Between Good and Fair
Deficiency	HEAVING
Deficiency Location/Instance	95th Avenue
Deficiency Quantity	20
Quantity Uom	S.F.
Potential Action	REPLACE
Urgency of Action	PRIORITY 3
Purpose of Action	LEVEL 2
Deficiency Photo1

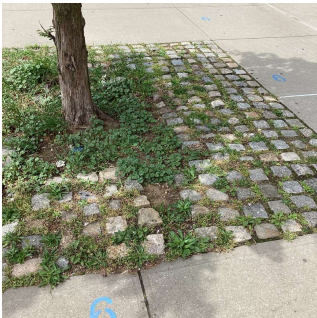
Violations	No violations recorded.
Deficiency	DAMAGED/MISSING
Deficiency Location/Instance	95th Avenue
Deficiency Quantity	20
Quantity Uom	S.F.
Potential Action	REPLACE
Urgency of Action	PRIORITY 3
Purpose of Action	LEVEL 2
Deficiency Photo1
