NYC Department of Education
Building Condition Assessment Survey 2023 - 2024

Architectural Inspection

Asset: SKILLMAN HIGH SCHOOL - QUEENS, 24-30 SKILLMAN AVENUE, New York, 11101

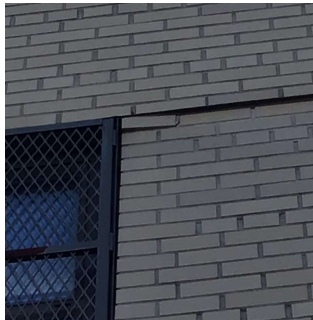
Facade B

BRICK: DETERIORATED JOINTS

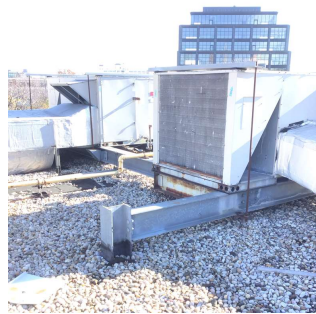
Roof 2
No violations recorded.

Violations	BH1 No violations recorded.
CUPOLA/ SPIRES/ TOWERS	Does not Exist
DORMER	Does not Exist
DUNNAGE STEEL	Inspected
Condition	3 - Fair
Deficiency	HEIGHT LESS THAN 18"

100
L.F.
REPLACE
PRIORITY 3
LEVEL 2

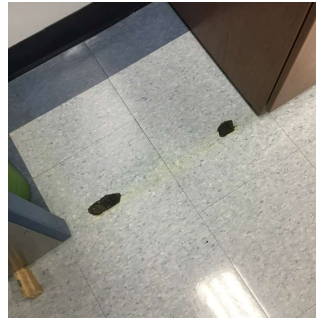
Room 216

VINYL TILES: BROKEN/DETERIORATED/MISSING TILES

REPLACE

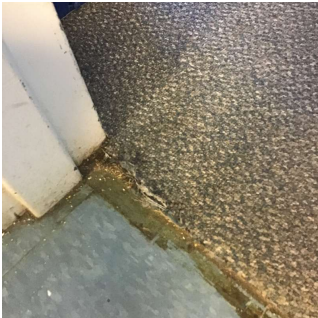
Violations	Near Entrance No violations recorded.
Door(s)	
Instance on Room 110 (600 SF)	Inspected
Condition	2 - Between Good and Fair
Deficiency	No deficiencies recorded
Floor Finish	
Instance on Room 110 (600 SF)	Inspected
Condition	2 - Between Good and Fair
Deficiency	CARPET: WORN/DETERIORATED
Deficiency Location/Instance	Room 110B
Deficiency Quantity	10
Quantity Uom	S.F.
Potential Action	REPLACE
Urgency of Action	PRIORITY 3
Purpose of Action	LEVEL 2
Deficiency Photo1

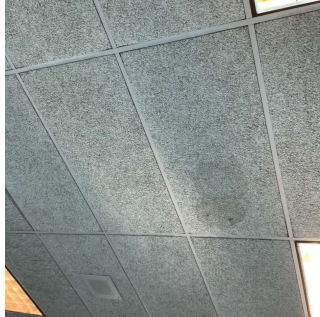
Violations	Column No violations recorded.
LOCKER ROOM	Does not Exist
MULTI-PURPOSE ROOM	Inspected
Instance on 1st Floor	Inspected
Instance on 2nd Floor	Inspected
Ceiling	
Instance on 1st Floor	Inspected
Condition	2 - Between Good and Fair
Deficiency	ACOUSTIC TILES: DAMAGED/MISSING
Deficiency Location/Instance	Near Room 122A
Deficiency Quantity	20
Quantity Uom	S.F.
Potential Action	REPLACE
Urgency of Action	PRIORITY 3
Purpose of Action	LEVEL 2
Deficiency Photo1

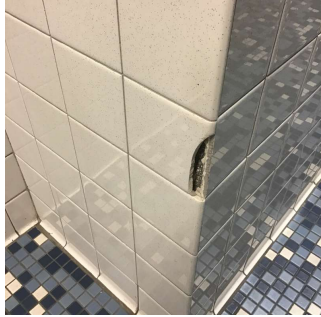
Question	Response
INTERIOR	
TOILET ROOMS - STUDENTS	
Walls	
Purpose of Action	LEVEL 2
Deficiency Photo1

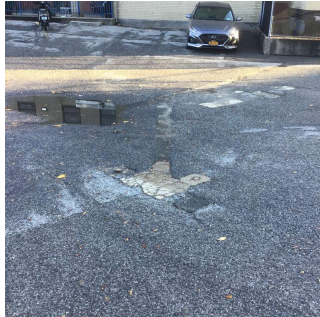
Question	Response
SITE	
PAVING	
Student Non-Use	
Asphalt	
Deficiency Photo1

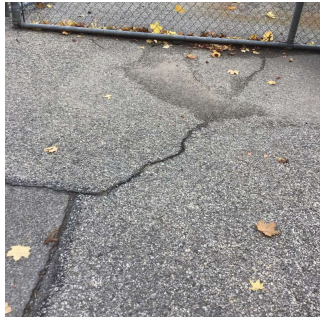
Violations	Near Exit 3 No violations recorded.
Pavers	Does not Exist
Site Sidewalks & Walkways	Inspected
Asphalt	Inspected
Condition	3 - Fair
Deficiency	CRACKS - MAJOR
Deficiency Location/Instance	Near Exit 8
Deficiency Quantity	50
Quantity Uom	S.F.
Potential Action	REPLACE
Urgency of Action	PRIORITY 3
Purpose of Action	LEVEL 2

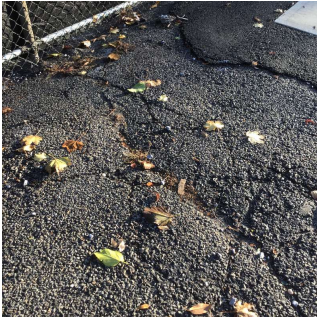
Violations	Near Exit 1 No violations recorded.
Pavers	Does not Exist
DOT Sidewalk	Inspected
Asphalt	Inspected
Condition	4 - Between Fair and Poor
Deficiency	CRACKS - MAJOR
Deficiency Location/Instance	49th Avenue, Skillman Avenue
Deficiency Quantity	4,000
Quantity Uom	S.F.
Potential Action	REPLACE
Urgency of Action	PRIORITY 3
Purpose of Action	LEVEL 2

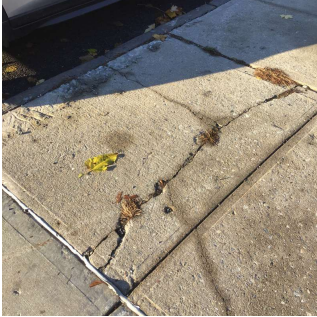
Violations	49th Avenue No violations recorded.
Deficiency	DAMAGED/DETERIORATED/MISSING SECTIONS
Deficiency Location/Instance	49th Avenue, Skillman Avenue.
Deficiency Quantity	1,325
Quantity Uom	S.F.
Potential Action	REPLACE
Urgency of Action	PRIORITY 3
Purpose of Action	LEVEL 2

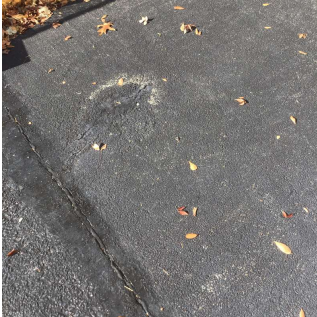
Near Exit 5
Violations	No violations recorded.
Play Equipment	
Instance on Schoolyard	Inspected
Condition	1 - Good

49th Avenue
Violations	No violations recorded.
Pavers	Does not Exist
PLAYGROUNDS	Inspected
Instance on Schoolyard	Inspected
Benches	
Instance on Schoolyard	Inspected
Condition	1 - Good
Deficiency	No deficiencies recorded
Fence	
Instance on Schoolyard	Inspected
Condition	1 - Good
Deficiency	No deficiencies recorded
Pavement	
Instance on Schoolyard	Inspected
Condition	2 - Between Good and Fair
Deficiency	ASPHALT: CRACKS - MAJOR
Deficiency Location/Instance	Near Exit 5, 6, 7
Deficiency Quantity	30
Quantity Uom	S.F.
Potential Action	REPLACE
Urgency of Action	PRIORITY 3
Purpose of Action	LEVEL 2
Deficiency Photo1
