**NYC Department of Education
Building Condition Assessment Survey 2023 - 2024**

Architectural Inspection

Q680

Asset: YOUNG WOMENS' LEADERSHIP SCHOOL - QUEENS, 150-91 87 ROAD, New York, 11432

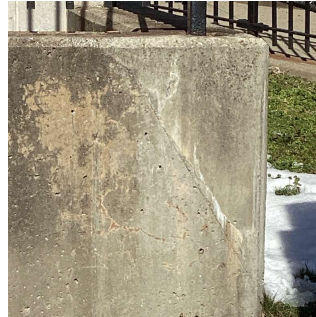
Facade A - AW6

Question	Response
Architectural	
EXTERIOR	Inspected
AREAWAY	Inspected
Instance on AW1-AW6	Inspected
Instance Condition	3 - Fair
Instance Quantity	6
Instance Quantity Uom	EACH
Deficiency	AREAWAY WALLS: CRACKS AND SPALLING
Roof Plan reference

Deficiency Quantity	10
Quantity Uom	S.F.

REPAIR
PRIORITY 3
LEVEL 2

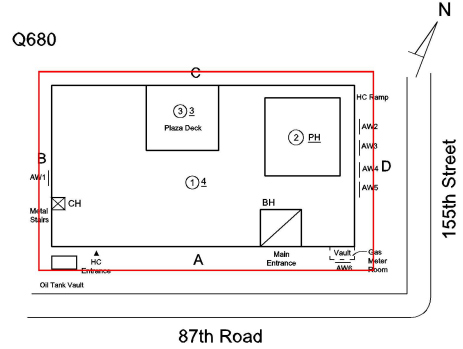
CAST STONE: DETERIORATED TRANSVERSE JOINTS

20
L.F.
MAINTENANCE
PRIORITY 3
LEVEL 2

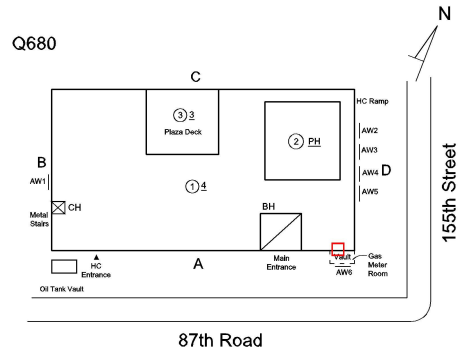
CAST STONE: CRACKED/BROKEN PIECES

10
L.F.
REPLACE-IN-KIND
PRIORITY 4
LEVEL 2

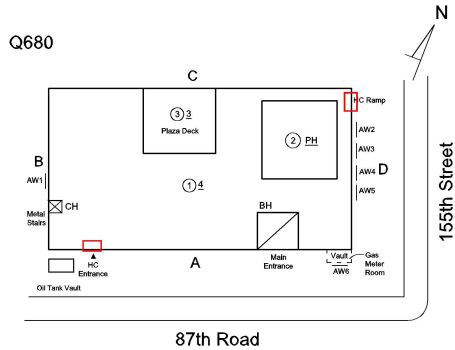
Violations	Roof 1 No violations recorded.
CORNICE	Does not Exist
DOORS	Inspected
DOORS AND FRAMES	Inspected
Condition	3 - Fair
Deficiency	METAL: DETERIORATED DOOR AND FRAME - MINOR DETERIORATION
Roof Plan reference

<p>Q680</p> <p>87th Road</p> <p>155th Street</p>
Deficiency Quantity	3
Quantity Uom	EACH
Potential Action	MAINTENANCE
Urgency of Action	PRIORITY 3
Purpose of Action	LEVEL 2
Deficiency Photo1

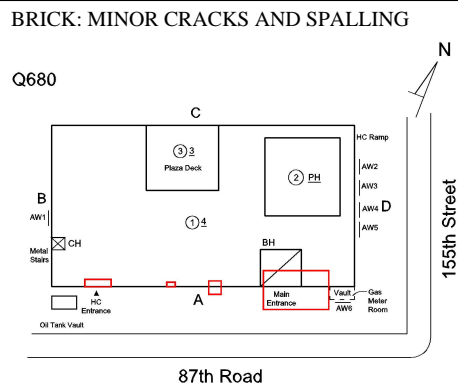
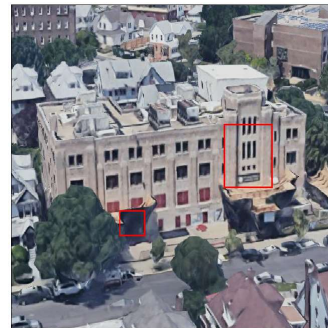
Question	Response
EXTERIOR	
DOORS	Inspected
LINTELS	Inspected
Deficiency	No deficiencies recorded
TRANSOM/SIDE LIGHT	Inspected
Condition	2 - Between Good and Fair
Deficiency	No deficiencies recorded
EXTERIOR WALLS	Inspected
Material Type(s)	Masonry
Replacement Quantity	18,000
Replacement Uom	S.F.
Instance on All Facades	Inspected
Instance Condition	3 - Fair
Instance Quantity	18,000
Instance Quantity Uom	S.F.

200
S.F.
RESTITCH
PRIORITY 3
LEVEL 2

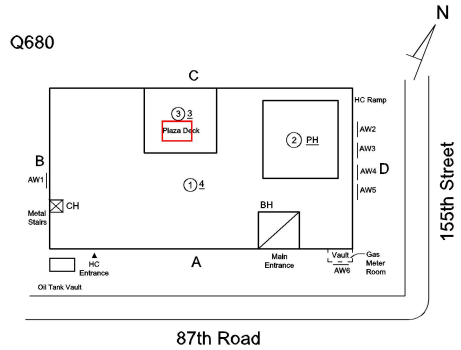
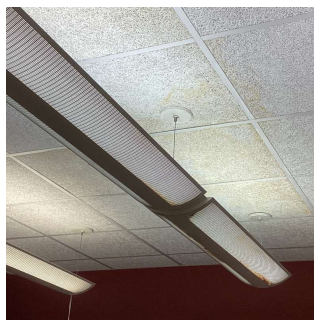
Question	Response
EXTERIOR	
EXTERIOR WALLS	Inspected
Violations	No violations recorded.
EXTERIOR SOFFITS	Does not Exist
LOADING DOCK	Does not Exist
LOUVER	Inspected
Condition	2 - Between Good and Fair
Deficiency	No deficiencies recorded
PARAPETS	Inspected
Material Type(s)	Concrete, Masonry, Metal
Replacement Quantity	3,000
Replacement Uom	C.F.
Instance on All Facades	Inspected
Instance Condition	2 - Between Good and Fair
Instance Quantity	3,000
Instance Quantity Uom	C.F.
Deficiency	No deficiencies recorded
PLAZA DECK	Inspected
Instance on Pavers: Roof 3	Inspected
Instance Condition	5 - Poor
Instance Quantity	1,000
Instance Quantity Uom	S.F.
Installation Year	2018
Source of Installation	Custodial Staff
Deficiency	PAVERS: MAJOR ACTIVE PLAZA DECK LEAKS IN INSTRUCTIONAL SPACE

100
S.F.
REPLACE
PRIORITY 5
LEVEL 2

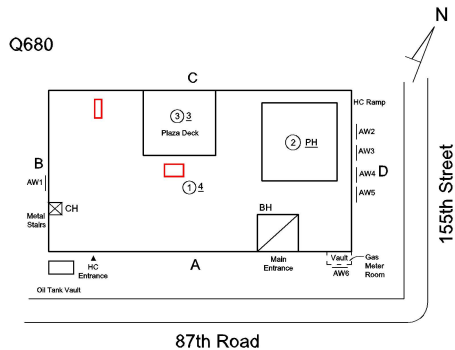
Source of Installation	Custodial Staff
Deficiency	BUILT-UP: ROOFING: MAJOR ACTIVE ROOF LEAKS IN INSTRUCTIONAL SPACE
Roof Plan reference

Deficiency Quantity	200
Quantity Uom	S.F.
Potential Action	REPLACE ROOFING WITHOUT MAJOR EQUIPMENT REMOVAL

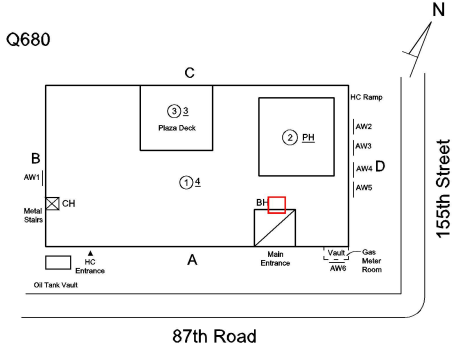
Violations	Roof 1 No violations recorded.
Specialties	Inspected
BULKHEAD/PENTHOUSE	Inspected
Condition	3 - Fair
Deficiency	BULKHEAD/PENTHOUSE WALLS/EXTERIOR: CRACKS/SPALLING - MINOR
Roof Plan reference

Deficiency Quantity	10
Quantity Uom	S.F.
Potential Action	REPAIR
Urgency of Action	PRIORITY 3
Purpose of Action	LEVEL 2
Deficiency Photo1

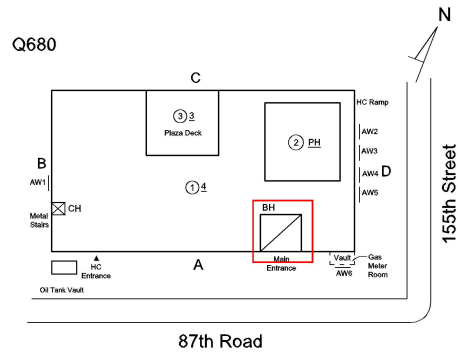
Violations	Roof 1 - Bulkhead No violations recorded.
Deficiency	BULKHEAD/PENTHOUSE WALLS/EXTERIOR: DETERIORATED JOINTS

30
S.F.
REPOINT
PRIORITY 3
LEVEL 2

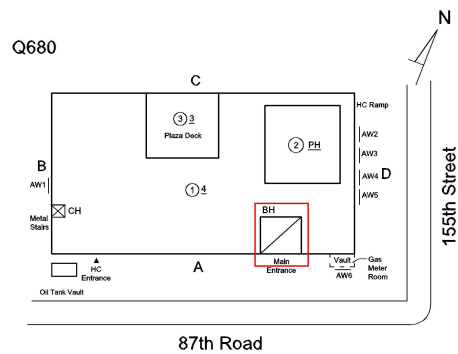
Deficiency	BULKHEAD/PENTHOUSE CEILING: PLASTER DAMAGED/DETERIORATED
------------	---

30
S.F.
REPLACE
PRIORITY 3
LEVEL 2

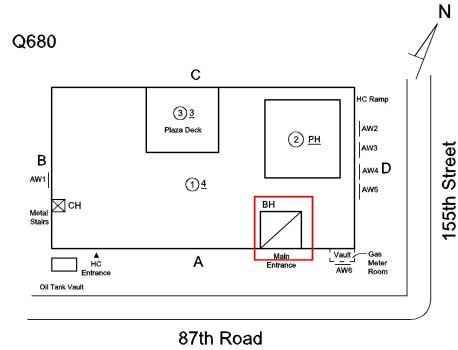
BULKHEAD/PENTHOUSE WALLS/INTERIOR: GYPSUM BOARD DAMAGED/DETERIORATED

REPLACE

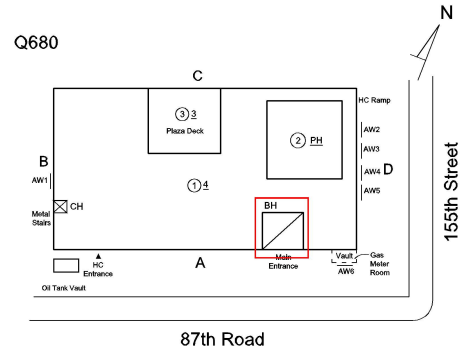
BULKHEAD/PENTHOUSE WALLS/EXTERIOR: WATER INFILTRATION

50
S.F.
REPAIR
PRIORITY 5
LEVEL 2

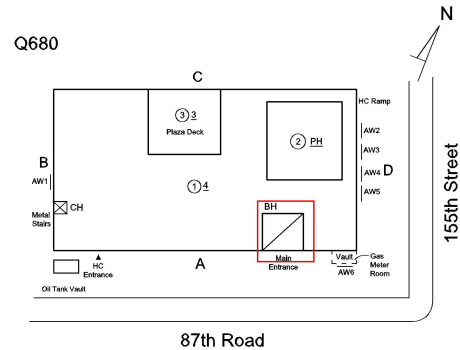
BULKHEAD/PENTHOUSE ROOF: MAJOR LEAKAGE

100
S.F.
REPLACE
PRIORITY 5
LEVEL 2

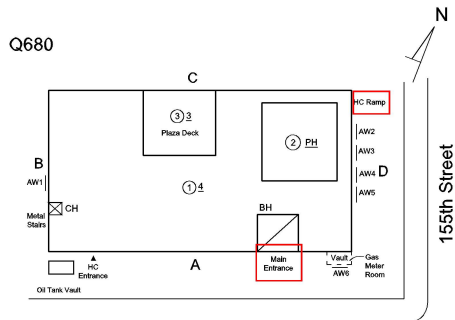
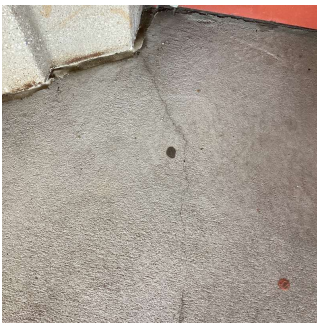
Violations	Roof 1 - Bulkhead No violations recorded.
CUPOLA/ SPIRES/ TOWERS	Does not Exist
DORMER	Does not Exist
DUNNAGE STEEL	Inspected
Condition	2 - Between Good and Fair
Deficiency	No deficiencies recorded
SKYLIGHT/ROOF VENT	Does not Exist
ROOF/GRAVITY TANK	Does not Exist
STAIRS/RAMPS: EXTERIOR	Inspected
BUILDING CHEEK/FLANK WALLS	Inspected
Condition	2 - Between Good and Fair
Deficiency	No deficiencies recorded
RAILINGS	Inspected
Condition	2 - Between Good and Fair
Deficiency	No deficiencies recorded
STAIRS/RAMPS	Inspected
Condition	3 - Fair
Deficiency	CONCRETE: CRACKS/SPALLING - MINOR
Roof Plan reference

Deficiency Quantity	20
Quantity Uom	S.F.
Potential Action	REPAIR
Urgency of Action	PRIORITY 3
Purpose of Action	LEVEL 2

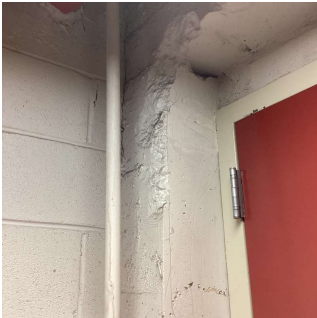
Basement - Boiler Room
Violations	No violations recorded.
Deficiency	CONCRETE COLUMNS/BEAMS: CRACKED/SPALLED/REINFORCEMENT EXPOSED
Deficiency Location/Instance	Basement - Boiler Mechanical Room, Boiler Room
Deficiency Quantity	30
Quantity Uom	S.F.
Potential Action	REPAIR
Urgency of Action	PRIORITY 3
Purpose of Action	LEVEL 5
Deficiency Photo1

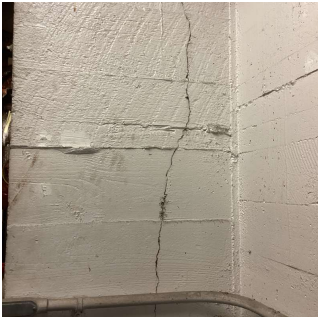
Basement - Boiler Mechanical Room
Violations	No violations recorded.
FLOOR STRUCTURE	Inspected
Condition	2 - Between Good and Fair
Deficiency	No deficiencies recorded
FOUNDATION WALLS	Inspected
Material Type(s)	Concrete
Condition	3 - Fair
Deficiency	CONCRETE: CRACKED/SPALLED/REINFORCEMENT EXPOSED
Deficiency Location/Instance	Basement - Boiler Room
Deficiency Quantity	30

Quantity Uom	S.F.
Potential Action	REPAIR
Urgency of Action	PRIORITY 3

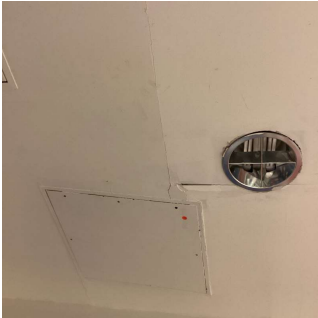
Question	Response
INTERIOR	
CAFETERIA	
Ceiling	
Deficiency	GYPSUM BOARD: DAMAGED/DETERIORATED
Deficiency Location/Instance	Near Entrances, Serving Area, Columns
Deficiency Quantity	100
Quantity Uom	S.F.
Potential Action	REPLACE
Urgency of Action	PRIORITY 3
Purpose of Action	LEVEL 2
Deficiency Photo1

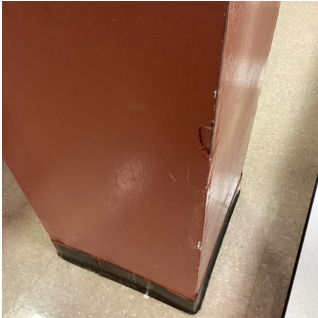
Question	Response
INTERIOR	
CAFETERIA	
Stage	
Instance on 2nd Floor	Does not Exist
Walls	
Instance on 2nd Floor	Inspected
Condition	2 - Between Good and Fair
Deficiency	GYP SUM BOARD: DETERIORATED
Deficiency Location/Instance	Columns, Near Entrance, Serving Area
Deficiency Quantity	40
Quantity Uom	S.F.
Potential Action	REPLACE
Urgency of Action	PRIORITY 3
Purpose of Action	LEVEL 2
Deficiency Photo1

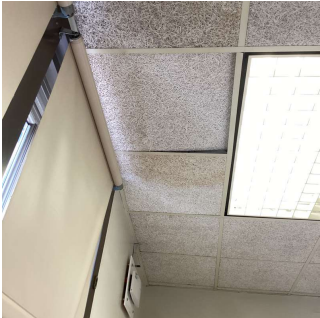
Room 418
Violations	No violations recorded.
Deficiency	TECTUM: DAMAGED/MISSING
Deficiency Location/Instance	Rooms 211, 421, 426, Corridor near Rooms 313, 416, and others.
Deficiency Quantity	200
Quantity Uom	S.F.
Potential Action	REPLACE
Urgency of Action	PRIORITY 3
Purpose of Action	LEVEL 2
Deficiency Photo1

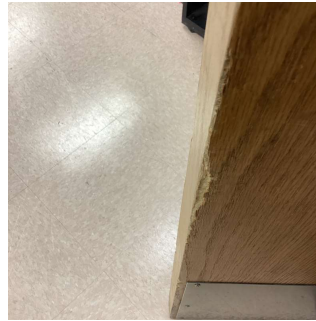
Room 213

Room 211
Violations	No violations recorded.
Door(s)	Inspected
Condition	5 - Poor
Deficiency	WOOD: DETERIORATED DOOR
Deficiency Location/Instance	Rooms 110, 213, 220, 311, 416, and others.
Deficiency Quantity	12
Quantity Uom	EACH
Potential Action	MAINTENANCE
Urgency of Action	PRIORITY 3
Purpose of Action	LEVEL 2

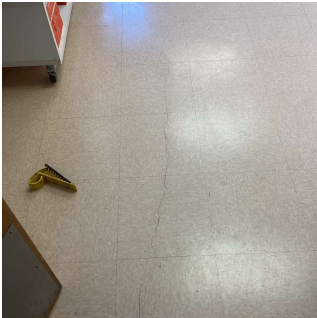
Question	Response
INTERIOR	
CLASSROOMS/CORRIDORS/ADMIN SPACES	
Floor Finish	
Violations	Room 224 No violations recorded.
Deficiency	VINYL TILES: BROKEN/DETERIORATED/MISSING TILES
Deficiency Location/Instance	Rooms 211, 217, 221, 222, 313, and others.
Deficiency Quantity	120
Quantity Uom	S.F.
Potential Action	REPLACE
Urgency of Action	PRIORITY 3
Purpose of Action	LEVEL 2
Deficiency Photo1

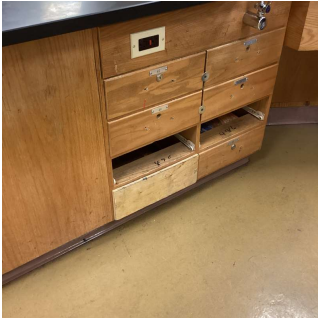
Question	Response
INTERIOR	
LOCKER ROOM	
Floor Finish	
Instance on 1st Floor - Girls	Inspected
Condition	2 - Between Good and Fair
Deficiency	No deficiencies recorded
Locker Room Lockers	
Instance on 1st Floor - Girls	Inspected
Condition	2 - Between Good and Fair
Deficiency	No deficiencies recorded
Walls	
Instance on 1st Floor - Girls	Inspected
Condition	2 - Between Good and Fair
Deficiency	No deficiencies recorded
MULTI-PURPOSE ROOM	Does not Exist
SCIENCE DEMO ROOM	Inspected
Instance on Rooms 424, 426	Inspected
Alternative use	No
Fixed Equipment	
Instance on Rooms 424, 426	Inspected
Condition	2 - Between Good and Fair
Deficiency	No deficiencies recorded
SCIENCE LAB	Inspected
Instance on Rooms 318, 322	Inspected
Alternative use	No
Fixed Equipment	
Instance on Rooms 318, 322	Inspected
Condition	5 - Poor
Deficiency	CABINETS: MISSING/DAMAGED
Deficiency Location/Instance	Rooms 318, 322
Deficiency Quantity	30
Quantity Uom	L.F.

Potential Action	REPLACE
Urgency of Action	PRIORITY 3
Purpose of Action	LEVEL 2
Deficiency Photo1

Room 318
Violations	No violations recorded.
SCIENCE PREP ROOM	Inspected
Instance on Room 320	Inspected
Alternative use	No
Fixed Equipment

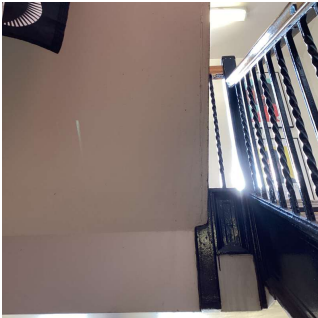
Question	Response
INTERIOR	
SCIENCE PREP ROOM	Inspected
Fixed Equipment	
Instance on Room 320	Inspected
Condition	2 - Between Good and Fair
Deficiency	No deficiencies recorded
SHOWER ROOM	Inspected
Instance on 1st Floor - Boys	Inaccessible
Instance on 1st Floor - Girls	Inaccessible
STAIRS/RAMPS: INTERIOR	Inspected
Do Letter Stair Signs Exist?	Yes
Ceiling	Inspected
Condition	2 - Between Good and Fair
Deficiency	GYPSUM BOARD: DAMAGED/DETERIORATED
Deficiency Location/Instance	Stair A/2
Deficiency Quantity	20
Quantity Uom	S.F.
Potential Action	REPLACE
Urgency of Action	PRIORITY 3
Purpose of Action	LEVEL 2
Deficiency Photo1

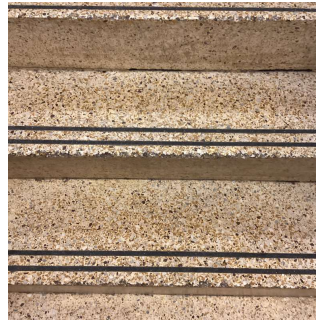
Violations	No violations recorded.
Door(s)	Inspected
Condition	2 - Between Good and Fair
Deficiency	No deficiencies recorded
Partition	Does not Exist
Railings	Inspected
Condition	2 - Between Good and Fair
Deficiency	No deficiencies recorded
Stairs and Landings	Inspected
Condition	3 - Fair
Deficiency	TERRAZZO: CRACKS

Deficiency Location/Instance	Stair A/Basement
Deficiency Quantity	50
Quantity Uom	S.F.
Potential Action	REPLACE
Urgency of Action	PRIORITY 3
Purpose of Action	LEVEL 2

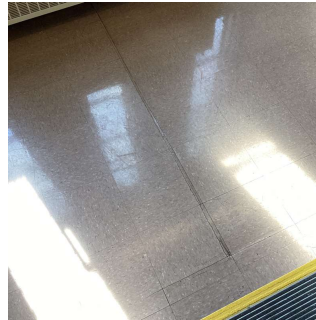
Stair A/4

VINYL TILES: DETERIORATED SUBSTRATE

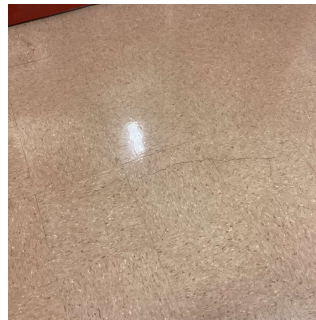
Stair B/2

VINYL TILES: BROKEN/DETERIORATED/MISSING TILES

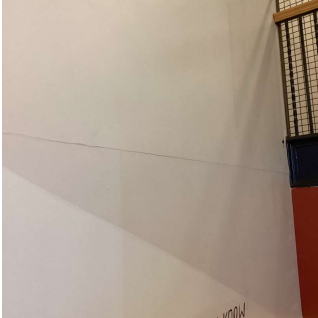
Question	Response
INTERIOR	
STAIRS/RAMPS: INTERIOR	
Walls	Inspected
Condition	2 - Between Good and Fair
Deficiency	GYPSUM BOARD: DETERIORATED
Deficiency Location/Instance	Stairs A/2, 4, B/2, 3
Deficiency Quantity	50
Quantity Uom	S.F.
Potential Action	REPLACE
Urgency of Action	PRIORITY 3
Purpose of Action	LEVEL 2
Deficiency Photo1

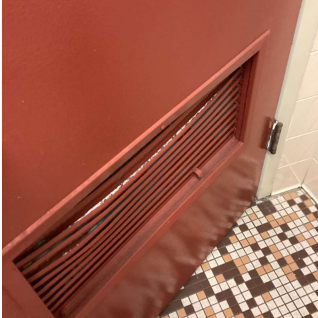
Violations	Stair B/3 No violations recorded.
TOILET ROOMS - STAFF	
Ceiling	Inspected
Condition	2 - Between Good and Fair
Deficiency	No deficiencies recorded
Door(s)	Inspected
Condition	5 - Poor
Deficiency	METAL: DAMAGED LOUVER
Deficiency Location/Instance	Room 226
Deficiency Quantity	1
Quantity Uom	EACH
Potential Action	MAINTENANCE
Urgency of Action	PRIORITY 3
Purpose of Action	LEVEL 2
Deficiency Photo1

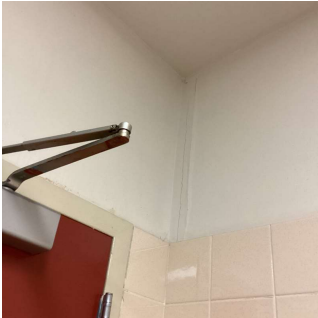
Question	Response
INTERIOR	
TOILET ROOMS - STAFF	
Stalls	Inspected
Condition	2 - Between Good and Fair
Deficiency	No deficiencies recorded
Walls	Inspected
Condition	2 - Between Good and Fair
Deficiency	GYPNUM BOARD: DETERIORATED
Deficiency Location/Instance	Room 226
Deficiency Quantity	10
Quantity Uom	S.F.
Potential Action	REPLACE
Urgency of Action	PRIORITY 3
Purpose of Action	LEVEL 2
Deficiency Photo1

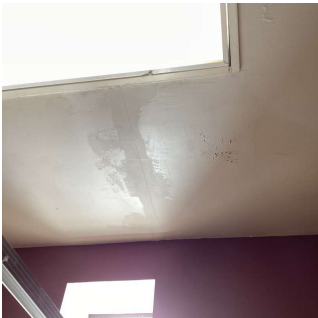
Violations	Room 226 No violations recorded.
TOILET ROOMS - STUDENTS	
Ceiling	Inspected
Condition	2 - Between Good and Fair
Deficiency	GYPNUM BOARD: DAMAGED/DETERIORATED
Deficiency Location/Instance	Rooms B10 415
Deficiency Quantity	40
Quantity Uom	S.F.
Potential Action	REPLACE
Urgency of Action	PRIORITY 3
Purpose of Action	LEVEL 2
Deficiency Photo1

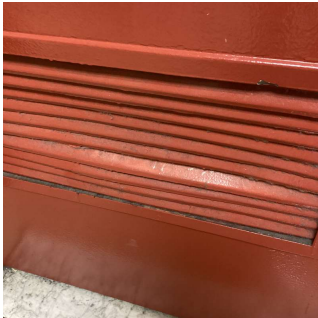
Violations	Room 415 No violations recorded.
Door(s)	Inspected
Condition	5 - Poor
Deficiency	METAL: DAMAGED LOUVER
Deficiency Location/Instance	Rooms B8, B10, 408

Question	Response
INTERIOR	
TOILET ROOMS - STUDENTS	
Door(s)	
Deficiency Quantity	3
Quantity Uom	EACH
Potential Action	MAINTENANCE
Urgency of Action	PRIORITY 3
Purpose of Action	LEVEL 2
Deficiency Photo1

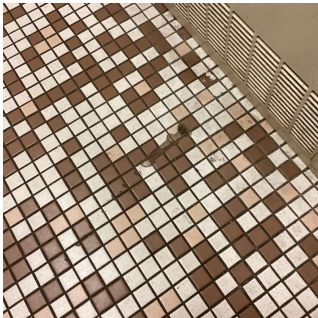
Room 408
Violations	No violations recorded.
Floor Finish	Inspected
Condition	2 - Between Good and Fair
Deficiency	CERAMIC TILE: BROKEN/MISSING TILES
Deficiency Location/Instance	Room 228
Deficiency Quantity	10
Quantity Uom	S.F.
Potential Action	REPLACE
Urgency of Action	PRIORITY 3
Purpose of Action	LEVEL 2
Deficiency Photo1

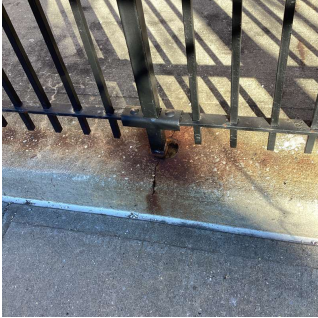
Question	Response
SITE	Inspected
CONTAINERIZATION	Does not Exist
Drainage System for Asphalt	Does not Exist
Drainage System for Concrete	Inspected
Catch Basins/Manhole - Surrounded by concrete	Inspected
Condition	2 - Between Good and Fair
Deficiency	No deficiencies recorded
Culverts - Concrete Covering	Inspected
Condition	2 - Between Good and Fair
Deficiency	No deficiencies recorded
Drainage System for Soil	Does not Exist
DRINKING FOUNTAINS	Does not Exist
FENCES	Inspected
Condition	2 - Between Good and Fair
Deficiency	CONCRETE CURB: DAMAGED/DETERIORATED
Deficiency Location/Instance	87th Road
Deficiency Quantity	35
Quantity Uom	S.F.
Potential Action	REPLACE
Urgency of Action	PRIORITY 3
Purpose of Action	LEVEL 2
Deficiency Photo1

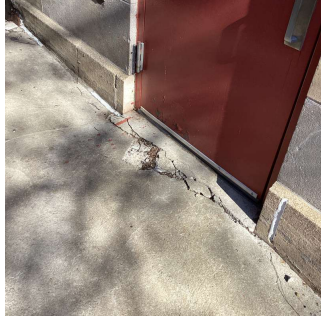
Question	Response
SITE	
PAVING	
Student Non-Use	
Concrete	
Deficiency Photo1	 
	Near Exit 3
Violations	No violations recorded.
Pavers	Does not Exist
Student Use	Inspected
Gravel Exists?	No
Asphalt	Does not Exist
Concrete	Inspected
Condition	3 - Fair
Deficiency	DAMAGED/DETERIORATED/MISSING SECTIONS
Deficiency Location/Instance	Near Main Entrance , Exit 3, Center
Deficiency Quantity	250
Quantity Uom	S.F.
Potential Action	REPLACE
Urgency of Action	PRIORITY 3
Purpose of Action	LEVEL 2
Deficiency Photo1	 
	Near Main Entrance
Violations	No violations recorded.
Pavers	Does not Exist
Site Sidewalks & Walkways	Inspected
Asphalt	Does not Exist
Concrete	Inspected
Condition	2 - Between Good and Fair
Deficiency	DAMAGED/DETERIORATED/MISSING SECTIONS
Deficiency Location/Instance	Near Exit 4
Deficiency Quantity	25
Quantity Uom	S.F.
Potential Action	REPLACE

Question	Response
SITE	
PAVING	
Site Sidewalks & Walkways	
Concrete	
Urgency of Action	PRIORITY 3
Purpose of Action	LEVEL 2
Deficiency Photo1

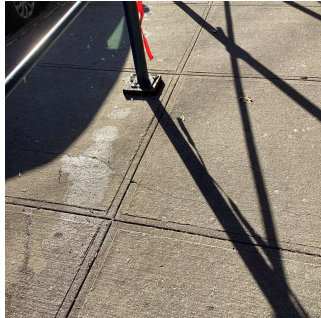
Near Exit 4
Violations	No violations recorded.
Pavers	Does not Exist
DOT Sidewalk	Inspected
Asphalt	Does not Exist
Concrete	Inspected
Condition	3 - Fair
Deficiency	DAMAGED/DETERIORATED/MISSING SECTIONS
Deficiency Location/Instance	87th Road, 155th Street
Deficiency Quantity	225
Quantity Uom	S.F.
Potential Action	REPLACE
Urgency of Action	PRIORITY 3
Purpose of Action	LEVEL 2
Deficiency Photo1

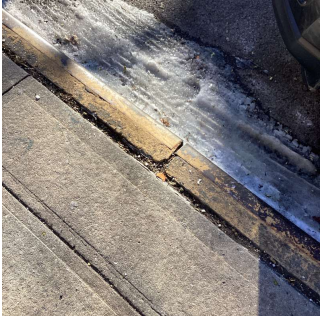
155th Street
Violations	No violations recorded.
Deficiency	DAMAGED CURBS
Deficiency Location/Instance	87th Road
Deficiency Quantity	10
Quantity Uom	L.F.
Potential Action	REPLACE
Urgency of Action	PRIORITY 3
Purpose of Action	LEVEL 2

Question	Response
SITE	
PAVING	
DOT Sidewalk	
Concrete	
Deficiency Photo1
