NYC Department of Education
Building Condition Assessment Survey 2023 - 2024

Architectural Inspection

Q686

Asset: METROPOLITAN AVENUE CAMPUS - QUEENS, 91-30 METROPOLITAN AVENUE, New York, 11375

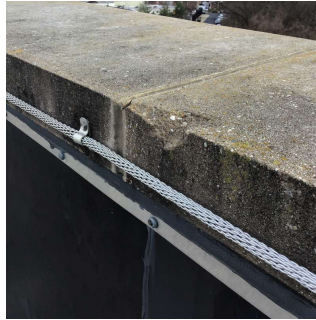
Roof 2

Violations	Facade C No violations recorded.
CHIMNEY	
Material Type(s)	Inspected Metal
Condition	2 - Between Good and Fair
Deficiency	No deficiencies recorded
COPING	
Condition	Inspected 3 - Fair
Deficiency	CAST STONE: CRACKED/BROKEN PIECES

REPLACE-IN-KIND

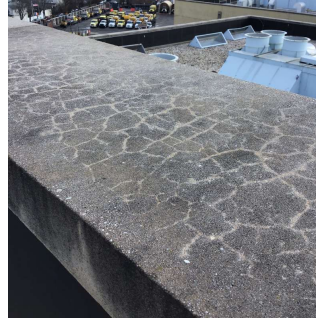
Roof 1

CAST STONE: DISINTEGRATING / FREEZE THAW

REPLACE-IN-KIND

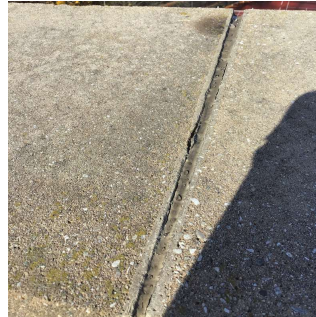
Roof 1

CAST STONE: DETERIORATED TRANSVERSE JOINTS

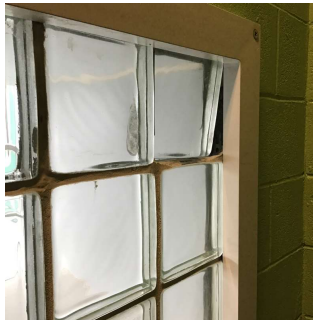
Facade C Stair FG

GLASS BLOCK: CHIPPED/ BROKEN PIECES

REPLACE-IN-KIND

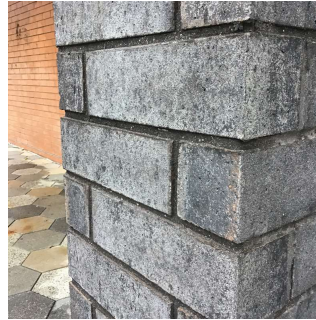
Facade C

BRICK: DETERIORATED JOINTS

30
S.F.
REPOINT
PRIORITY 3
LEVEL 2

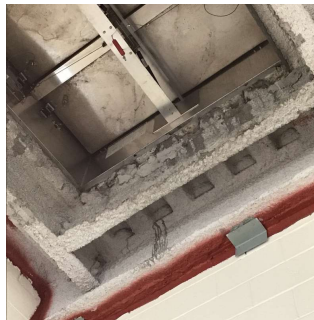
Roof 1 - RH2
No violations recorded.

Deficiency Quantity	30
Quantity Uom	S.F.
Potential Action	MAINTENANCE
Urgency of Action	PRIORITY 1
Purpose of Action	LEVEL 1
Deficiency Photo1	No photo recorded
Violations	No violations recorded.
PLAZA DECK	Does not Exist
ROOF	Inspected
Roofing	Inspected
Replacement Quantity	70,400
Replacement Uom	S.F.
ROOF HATCH/SMOKE HATCH	Inspected
Condition	5 - Poor
Deficiency	WATER INFILTRATION

1
EACH
REPAIR
PRIORITY 5
LEVEL 2

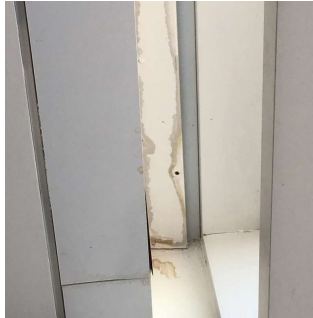
Facade D - 3rd Floor Corridor near Room 3001

ALUMINUM - OTHER: AIR/WATER INFILTRATION

REPLACE TRIM, SILLS OR WEATHERSTRIPPING

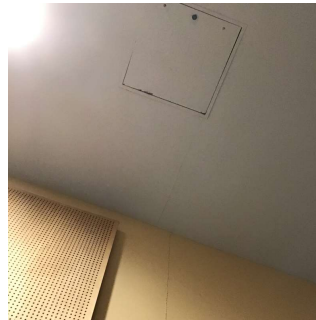
Near Entrance

Ceiling

Deficiency Quantity	10
Quantity Uom	S.F.
Potential Action	REPLACE
Urgency of Action	PRIORITY 3
Purpose of Action	LEVEL 2
Deficiency Photo1

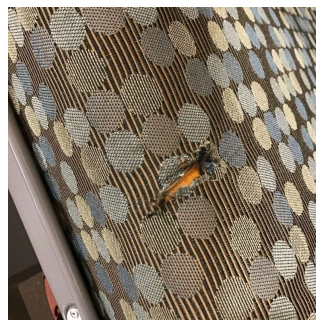
Instance on 1st Floor (762 Seats)	Inspected
Condition	2 - Between Good and Fair
Deficiency	DAMAGED/BROKEN/INOPERABLE
Deficiency Location/Instance	Seat Q/19
Deficiency Quantity	1
Quantity Uom	EACH
Potential Action	REPLACE
Urgency of Action	PRIORITY 3
Purpose of Action	LEVEL 2
Deficiency Photo1

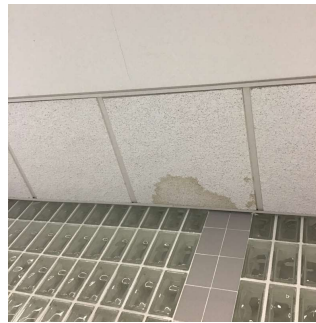
Near Entrance

Condition	2 - Between Good and Fair
Deficiency	ACOUSTIC TILES: DAMAGED/MISSING
Deficiency Location/Instance	Near Entrance, Center
Deficiency Quantity	10
Quantity Uom	S.F.
Potential Action	REPLACE
Urgency of Action	PRIORITY 3
Purpose of Action	LEVEL 2

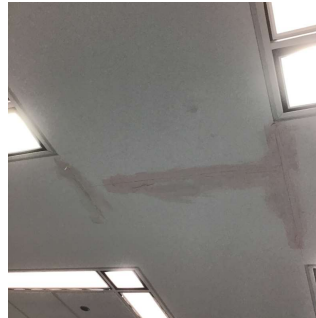
Near center

GYPSUM BOARD: DAMAGED/DETERIORATED

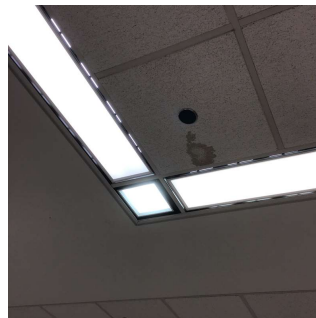
ACOUSTIC TILES: DAMAGED/MISSING

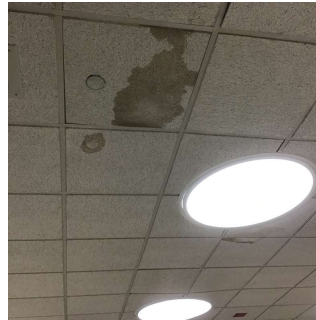
Near center

ACOUSTIC TILES: DAMAGED/MISSING

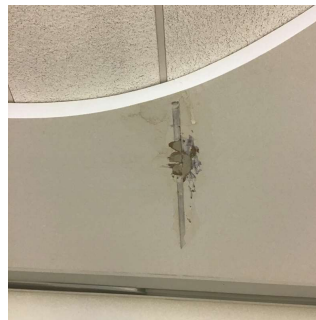
GYPSON BOARD: DAMAGED/DETERIORATED

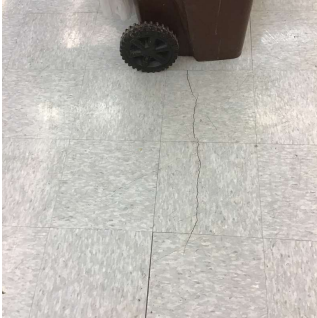
Question	Response
INTERIOR	
CAFETERIA	
Fixed Equipment	
Instance on Basement - Students - Room 0012	Does not Exist
Instance on Basement - Students - Room 0060	Does not Exist
Instance on Basement - Students - Room 0062	Does not Exist
Floor Finish	
Instance on Basement - Students - Room 0012	Inspected
Condition	2 - Between Good and Fair
Deficiency	VINYL TILES: BROKEN/DETERIORATED/MISSING TILES
Deficiency Location/Instance	Near Serving Area
Deficiency Quantity	10
Quantity Uom	S.F.
Potential Action	REPLACE
Urgency of Action	PRIORITY 3
Purpose of Action	LEVEL 2
Deficiency Photo1

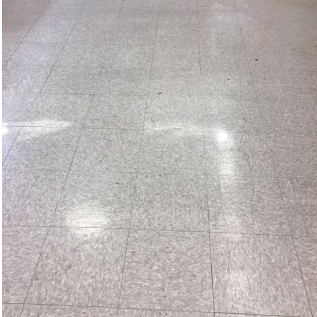
Violations	Near Serving Area No violations recorded.
Instance on Basement - Students - Room 0014	Inspected
Condition	2 - Between Good and Fair
Deficiency	VINYL TILES: BROKEN/DETERIORATED/MISSING TILES
Deficiency Location/Instance	Near Serving Area, Entrance
Deficiency Quantity	20
Quantity Uom	S.F.
Potential Action	REPLACE
Urgency of Action	PRIORITY 3

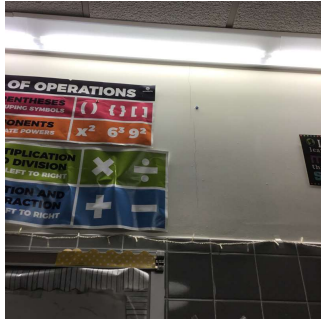
Near Serving Area
Violations	No violations recorded.
Instance on Basement - Students - Room 0012	Inspected

Question	Response
INTERIOR	
CAFETERIA	
Sliding-folding Partition	
Instance on Basement - Students - Room 0014	Does not Exist
Instance on Basement - Students - Room 0060	Does not Exist
Instance on Basement - Students - Room 0062	Does not Exist
Stage	
Instance on Basement - Staff - Room 0072	Does not Exist
Instance on Basement - Students - Room 0012	Does not Exist
Instance on Basement - Students - Room 0060	Does not Exist
Instance on Basement - Students - Room 0062	Does not Exist
Instance on Basement - Students - Room 0014	Does not Exist
Walls	
Instance on Basement - Staff - Room 0072	Inspected
Condition	2 - Between Good and Fair
Deficiency	GYPSUM BOARD: DETERIORATED
Deficiency Location/Instance	Near Serving Area
Deficiency Quantity	10
Quantity Uom	S.F.
Potential Action	REPLACE
Urgency of Action	PRIORITY 3
Purpose of Action	LEVEL 2
Deficiency Photo1

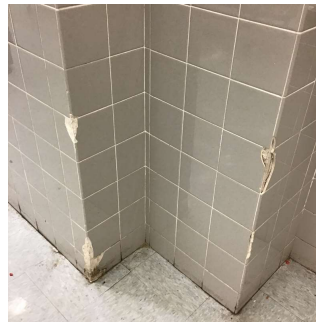
Condition	2 - Between Good and Fair
Deficiency	CERAMIC TILE: BROKEN/ MISSING
Deficiency Location/Instance	Columns, Near Entrance
Deficiency Quantity	10
Quantity Uom	S.F.
Potential Action	REPLACE
Urgency of Action	PRIORITY 3
Purpose of Action	LEVEL 2

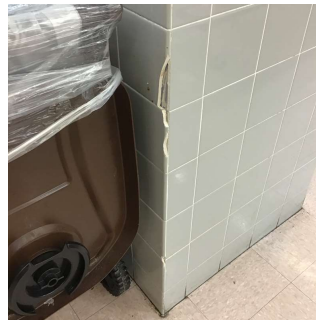
Column

CERAMIC TILE: BROKEN/ MISSING

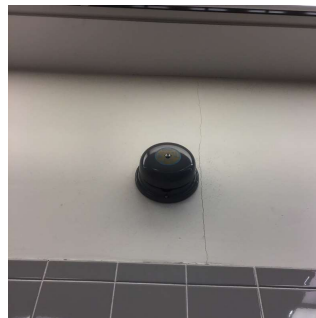
GYPSON BOARD: DETERIORATED

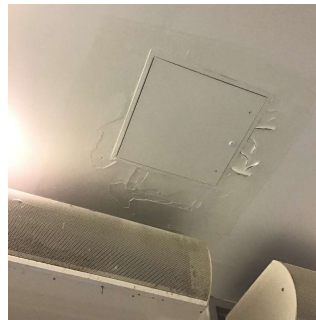
GYP SUM BOARD: DAMAGED/DETERIORATED
Main Entrance - Vestibule
20
S.F.
REPLACE
PRIORITY 3
LEVEL 2

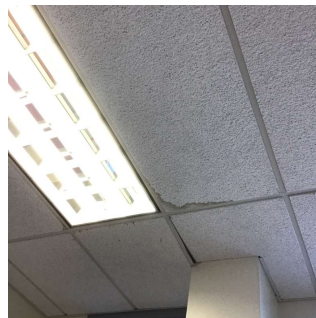
ACOUSTIC TILES: DAMAGED/MISSING
Rooms 3107, 4003, 5050, 5009, Main Entrance, and others.
200
S.F.
REPLACE
PRIORITY 3
LEVEL 2

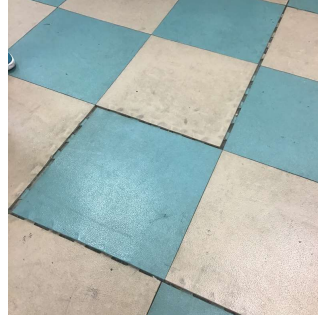
Room 0093
Violations	No violations recorded.
Deficiency	RUBBER MATTING: WORN/DETERIORATED
Deficiency Location/Instance	Room 1066
Deficiency Quantity	40
Quantity Uom	S.F.
Potential Action	REPLACE

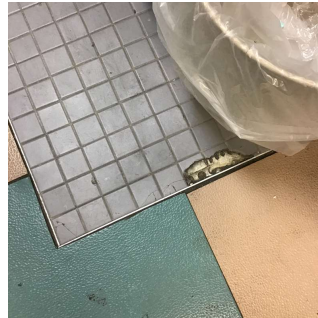
Room 1066

CERAMIC TILE: BROKEN/MISSING TILES

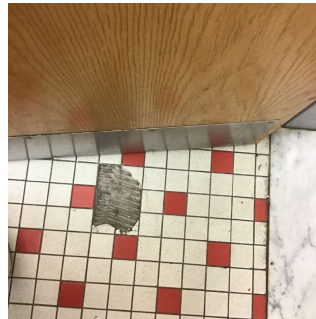
Near Entrance

Instance on Room 1052 (472 Lockers)	Inspected
Condition	2 - Between Good and Fair
Deficiency	CERAMIC TILE: BROKEN/MISSING TILES
Deficiency Location/Instance	Near Entrance, Locker 8
Deficiency Quantity	10
Quantity Uom	S.F.
Potential Action	REPLACE
Urgency of Action	PRIORITY 3
Purpose of Action	LEVEL 2
Deficiency Photo1

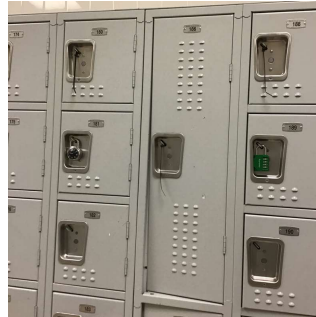
Locker 186

Instance on Room 3078H (465 Lockers)	Inspected
Condition	2 - Between Good and Fair
Deficiency	DAMAGED UNITS
Deficiency Location/Instance	Lockers 143, 144, 186, 257, 284, and others.
Deficiency Quantity	12
Quantity Uom	EACH
Potential Action	REPLACE
Urgency of Action	PRIORITY 3
Purpose of Action	LEVEL 2
Deficiency Photo1

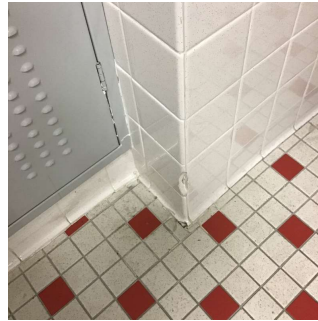
Near Entrance

CERAMIC TILE: BROKEN/ MISSING

REPLACE

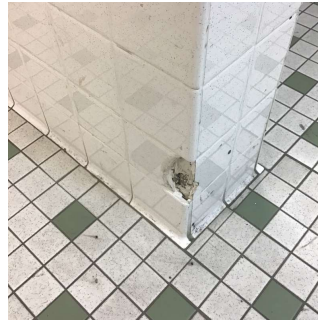
Near Entrance

CERAMIC TILE: BROKEN/ MISSING

REPLACE

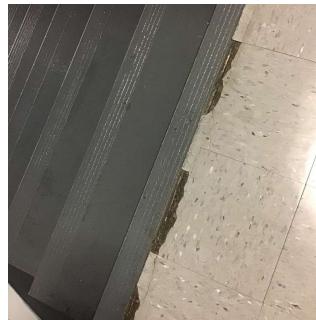
Stair BC/3

MASONRY: CRACKS/SPALLING

REPLACE

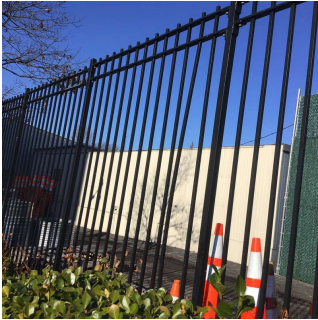
Question	Response
SITE	
Drainage System for Concrete	Inspected
Catch Basins/Manhole - Surrounded by concrete	Inspected
Condition	2 - Between Good and Fair
Deficiency	No deficiencies recorded
Culverts - Concrete Covering	Does not Exist
Drainage System for Soil	Inspected
Catch Basins/Manhole - Surrounded by Soil	Inspected
Condition	2 - Between Good and Fair
Deficiency	No deficiencies recorded
Culverts - Soil Covering	Does not Exist
DRINKING FOUNTAINS	Inspected
Condition	2 - Between Good and Fair
Deficiency	No deficiencies recorded
FENCES	Inspected
Condition	3 - Fair
Deficiency	WROUGHT IRON: DAMAGED/DETERIORATED
Deficiency Location/Instance	Near Playground, Playing Field
Deficiency Quantity	80
Quantity Uom	S.F.
Potential Action	REPLACE
Urgency of Action	PRIORITY 3
Purpose of Action	LEVEL 2
Deficiency Photo1

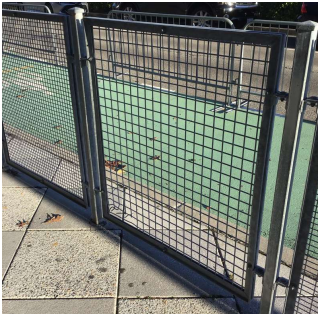
Violations	Near Playground No violations recorded.
Deficiency	ALUMINUM: DAMAGED/DETERIORATED
Deficiency Location/Instance	Near Exit 12

Deficiency Quantity	40
Quantity Uom	S.F.
Potential Action	REPLACE
Urgency of Action	PRIORITY 3
Purpose of Action	LEVEL 2
Deficiency Photo1

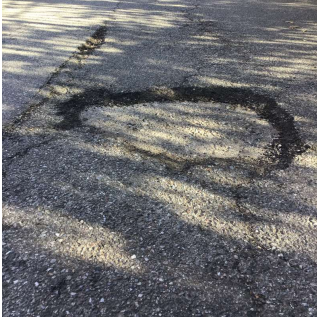
Question	Response
SITE	
FENCES	Inspected
	Near Exit 13
Violations	No violations recorded.
IRRIGATION SYSTEM	Does not Exist
PAVING	Inspected
Student Non-Use	Inspected
Gravel Exists?	No
Asphalt	Inspected
Condition	5 - Poor
Deficiency	POTHOLES
Deficiency Location/Instance	Roadway Near Generator Enclosure
Deficiency Quantity	40
Quantity Uom	S.F.
Potential Action	REPAIR
Urgency of Action	PRIORITY 3
Purpose of Action	LEVEL 2
Deficiency Photo1

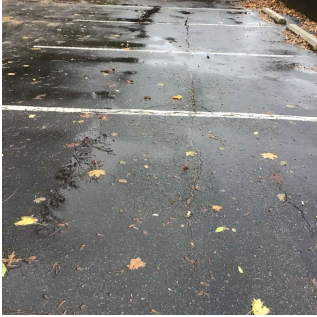
Roadway Near Generator Enclosure
Violations	No violations recorded.
Deficiency	CRACKS - MAJOR
Deficiency Location/Instance	Near Metropolitan Avenue, Car Main Entrance, Playground, Playing Surface, Loading Dock, and others.
Deficiency Quantity	6,000
Quantity Uom	S.F.
Potential Action	REPLACE
Urgency of Action	PRIORITY 3
Purpose of Action	LEVEL 2
Deficiency Photo1

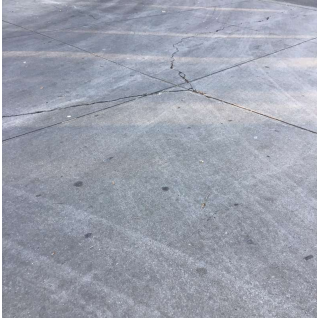
Near Metropolitan Avenue
Violations	No violations recorded.
Concrete	Inspected
Condition	3 - Fair
Deficiency	CRACKS - MAJOR

Question	Response
SITE	
PAVING	Inspected
Student Non-Use	
Concrete	
Deficiency Location/Instance	Near Cars Main Entrance, Exit 10
Deficiency Quantity	200
Quantity Uom	S.F.
Potential Action	REPLACE
Urgency of Action	PRIORITY 3
Purpose of Action	LEVEL 2
Deficiency Photo1

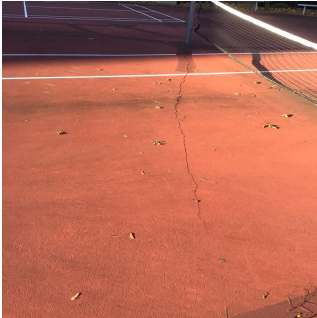
Violations	Near Cars Main Entrance No violations recorded.
Pavers	Inspected
Condition	2 - Between Good and Fair
Deficiency	No deficiencies recorded
Student Use	Inspected
Gravel Exists?	No
Asphalt	Inspected
Condition	3 - Fair
Deficiency	CRACKS - MAJOR
Deficiency Location/Instance	Tennis Court Area
Deficiency Quantity	300
Quantity Uom	S.F.
Potential Action	REPLACE
Urgency of Action	PRIORITY 3
Purpose of Action	LEVEL 2
Deficiency Photo1

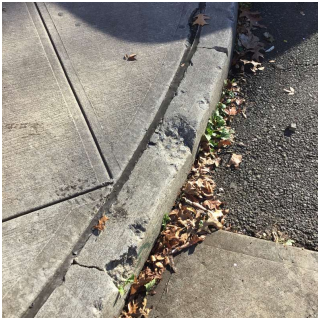
Question	Response
SITE	
PAVING	
Site Sidewalks & Walkways	
Concrete	Inspected
Condition	4 - Between Fair and Poor
Deficiency	DAMAGED CURBS
Deficiency Location/Instance	Near Exit 11, Playground, Car Main entrance, Parking Area, Safety Surfacing, and others.
Deficiency Quantity	350
Quantity Uom	L.F.
Potential Action	REPLACE
Urgency of Action	PRIORITY 3
Purpose of Action	LEVEL 2
Deficiency Photo1

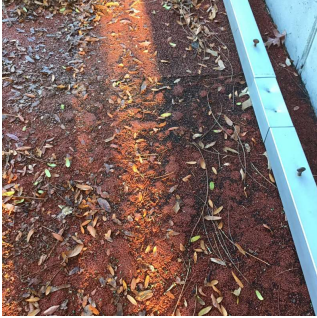
Question	Response
SITE	
PLAYGROUNDS	Inspected
Unpaved Area	
Instance on South Side	Does not Exist
PLAYING SURFACE	Inspected
Playing Field	Inspected
Instance on North Side	Inspected
Instance Condition	2 - Between Good and Fair
Deficiency	No deficiencies recorded
Running Track	Inspected
Instance on North Side	Inspected
Instance Condition	2 - Between Good and Fair
Deficiency	ATHLETIC WEARING SURFACE: DAMAGED/DETERIORATED
Deficiency Location/Instance	Near Exit 4
Deficiency Quantity	30
Quantity Uom	S.F.
Potential Action	REPLACE
Urgency of Action	PRIORITY 3
Purpose of Action	LEVEL 2
Deficiency Photo1

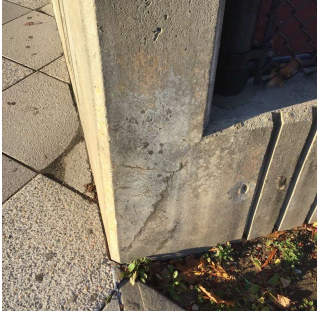
Near Exit 4	
Violations	No violations recorded.
RETAINING WALLS	Inspected
Are there any Retaining Walls 6' OR higher facing public street/sidewalk?	No
Condition	3 - Fair
Deficiency	CAST IN PLACE CONCRETE: CRACKS/SPALLING - MAJOR
Deficiency Location/Instance	Near Exit 4, Main Entrance, Playground
Deficiency Quantity	40
Quantity Uom	S.F.

Potential Action	REPLACE
Urgency of Action	PRIORITY 3
Purpose of Action	LEVEL 2
Deficiency Photo1

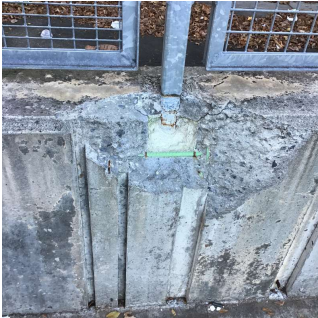
Question	Response
SITE	
RETAINING WALLS	Inspected
	Near Exit 4
Violations	No violations recorded.
SEATING	Inspected
Benches	Inspected
Concrete	Inspected
Condition	2 - Between Good and Fair
Deficiency	No deficiencies recorded
Metal/Wood/Plastic	Inspected
Condition	2 - Between Good and Fair
Deficiency	No deficiencies recorded
Bleachers	Does not Exist
SITE WALLS (NOT RETAINING WALLS)	Inspected
Condition	3 - Fair
Deficiency	CAST IN PLACE CONCRETE: CRACKS/SPALLING - MAJOR
Deficiency Location/Instance	Near Car Main Entrance, Playground border.
Deficiency Quantity	100
Quantity Uom	S.F.
Potential Action	REPLACE
Urgency of Action	PRIORITY 3
Purpose of Action	LEVEL 2
Deficiency Photo1

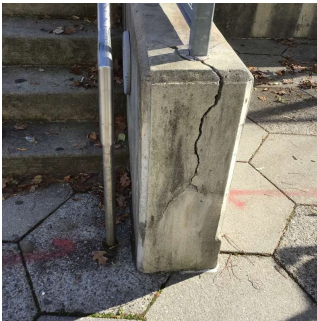
Deficiency	CAST IN PLACE CONCRETE: CRACKS/SPALLING - MAJOR
Deficiency Location/Instance	Near Exits 6/7, 8
Deficiency Quantity	20
Quantity Uom	S.F.
Potential Action	REPLACE
Urgency of Action	PRIORITY 3
Purpose of Action	LEVEL 2

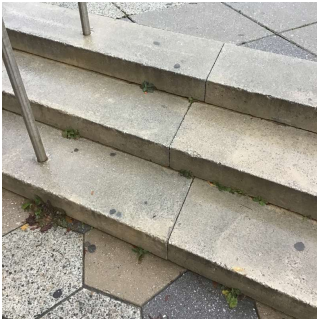
Violations	Near Exit 6/7 No violations recorded.
Stairs/ramps	Inspected
Condition	2 - Between Good and Fair
Deficiency	CAST IN PLACE CONCRETE: CRACKS/SPALLING - MAJOR
Deficiency Location/Instance	Near Exit 8
Deficiency Quantity	10
Quantity Uom	S.F.
Potential Action	REPLACE
Urgency of Action	PRIORITY 3
Purpose of Action	LEVEL 2
Deficiency Photo1
