NYC Department of Education
Building Condition Assessment Survey 2023 - 2024

Architectural Inspection

Asset: QUEENS GATEWAY TO HEALTH SCIENCES SECONDARY SCHOOL - QUEENS, 160-20 GOETHALS AVENUE, New York, 11432

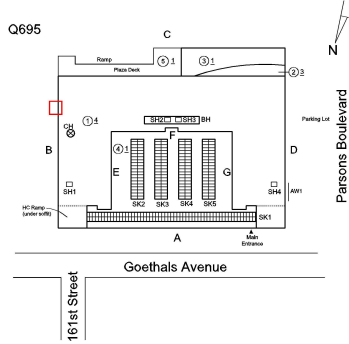
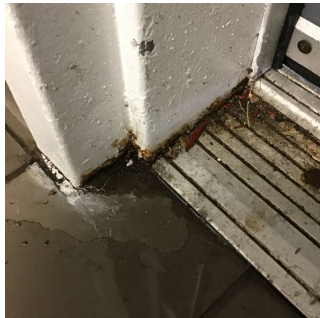
Violations	Roof 1 No violations recorded.
COPING	
Condition	Inspected
Deficiency	2 - Between Good and Fair
Deficiency	No deficiencies recorded
CORNICE	
Deficiency	Does not Exist
DOORS	
Deficiency	Inspected
DOORS AND FRAMES	
Condition	Inspected
Deficiency	3 - Fair
Deficiency	METAL: DETERIORATED DOOR AND FRAME - MINOR DETERIORATION
Roof Plan reference

Deficiency Quantity	1
Quantity Uom	EACH
Potential Action	MAINTENANCE
Urgency of Action	PRIORITY 3
Purpose of Action	LEVEL 2
Deficiency Photo1

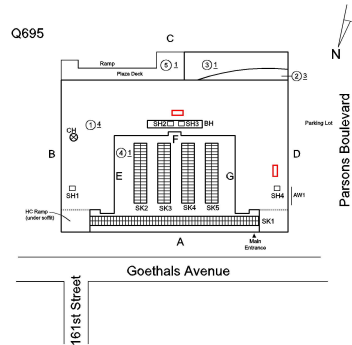
Roof Plan reference

Deficiency	IRMA: ROOFING: DETERIORATED PAVERS WITH INTEGRAL INSULATION
------------	---

Deficiency Quantity	20
---------------------	----

Potential Action	REPLACE
------------------	---------

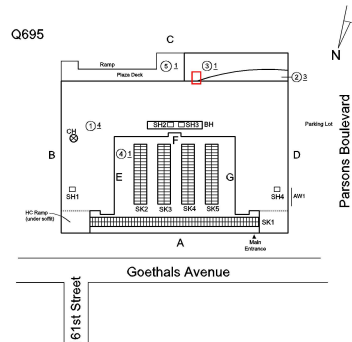
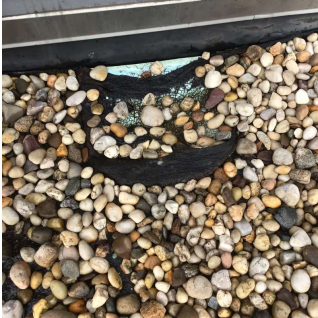
Roof Plan reference

Deficiency	IRMA: ROOFING: DAMAGED INSULATION
------------	-----------------------------------

Deficiency Quantity	10
---------------------	----

Question	Response
EXTERIOR	
ROOF	
Roofing	
ROOFING	
Potential Action	REPLACE
Urgency of Action	PRIORITY 4
Purpose of Action	LEVEL 2
Deficiency Photo1

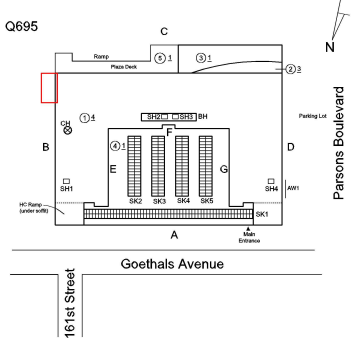
Violations	Roof 3 No violations recorded.
ROOFING DRAINS	Inspected
Condition	2 - Between Good and Fair
Deficiency	No deficiencies recorded
Specialties	Inspected
BULKHEAD/PENTHOUSE	Inspected
Condition	2 - Between Good and Fair
Deficiency	No deficiencies recorded
CUPOLA/ SPIRES/ TOWERS	Does not Exist
DORMER	Does not Exist
DUNNAGE STEEL	Does not Exist
SKYLIGHT/ROOF VENT	Inspected
Material Type(s)	Glass
Condition	2 - Between Good and Fair
Deficiency	No deficiencies recorded
ROOF/GRAVITY TANK	Does not Exist
STAIRS/RAMPS: EXTERIOR	Inspected
BUILDING CHEEK/FLANK WALLS	Inspected
Condition	3 - Fair
Deficiency	CAST IN PLACE CONCRETE: CRACKS/SPALLING - MAJOR
Roof Plan reference

Deficiency Quantity	10
Quantity Uom	S.F.
Potential Action	REPLACE

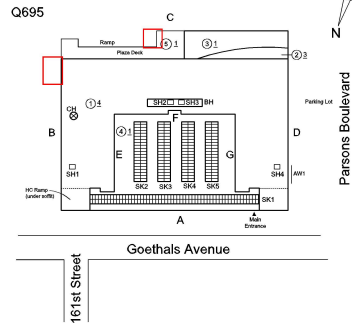
Roof Plan reference

STONE: CRACKS/SPALLING - MAJOR

50
S.F.
REPLACE
PRIORITY 4
LEVEL 2

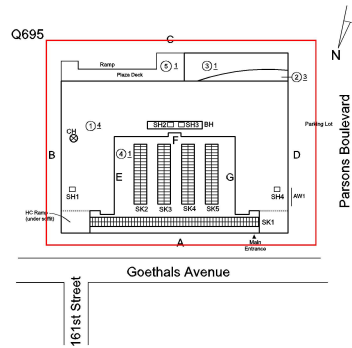
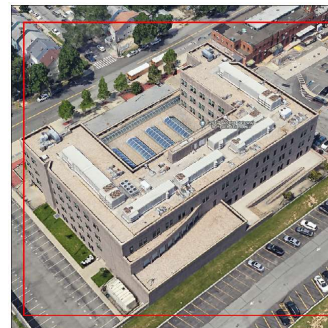
Deficiency	ALUMINUM - OTHER: DETERIORATED
------------	--------------------------------

Deficiency Quantity	1,800
Quantity Uom	S.F.
Potential Action	REPLACE WINDOW
Urgency of Action	PRIORITY 4
Purpose of Action	LEVEL 2

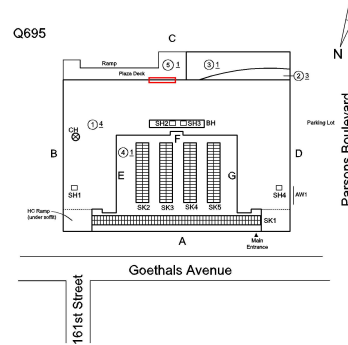
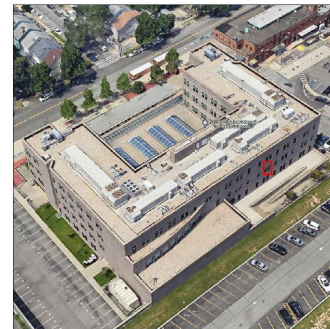
ALUMINUM - OTHER: AIR/WATER INFILTRATION, DETERIORATED JOINTS WITH DAMAGED CAULKING

60
L.F.
MAINTENANCE
PRIORITY 3
LEVEL 2

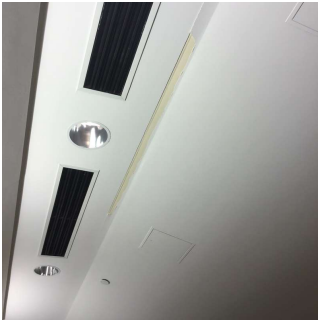
Balcony
Violations	No violations recorded.
Door(s)	
Instance on 1st Floor (371 Seats)	Inspected
Condition	2 - Between Good and Fair
Deficiency	No deficiencies recorded
Fixed H/C Lift	
Instance on 1st Floor (371 Seats)	Does not Exist
Fixed Seating	
Instance on 1st Floor (371 Seats)	Inspected

Basement - Room B59
Violations	No violations recorded.
ROOF STRUCTURE	
Condition	Inspected
	2 - Between Good and Fair
Deficiency	No deficiencies recorded
VAULTS-BUNKERS	
	Does not Exist
AUDITORIUM	
	Inspected
Instance on 1st Floor (371 Seats)	Inspected
Ceiling	
Instance on 1st Floor (371 Seats)	Inspected
Condition	2 - Between Good and Fair
Deficiency	GYP SUM BOARD: DAMAGED/DETERIORATED
Deficiency Location/Instance	Room 241
Deficiency Quantity	10
Quantity Uom	S.F.
Potential Action	REPLACE
Urgency of Action	PRIORITY 3
Purpose of Action	LEVEL 2
Deficiency Photo1

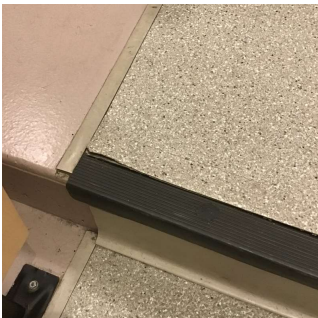
Seat AA/111 (Balcony)
Violations	No violations recorded.
Floor Finish	
Instance on 1st Floor (371 Seats)	Inspected
Condition	2 - Between Good and Fair
Deficiency	VINYL TILES: BROKEN/DETERIORATED/MISSING TILES
Deficiency Location/Instance	Near Seat J/111
Deficiency Quantity	10
Quantity Uom	S.F.
Potential Action	REPLACE
Urgency of Action	PRIORITY 3
Purpose of Action	LEVEL 2
Deficiency Photo1

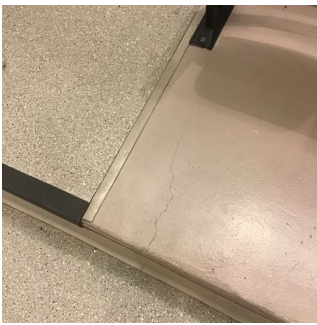
Near Seat J/111
Violations	No violations recorded.
Deficiency	CONCRETE: CRACKS
Deficiency Location/Instance	Near Seats B/101, G/1, 101, G/111
Deficiency Quantity	10
Quantity Uom	S.F.
Potential Action	REPLACE
Urgency of Action	PRIORITY 3
Purpose of Action	LEVEL 2

Seat G/1
Violations	No violations recorded.
Sliding-folding Partition	
Instance on 1st Floor (371 Seats)	Does not Exist
Stage	
Instance on 1st Floor (371 Seats)	Inspected
Stage	Inspected
Instance on 1st Floor (371 Seats)	Inspected
Condition	2 - Between Good and Fair
Deficiency	No deficiencies recorded
Stage Curtain Rigging	
Instance on 1st Floor (371 Seats)	Inspected
Condition	2 - Between Good and Fair
Deficiency	No deficiencies recorded
Stage Curtains	
Instance on 1st Floor (371 Seats)	Inspected
Condition	2 - Between Good and Fair
Deficiency	No deficiencies recorded
Walls	
Instance on 1st Floor (371 Seats)	Inspected
Condition	2 - Between Good and Fair
Deficiency	No deficiencies recorded
Window Curtains/Shades/Blinds	
Instance on 1st Floor (371 Seats)	Does not Exist
CAFETERIA	
Instance on 1st Floor - Staff (600SF)	Inspected
Instance on 1st Floor - Students	Inspected

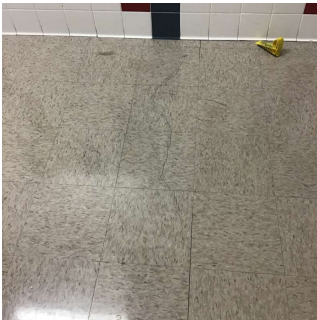
Room 241
Violations	No violations recorded.
Door(s)	Inspected
Condition	2 - Between Good and Fair
Deficiency	No deficiencies recorded
Floor Finish	Inspected
Condition	2 - Between Good and Fair
Deficiency	VINYL TILES: DETERIORATED SUBSTRATE
Deficiency Location/Instance	Corridor near room B61, B34,B12, B10, by Stair B/Basement
Deficiency Quantity	130
Quantity Uom	S.F.
Potential Action	REPLACE
Urgency of Action	PRIORITY 3
Purpose of Action	LEVEL 2
Deficiency Photo1

Corridor near room B61
Violations	No violations recorded.
Deficiency	VINYL TILES: BROKEN/DETERIORATED/MISSING TILES
Deficiency Location/Instance	Corridor near room 121A, near Cafeteria
Deficiency Quantity	20
Quantity Uom	S.F.
Potential Action	REPLACE
Urgency of Action	PRIORITY 3
Purpose of Action	LEVEL 2

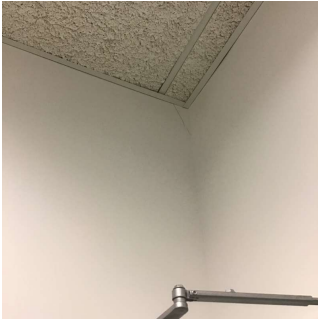
Question	Response
INTERIOR	
KITCHEN	
Floor Finish	
Deficiency	No deficiencies recorded
Walls	
Instance on 1st Floor	Inspected
Condition	2 - Between Good and Fair
Deficiency	PLASTER: CRACKS/SPALLING
Deficiency Location/Instance	Office, Corridor near Room 141R
Deficiency Quantity	15
Quantity Uom	S.F.
Potential Action	REPLACE
Urgency of Action	PRIORITY 3
Purpose of Action	LEVEL 2
Deficiency Photo1

Violations	Office No violations recorded.
LIBRARY	
Instance on Room 321	Inspected
Built-in Furnishing	
Instance on Room 321	Does not Exist
Ceiling	
Instance on Room 321	Inspected
Condition	2 - Between Good and Fair
Deficiency	ACOUSTIC TILES: DAMAGED/MISSING
Deficiency Location/Instance	Center
Deficiency Quantity	10
Quantity Uom	S.F.
Potential Action	REPLACE
Urgency of Action	PRIORITY 3
Purpose of Action	LEVEL 2
Deficiency Photo1

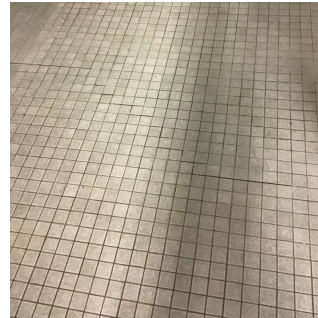
Violations	Entrance No violations recorded.
Instance on Basement- Girls (497 Lockers)	Inspected
Condition	2 - Between Good and Fair
Deficiency	CERAMIC TILE: DETERIORATED SUBSTRATE
Deficiency Location/Instance	Entrance
Deficiency Quantity	10
Quantity Uom	S.F.
Potential Action	REPLACE
Urgency of Action	PRIORITY 3

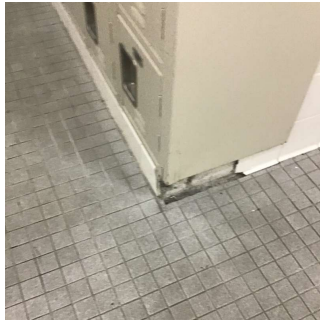
Near Entrance
Violations	No violations recorded.
Instance on Basement- Boys (507 Lockers)	Inspected
Condition	2 - Between Good and Fair
Deficiency	CERAMIC TILE: BROKEN/ MISSING
Deficiency Location/Instance	Center
Deficiency Quantity	10
Quantity Uom	S.F.
Potential Action	REPLACE
Urgency of Action	PRIORITY 3
Purpose of Action	LEVEL 2
Deficiency Photo1

Center
Violations	No violations recorded.
MULTI-PURPOSE ROOM	Does not Exist
SCIENCE DEMO ROOM	Does not Exist
SCIENCE LAB	Inspected
Instance on Room 337	Inspected
Alternative use	No
Instance on Room 437	Inspected
Alternative use	Yes
Instance on Rooms 325, 425	Inspected
Alternative use	Yes
Instance on Rooms 341, 423, 441	Inspected
Alternative use	No
Fixed Equipment	
Instance on Room 437	Inspected
Condition	3 - Fair
Deficiency	CABINetry: MISSING/DAMAGED

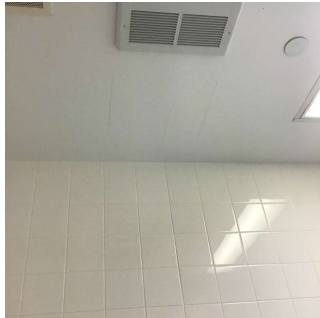
Stair B/1
Violations	No violations recorded.
TOILET ROOMS - STAFF	
	Inspected
Ceiling	
	Inspected
Condition	2 - Between Good and Fair
Deficiency	GYPSUM BOARD: DAMAGED/DETERIORATED
Deficiency Location/Instance	Room 141R
Deficiency Quantity	10
Quantity Uom	S.F.
Potential Action	REPLACE
Urgency of Action	PRIORITY 3
Purpose of Action	LEVEL 2
Deficiency Photo1

Room 141R
Violations	No violations recorded.
Door(s)	
	Inspected
Condition	2 - Between Good and Fair
Deficiency	No deficiencies recorded
Floor Finish	
	Inspected
Condition	2 - Between Good and Fair
Deficiency	No deficiencies recorded
Stalls	
	Does not Exist
Walls	
	Inspected

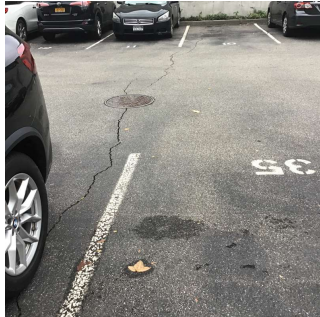
Deficiency	CRACKS - MAJOR
Deficiency Location/Instance	Parking Lot
Deficiency Quantity	1,000
Quantity Uom	S.F.
Potential Action	REPLACE
Urgency of Action	PRIORITY 3
Purpose of Action	LEVEL 2

Violations	Parking Lot No violations recorded.
Concrete	Inspected
Condition	2 - Between Good and Fair
Deficiency	CRACKS - MAJOR
Deficiency Location/Instance	Parking Lot
Deficiency Quantity	25
Quantity Uom	S.F.
Potential Action	REPLACE
Urgency of Action	PRIORITY 3
Purpose of Action	LEVEL 2
Deficiency Photo1

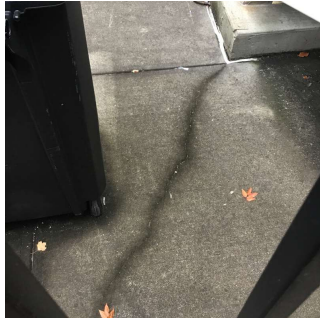
Violations	Parking Lot No violations recorded.
Pavers	Does not Exist
Student Use	Inspected
Gravel Exists?	No
Asphalt	Inspected
Condition	4 - Between Fair and Poor
Deficiency	LOCALIZED SINK AREA
Deficiency Location/Instance	Schoolyard
Deficiency Quantity	30
Quantity Uom	S.F.
Potential Action	REPAIR
Urgency of Action	PRIORITY 3
Purpose of Action	LEVEL 2

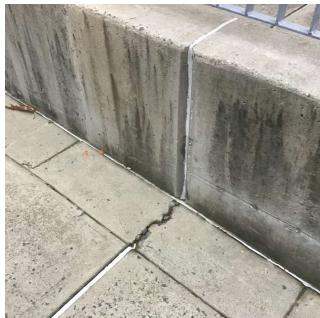
Goethals Avenue
Violations	No violations recorded.
Pavers	Does not Exist
Site Sidewalks & Walkways	Inspected
Asphalt	Does not Exist
Concrete	Inspected
Condition	4 - Between Fair and Poor
Deficiency	CRACKS - MAJOR
Deficiency Location/Instance	Left Side of Building , Near main entrance, rear of building
Deficiency Quantity	300
Quantity Uom	S.F.
Potential Action	REPLACE
Urgency of Action	PRIORITY 3
Purpose of Action	LEVEL 2
Deficiency Photo1

Left Side of Building
Violations	No violations recorded.
Deficiency	HEAVING
Deficiency Location/Instance	Main Entrance
Deficiency Quantity	150
Quantity Uom	S.F.
Potential Action	REPLACE
Urgency of Action	PRIORITY 3
Purpose of Action	LEVEL 2

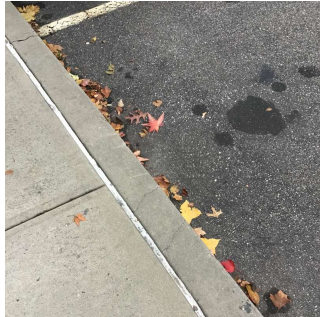
Violations	Main Entrance No violations recorded.
Deficiency	DAMAGED CURBS
Deficiency Location/Instance	Parking Lot
Deficiency Quantity	50
Quantity Uom	L.F.
Potential Action	REPLACE
Urgency of Action	PRIORITY 3
Purpose of Action	LEVEL 2
Deficiency Photo1

Violations	Parking Lot No violations recorded.
Pavers	Does not Exist
DOT Sidewalk	Inspected
Asphalt	Does not Exist
Concrete	Inspected
Condition	4 - Between Fair and Poor
Deficiency	DAMAGED CURBS
Deficiency Location/Instance	Goethals Avenue
Deficiency Quantity	50
Quantity Uom	L.F.
Potential Action	REPLACE
Urgency of Action	PRIORITY 3
Purpose of Action	LEVEL 2

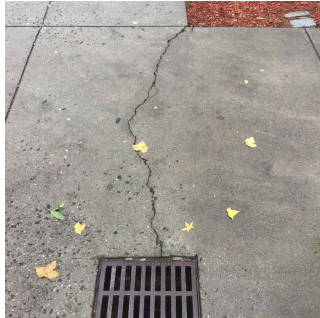
Violations	Goethals Avenue No violations recorded.
Deficiency	DAMAGED/DETERIORATED/MISSING SECTIONS
Deficiency Location/Instance	Goethals Avenue
Deficiency Quantity	600
Quantity Uom	S.F.
Potential Action	REPLACE
Urgency of Action	PRIORITY 3
Purpose of Action	LEVEL 2
Deficiency Photo1

Violations	Goethals Avenue No violations recorded.
Pavers	Does not Exist
PLAYGROUNDS	Does not Exist
PLAYING SURFACE	Does not Exist
RETAINING WALLS	Inspected
Are there any Retaining Walls 6' OR higher facing public street/sidewalk?	No
Condition	3 - Fair
Deficiency	CAST IN PLACE CONCRETE: CRACKS/SPALLING - MAJOR
Deficiency Location/Instance	Parking Lot, Goethals Avenue
Deficiency Quantity	60
Quantity Uom	S.F.
Potential Action	REPLACE
Urgency of Action	PRIORITY 3
Purpose of Action	LEVEL 2
