NYC Department of Education
Building Condition Assessment Survey 2023 - 2024

Architectural Inspection

Q725

Asset: HS FOR INFORMATION TECH - QUEENS, 21-16 44TH ROAD, New York, 11101

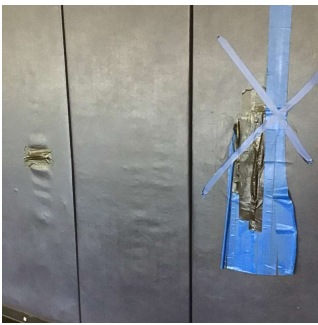
Question	Response
INTERIOR	
GYMNASIUM	
Walls	
Deficiency Photo1

Violations	Near Entrance No violations recorded.
Window Curtains/Shades/Blinds	
Instance on 4th Floor	Does not Exist
INTERIOR DOOR HARDWARE	
Condition	Inspected 3 - Fair
Deficiency	No deficiencies recorded
INTERIOR GUARDS	
Condition	Inspected 2 - Between Good and Fair
Deficiency	No deficiencies recorded
KITCHEN	
Instance on 1st Floor	Inspected
Ceiling	
Instance on 1st Floor	Inspected
Condition	2 - Between Good and Fair
Deficiency	No deficiencies recorded
Door(s)	
Instance on 1st Floor	Inspected
Condition	2 - Between Good and Fair
Deficiency	No deficiencies recorded
Floor Finish	
Instance on 1st Floor	Inspected
Condition	2 - Between Good and Fair
Deficiency	No deficiencies recorded
Walls	
Instance on 1st Floor	Inspected
Condition	2 - Between Good and Fair
Deficiency	GYPSUM BOARD: DETERIORATED
Deficiency Location/Instance	Room 155B, 155E, 155F
Deficiency Quantity	20

Quantity Uom	S.F.
Potential Action	REPLACE
Urgency of Action	PRIORITY 3
Purpose of Action	LEVEL 2

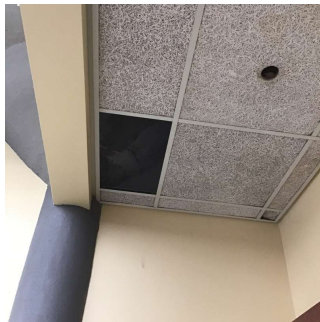
Question	Response
INTERIOR	
KITCHEN	
Walls	
Deficiency Photo1	 
Violations	Room 155B No violations recorded.
LIBRARY	
Instance on Room 433	Inspected
Built-in Furnishing	Inspected
Instance on Room 433	Inspected
Condition	2 - Between Good and Fair
Deficiency	No deficiencies recorded
Ceiling	
Instance on Room 433	Inspected
Condition	2 - Between Good and Fair
Deficiency	TECTUM: DAMAGED/MISSING
Deficiency Location/Instance	Near Room 433E
Deficiency Quantity	10
Quantity Uom	S.F.
Potential Action	REPLACE
Urgency of Action	PRIORITY 3
Purpose of Action	LEVEL 2
Deficiency Photo1

Violations	Near room 433E No violations recorded.
Door(s)	
Instance on Room 433	Inspected
Condition	2 - Between Good and Fair
Deficiency	No deficiencies recorded
Floor Finish	
Instance on Room 433	Inspected
Condition	2 - Between Good and Fair
Deficiency	No deficiencies recorded
Walls

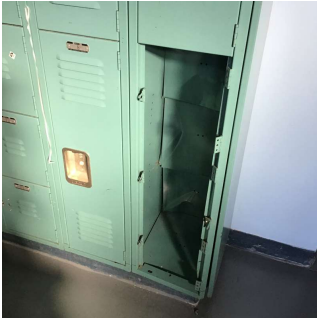
Locker 43
Violations	No violations recorded.
Instance on 4th Floor - Boys (680 Lockers)	Inspected
Condition	2 - Between Good and Fair
Deficiency	DAMAGED UNITS
Deficiency Location/Instance	Lockers 4, 58, 59, 96, 115, and others.
Deficiency Quantity	9
Quantity Uom	EACH
Potential Action	REPLACE
Urgency of Action	PRIORITY 3
Purpose of Action	LEVEL 2
Deficiency Photo1

Locker 4
Violations	No violations recorded.
Walls	
Instance on 4th Floor - Boys (680 Lockers)	Inspected
Condition	2 - Between Good and Fair
Deficiency	GYPSUM BOARD: DETERIORATED
Deficiency Location/Instance	Near Gymnasium Entrance
Deficiency Quantity	20
Quantity Uom	S.F.
Potential Action	REPLACE
Urgency of Action	PRIORITY 3
Purpose of Action	LEVEL 2

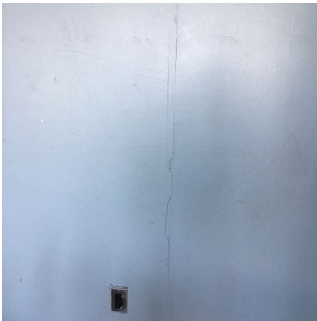
Question	Response
INTERIOR	
LOCKER ROOM	
Walls	
Deficiency Photo1

Violations	Near Gymnasium Entrance No violations recorded.
MULTI-PURPOSE ROOM	Does not Exist
SCIENCE DEMO ROOM	Inspected
Instance on Rooms 306, 308, 334, 336	Inspected
Alternative use	No
Fixed Equipment	
Instance on Rooms 306, 308, 334, 336	Inspected
Condition	2 - Between Good and Fair
Deficiency	No deficiencies recorded
SCIENCE LAB	Inspected
Instance on Rooms 311, 315	Inspected
Alternative use	No
Fixed Equipment	
Instance on Rooms 311, 315	Inspected
Condition	3 - Fair
Deficiency	CABINETRY: MISSING/DAMAGED
Deficiency Location/Instance	Rooms 311, 315
Deficiency Quantity	12
Quantity Uom	L.F.
Potential Action	REPLACE
Urgency of Action	PRIORITY 3
Purpose of Action	LEVEL 2
Deficiency Photo1

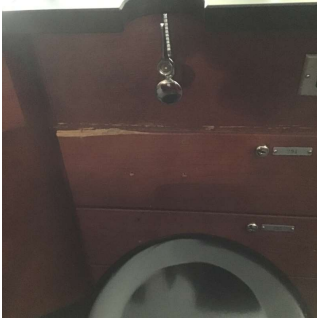
Violations	Room 315 No violations recorded.
SCIENCE PREP ROOM	Inspected
Instance on Room 313	Inspected
Alternative use	No
Fixed Equipment

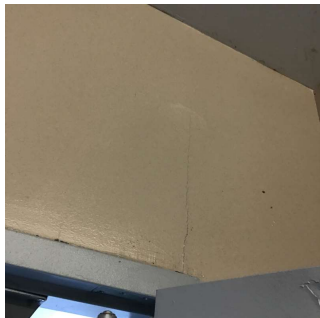
Question	Response
INTERIOR	
STAIRS/RAMPS: INTERIOR	
Door(s)	Inspected
Violations	No violations recorded.
Partition	Does not Exist
Railings	Inspected
Condition	2 - Between Good and Fair
Deficiency	No deficiencies recorded
Stairs and Landings	Inspected
Condition	2 - Between Good and Fair
Deficiency	VINYL TILES: BROKEN/DETERIORATED/MISSING TILES
Deficiency Location/Instance	Stair A/2, 3, B/3, C/3, 4 and others.
Deficiency Quantity	80
Quantity Uom	S.F.
Potential Action	REPLACE
Urgency of Action	PRIORITY 3
Purpose of Action	LEVEL 2
Deficiency Photo1	 
Violations	Stair C/4 No violations recorded.
Walls	Inspected
Condition	2 - Between Good and Fair
Deficiency	GYPSUM BOARD: DETERIORATED
Deficiency Location/Instance	Stair A/2, 3, 4, B/1, 3, and others.
Deficiency Quantity	100
Quantity Uom	S.F.
Potential Action	REPLACE
Urgency of Action	PRIORITY 3
Purpose of Action	LEVEL 2
Deficiency Photo1

Violations	Stair A/2 No violations recorded.

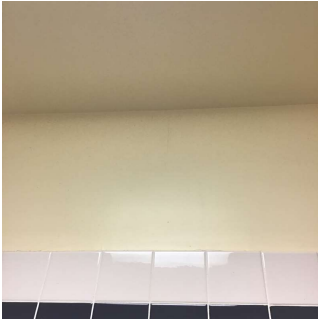
Question	Response
INTERIOR	
TOILET ROOMS - STUDENTS	
Floor Finish	
Deficiency Photo1	 
	Room 221
Violations	No violations recorded.
Stalls	Inspected
Condition	2 - Between Good and Fair
Deficiency	No deficiencies recorded
Walls	Inspected
Condition	2 - Between Good and Fair
Deficiency	GYPSUM BOARD: DETERIORATED
Deficiency Location/Instance	Rooms 142A, 144A, 223, 227, 327, and others.
Deficiency Quantity	140
Quantity Uom	S.F.
Potential Action	REPLACE
Urgency of Action	PRIORITY 3
Purpose of Action	LEVEL 2
Deficiency Photo1

Room 327
Violations	No violations recorded.
Deficiency	CERAMIC TILE: BROKEN/ MISSING
Deficiency Location/Instance	Room 146A
Deficiency Quantity	10
Quantity Uom	S.F.
Potential Action	REPLACE
Urgency of Action	PRIORITY 3
Purpose of Action	LEVEL 2

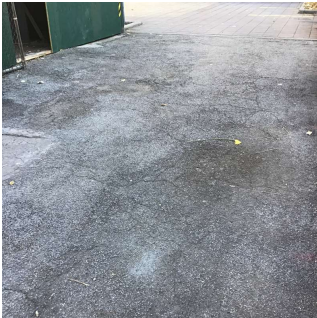
21st Street
Violations	No violations recorded.
IRRIGATION SYSTEM	Does not Exist
PAVING	Inspected
Student Non-Use	Inspected
Gravel Exists?	No
Asphalt	Inspected
Condition	3 - Fair
Deficiency	CRACKS - MAJOR
Deficiency Location/Instance	Near 44th Drive
Deficiency Quantity	450
Quantity Uom	S.F.
Potential Action	REPLACE
Urgency of Action	PRIORITY 3
Purpose of Action	LEVEL 2
Deficiency Photo1

Near 44th Drive
Violations	No violations recorded.
Concrete	Does not Exist
Pavers	Inspected
Condition	2 - Between Good and Fair
Deficiency	DAMAGED/MISSING
Deficiency Location/Instance	Near Center
Deficiency Quantity	20
Quantity Uom	S.F.
Potential Action	REPLACE

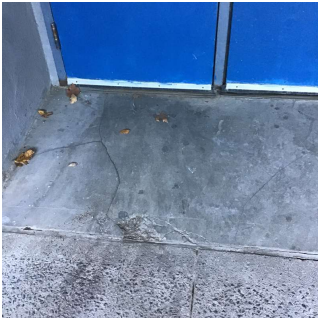
Question	Response
SITE	
PAVING	
Student Non-Use	
Pavers	
Urgency of Action	PRIORITY 3
Purpose of Action	LEVEL 2
Deficiency Photo1	 
	Near Center
Violations	No violations recorded.
Student Use	Does not Exist
Site Sidewalks & Walkways	Inspected
Asphalt	Does not Exist
Concrete	Inspected
Condition	2 - Between Good and Fair
Deficiency	DAMAGED/DETERIORATED/MISSING SECTIONS
Deficiency Location/Instance	Near Exit 4
Deficiency Quantity	25
Quantity Uom	S.F.
Potential Action	REPLACE
Urgency of Action	PRIORITY 3
Purpose of Action	LEVEL 2
Deficiency Photo1

Near Exit 4
Violations	No violations recorded.
Pavers	Inspected
Condition	2 - Between Good and Fair
Deficiency	No deficiencies recorded
DOT Sidewalk	Inspected
Asphalt	Does not Exist
Concrete	Inspected
Condition	3 - Fair
Deficiency	DAMAGED/DETERIORATED/MISSING SECTIONS
Deficiency Location/Instance	21st Street, 44th Road, 44th Drive.
