NYC Department of Education
Building Condition Assessment Survey 2023 - 2024

Architectural Inspection

Q727

Asset: P.S. 106 TRANSPORTABLE - Q, 180 BEACH 35 STREET, New York, 11691

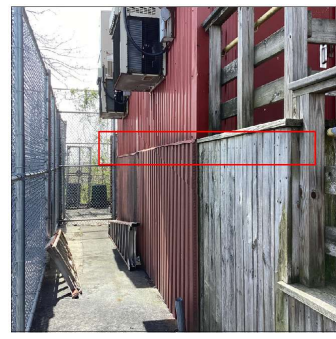
<p align="center">G108 Main Building</p> <p align="center">Beach 35th Street</p>
Elevation

Question	Response
EXTERIOR	
EXTERIOR WALLS	
Replacement Quantity	2,000
Replacement Uom	S.F.
Instance on All Facades	Inspected
Instance Condition	5 - Poor
Instance Quantity	2,000
Instance Quantity Uom	S.F.
Deficiency	METAL PANEL: DAMAGED TRIM
Roof Plan reference	<p>Q727

Deficiency Quantity	40
Quantity Uom	L.F.
Potential Action	REPLACE
Urgency of Action	PRIORITY 4
Purpose of Action	LEVEL 2
Deficiency Photo1

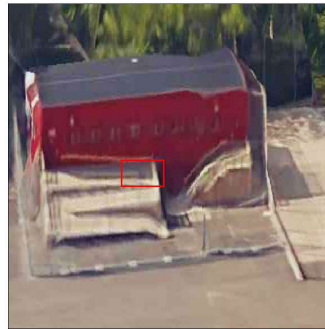
Elevation

Violations	Facade B No violations recorded.
Deficiency	METAL PANEL: MAJOR RUSTING

Deficiency Quantity

10

REPLACE
