**NYC Department of Education
Building Condition Assessment Survey 2023 - 2024**

Architectural Inspection

Q733

Asset: ALTERNATIVE HS SUPERINTENDENT-Q, 90-01 SUTPHIN BLVD, New York, 11435

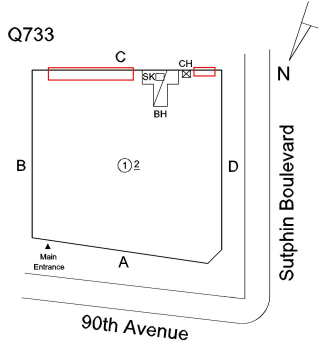
Violations	Roof 1 No violations recorded.
COPING	Inspected
Condition	3 - Fair
Deficiency	METAL: DETERIORATED
Roof Plan reference

Deficiency Quantity	40
Quantity Uom	L.F.
Potential Action	REPLACE-IN-KIND
Urgency of Action	PRIORITY 4
Purpose of Action	LEVEL 2
Deficiency Photo1

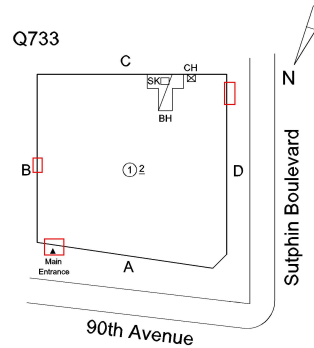
Violations	Roof 1 No violations recorded.
CORNICE	Does not Exist
DOORS	Inspected
DOORS AND FRAMES	Inspected
Condition	3 - Fair
Deficiency	ROLL-UP DOOR: DETERIORATED DOOR AND FRAME - MINOR DETERIORATION

60
S.F.
MAINTENANCE
PRIORITY 3
LEVEL 2

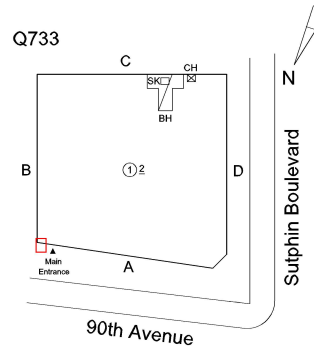
METAL: DETERIORATED DOOR AND FRAME - MINOR DETERIORATION

1
EACH
MAINTENANCE
PRIORITY 3
LEVEL 2

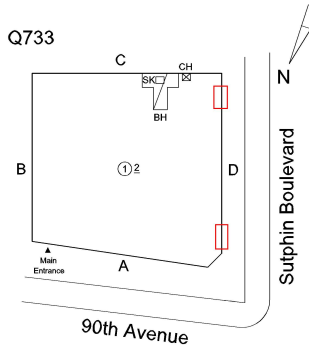
BRICK: MINOR CRACKS AND SPALLING

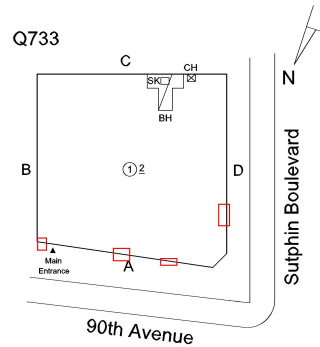
STUCCO CEMENT SURFACE: CRACKS, SPALLING

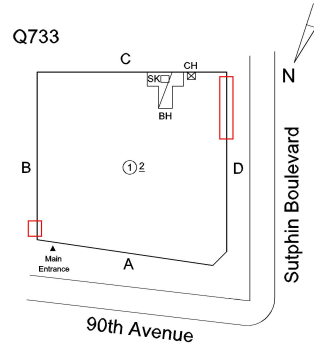
BRICK: DETERIORATED JOINTS

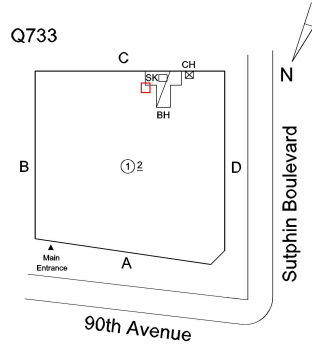
Condition	3 - Fair
-----------	----------

Deficiency	DAMAGED/MISSING
------------	-----------------

REPLACE

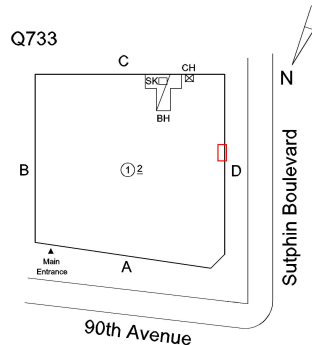
Condition	3 - Fair
-----------	----------

Deficiency	RAILINGS/PANELS: DETERIORATED, MAJOR RUSTING
------------	----------------------------------------------

REPLACE

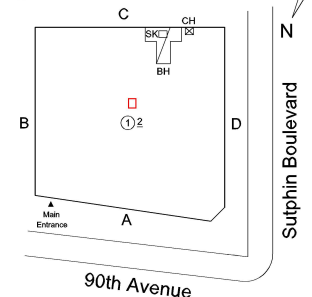
DETERIORATED

Deficiency Quantity	1
Quantity Uom	EACH
Potential Action	REPLACE
Urgency of Action	PRIORITY 4
Purpose of Action	LEVEL 2
Deficiency Photo1

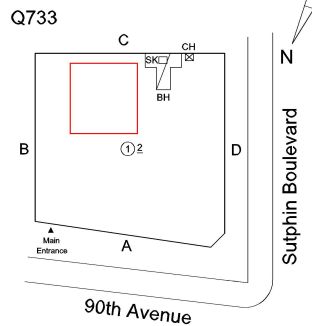
Condition	3 - Fair
-----------	----------

Deficiency	HEIGHT LESS THAN 18"
------------	----------------------

Deficiency Quantity	100
Quantity Uom	L.F.
Potential Action	REPLACE
Urgency of Action	PRIORITY 3
Purpose of Action	LEVEL 2
