NYC Department of Education
Building Condition Assessment Survey 2023 - 2024

Architectural Inspection

Q735

Asset: QUEENS HIGH SCHOOL COMPLEX - Q, 30-20 THOMSON AVE, New York, 11101

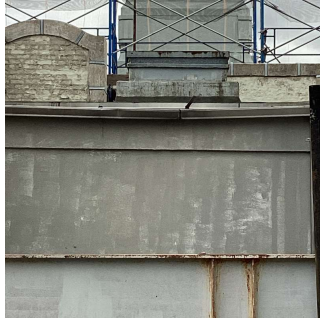
Violations	BH2 No violations recorded.
ROOF BARRIER/FENCE	Inspected
Condition	3 - Fair
Deficiency	RAILINGS/PANELS: DETERIORATED, MAJOR RUSTING
Roof Plan reference	0735

Question	Response
EXTERIOR	
ROOF	
Roofing	
LEADERS, GUTTERS, DOWNSPOUTS, SCUPPERS	
Deficiency Photo1

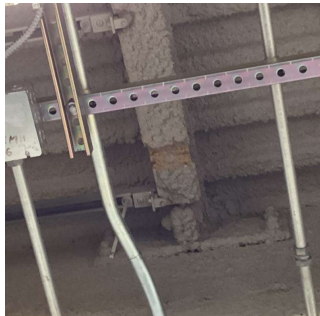
Question	Response
EXTERIOR	
WINDOWS	
WINDOWS	
Instance Quantity	20,000
Instance Quantity Uom	S.F.
Are these windows insulated	Yes
Installation Year	2001
Source of Installation	Custodial Staff
Deficiency	No deficiencies recorded
INTERIOR	Inspected
POOLS	Does not Exist
STRUCTURAL	Inspected
COLUMNS/BEAMS/BEARING WALLS	
Condition	3 - Fair
Deficiency	STEEL COLUMNS/BEAMS: DETERIORATED CONCRETE FIREPROOFING
Deficiency Location/Instance	Concourse - Gas Meter Room, Loading Dock, East Water Main
Deficiency Quantity	80
Quantity Uom	S.F.
Potential Action	REPLACE
Urgency of Action	PRIORITY 4
Purpose of Action	LEVEL 5
Deficiency Photo1	 
Violations	Room 754A No violations recorded.
Deficiency	STEEL COLUMNS/BEAMS: DETERIORATED/MISSING SPRAY-ON FIREPROOFING
Deficiency Location/Instance	PH3, Concourse - West Electrical Panel Room, Room 754B
Deficiency Quantity	40
Quantity Uom	S.F.
Potential Action	REPLACE
Urgency of Action	PRIORITY 3

Purpose of Action	LEVEL 5
Deficiency Photo1

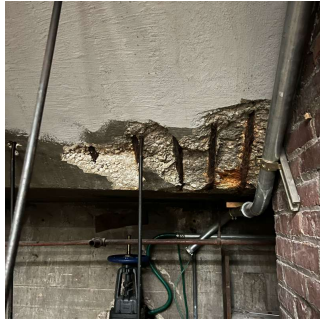
Question	Response
INTERIOR	
STRUCTURAL	
COLUMNS/BEAMS/BEARING WALLS	Inspected
	Room 754B
Violations	No violations recorded.
FLOOR STRUCTURE	Inspected
Condition	3 - Fair
Deficiency	CONCRETE: CRACKS/SPALLED/REINFORCEMENT EXPOSED
Deficiency Location/Instance	Concourse - Stair G/1, Water Main, PH - Boiler Room, 8th Floor Mechanical Equipment Room, Room 726A
Deficiency Quantity	60
Quantity Uom	S.F.
Potential Action	REPAIR
Urgency of Action	PRIORITY 4
Purpose of Action	LEVEL 5
Deficiency Photo1

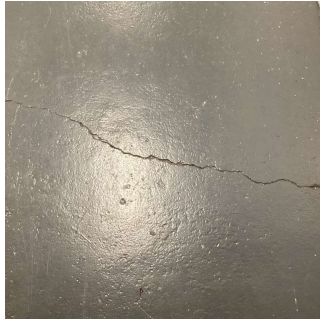
8th Floor - Corridor near Boiler Room
Violations	No violations recorded.
Deficiency	CONCRETE SLAB ON GRADE: THRU CRACKS
Deficiency Location/Instance	Concourse - Water Main
Deficiency Quantity	80
Quantity Uom	S.F.
Potential Action	REPAIR

Concourse - Stair G/1 Water Main
Violations	No violations recorded.
Deficiency	CONCRETE: CRACKS/SPALLED/REINFORCEMENT EXPOSED
Deficiency Location/Instance	PH2, PH3, 8th Floor Mechanical Equipment Areas, Rooms 438A, 654B, 738A, Concourse - Electrical Panel Room, Gas Meter Room, 7th Floor - Elevator Lobby
Deficiency Quantity	200
Quantity Uom	S.F.
Potential Action	REPAIR
Urgency of Action	PRIORITY 3
Purpose of Action	LEVEL 5

Deficiency Photo1

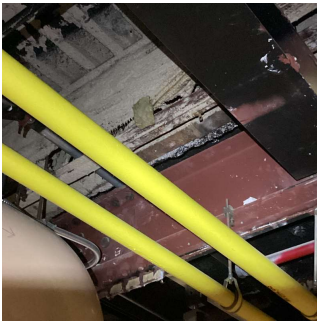
Facade B
Violations	No violations recorded.
ROOF STRUCTURE	
Condition	Inspected
Deficiency	4 - Between Fair and Poor
Deficiency Location/Instance	METAL DECK AND CONCRETE: DETERIORATED
Deficiency Quantity	PH3
Quantity Uom	60
Potential Action	S.F.
Urgency of Action	REPLACE
Purpose of Action	PRIORITY 4
	LEVEL 5

Question	Response
INTERIOR	
STRUCTURAL	
ROOF STRUCTURE	
Deficiency Photo1

Violations	PH3 No violations recorded.
Deficiency	CINDER CONCRETE, FLAT SLAB: CRACKED/SPALLED/REINFORCEMENT EXPOSED
Deficiency Location/Instance	PH1
Deficiency Quantity	100
Quantity Uom	S.F.
Potential Action	REPAIR
Urgency of Action	PRIORITY 4
Purpose of Action	LEVEL 5
Deficiency Photo1

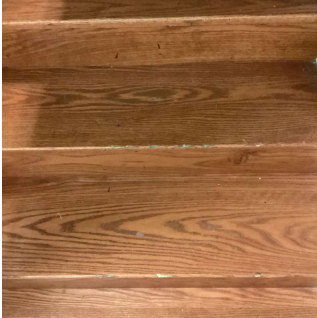
Question	Response
INTERIOR	
AUDITORIUM	
Sliding-folding Partition	
Instance on 8th Floor (342 Seats)	Does not Exist
Stage	
Instance on 8th Floor (342 Seats)	Inspected
Stage	Inspected
Instance on 8th Floor (342 Seats)	Inspected
Condition	2 - Between Good and Fair
Deficiency	DAMAGED STEPS
Deficiency Location/Instance	Left Side
Deficiency Quantity	10
Quantity Uom	S.F.
Potential Action	REPLACE
Urgency of Action	PRIORITY 3
Purpose of Action	LEVEL 2
Deficiency Photo1

Left Side
Violations	No violations recorded.
Deficiency	DAMAGED FLOOR
Deficiency Location/Instance	Center
Deficiency Quantity	10
Quantity Uom	S.F.
Potential Action	REPLACE
Urgency of Action	PRIORITY 3
Purpose of Action	LEVEL 2
Deficiency Photo1	 
	Center
Violations	No violations recorded.
Stage Curtain Rigging	
Instance on 8th Floor (342 Seats)	Inspected
Instance on 8th Floor (342 Seats)	Inspected
Condition	5 - Poor
Deficiency	INOPERABLE
Deficiency Location/Instance	Left Side

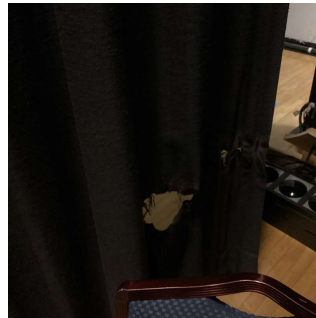
Instance on 8th Floor (342 Seats)	Inspected
Condition	3 - Fair
Deficiency	WORN/DETERIORATED
Deficiency Location/Instance	Left Side
Deficiency Quantity	100
Quantity Uom	S.F.
Potential Action	REPLACE
Urgency of Action	PRIORITY 3
Purpose of Action	LEVEL 2
Deficiency Photo1

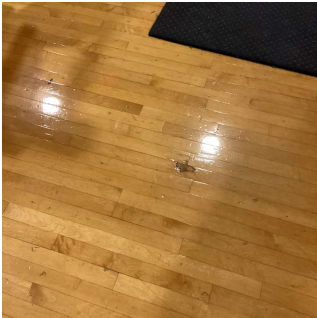
Question	Response
INTERIOR	
CLASSROOMS/CORRIDORS/ADMIN SPACES	
Floor Finish	
Violations	No violations recorded.
Deficiency	WOOD: DAMAGED/DETERIORATED
Deficiency Location/Instance	Room 708
Deficiency Quantity	10
Quantity Uom	S.F.
Potential Action	REPLACE
Urgency of Action	PRIORITY 3
Purpose of Action	LEVEL 2
Deficiency Photo1

Violations	Room 708 No violations recorded.
Walls	
Condition	Inspected 2 - Between Good and Fair
Deficiency	CERAMIC TILE: BROKEN/ MISSING
Deficiency Location/Instance	Corridor near Rooms 636B, 636, 635, 440, 436 and others
Deficiency Quantity	80
Quantity Uom	S.F.
Potential Action	REPLACE
Urgency of Action	PRIORITY 3
Purpose of Action	LEVEL 2
Deficiency Photo1

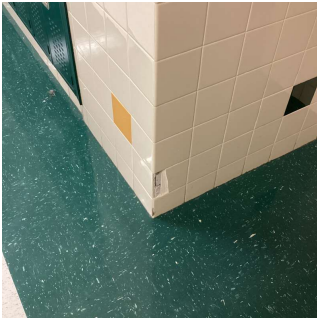
Violations	Corridor near Room 636B No violations recorded.
Deficiency	GYPSUM BOARD: DETERIORATED
Deficiency Location/Instance	Rooms 750/750A, 753, Corridor near Rooms 653, 532, 518 and others
Deficiency Quantity	320
Quantity Uom	S.F.

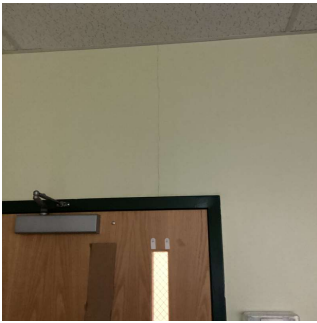
Potential Action	REPLACE
Urgency of Action	PRIORITY 3
Purpose of Action	LEVEL 2

Question	Response
INTERIOR	
CLASSROOMS/CORRIDORS/ADMIN SPACES	
Walls	
Deficiency Photo1

Violations	Room 750/750A No violations recorded.
Specialties	Inspected
Classroom Locker(s)	Inspected
Condition	2 - Between Good and Fair
Deficiency	No deficiencies recorded
Fixed Seating	Does not Exist
GYMNASIUM	Does not Exist
INTERIOR DOOR HARDWARE	Inspected
Condition	3 - Fair
Deficiency	No deficiencies recorded
INTERIOR GUARDS	Inspected
Condition	2 - Between Good and Fair
Deficiency	No deficiencies recorded
KITCHEN	Inspected
Instance on 5th Floor	Inspected
Instance on 7th Floor	Inspected
Ceiling	
Instance on 5th Floor	Inspected
Condition	2 - Between Good and Fair
Deficiency	METAL PAN: DAMAGED/MISSING
Deficiency Location/Instance	Left Side Near Windows
Deficiency Quantity	20
Quantity Uom	S.F.
Potential Action	REPLACE
Urgency of Action	PRIORITY 3
Purpose of Action	LEVEL 2
Deficiency Photo1

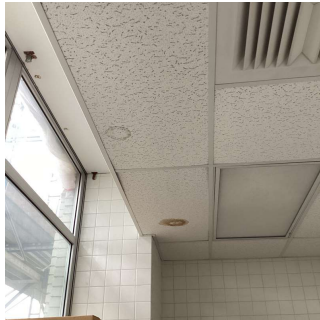
Question	Response
INTERIOR	
KITCHEN	
Ceiling	
Instance on 7th Floor	Inspected
Condition	2 - Between Good and Fair
Deficiency	ACOUSTIC TILES: DAMAGED/MISSING
Deficiency Location/Instance	Room 740D
Deficiency Quantity	10
Quantity Uom	S.F.
Potential Action	REPLACE
Urgency of Action	PRIORITY 3
Purpose of Action	LEVEL 2
Deficiency Photo1

Violations	Room 740D No violations recorded.
Door(s)	
Instance on 5th Floor	Inspected
Condition	3 - Fair
Deficiency	METAL: DETERIORATED DOOR AND FRAME
Deficiency Location/Instance	Room 544E
Deficiency Quantity	1
Quantity Uom	EACH
Potential Action	MAINTENANCE
Urgency of Action	PRIORITY 3
Purpose of Action	LEVEL 2
Deficiency Photo1

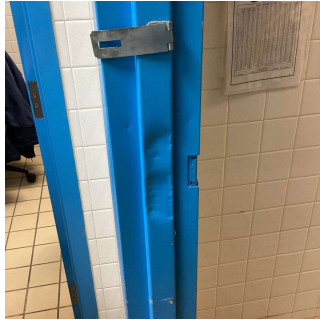
Violations	Room 544E No violations recorded.
Floor Finish	
Instance on 5th Floor	Inspected
Condition	2 - Between Good and Fair
Deficiency	No deficiencies recorded
Instance on 7th Floor	Inspected
Condition	2 - Between Good and Fair

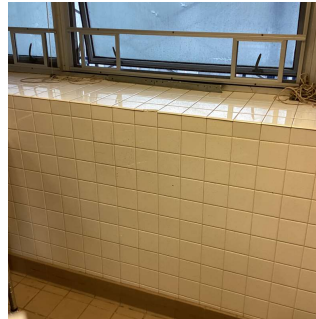
Left Side Near Windows

Purpose of Action	LEVEL 2
-------------------	---------

Deficiency Photo1

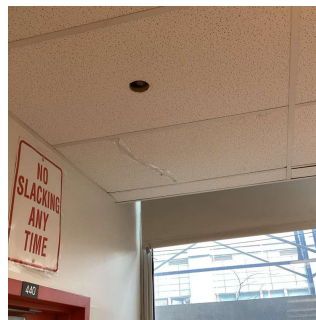
Deficiency Photo1

Question	Response
INTERIOR	
LIBRARY	
Ceiling	
Violations	Rear Near Windows No violations recorded.
Instance on Room 642	Inspected
Condition	2 - Between Good and Fair
Deficiency	ACOUSTIC TILES: DAMAGED/MISSING
Deficiency Location/Instance	Center, Near Windows
Deficiency Quantity	20
Quantity Uom	S.F.
Potential Action	REPLACE
Urgency of Action	PRIORITY 3
Purpose of Action	LEVEL 2
Deficiency Photo1

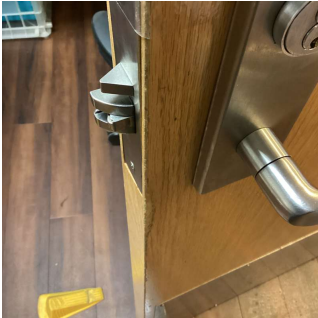
Violations	Center No violations recorded.
Door(s)	
Instance on Room 442	Inspected
Condition	3 - Fair
Deficiency	WOOD: DETERIORATED DOOR
Deficiency Location/Instance	Room 442B
Deficiency Quantity	1
Quantity Uom	EACH
Potential Action	MAINTENANCE
Urgency of Action	PRIORITY 3
Purpose of Action	LEVEL 2
Deficiency Photo1

Violations	Room 442B No violations recorded.
Instance on Room 642	Inspected
Condition	5 - Poor
Deficiency	WOOD: DETERIORATED DOOR
Deficiency Location/Instance	Rooms 642A, 642B, 642C, Main Entrance

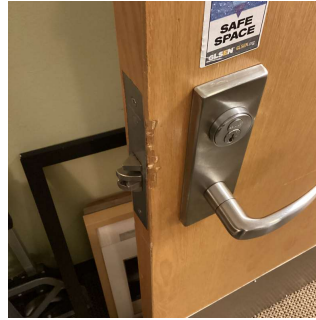
Room 642C

Deficiency Quantity	5
Quantity Uom	EACH
Potential Action	MAINTENANCE
Urgency of Action	PRIORITY 3
Purpose of Action	LEVEL 2
Deficiency Photo1

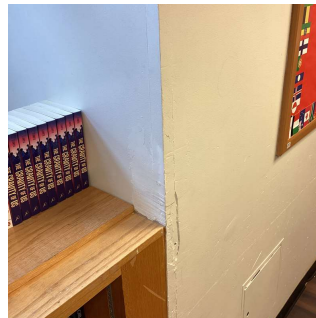
Instance on Room 442	Inspected
Condition	2 - Between Good and Fair
Deficiency	GYP SUM BOARD: DETERIORATED
Deficiency Location/Instance	Rear Near Windows
Deficiency Quantity	10
Quantity Uom	S.F.
Potential Action	REPLACE
Urgency of Action	PRIORITY 3
Purpose of Action	LEVEL 2
Deficiency Photo1

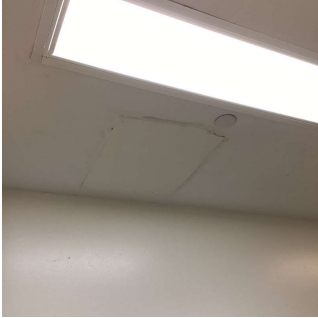
Instance on 4th Floor - Boys (80 Lockers)	Inspected
Condition	2 - Between Good and Fair
Deficiency	GYPSUM BOARD: DAMAGED/DETERIORATED
Deficiency Location/Instance	Near Locker 5
Deficiency Quantity	20
Quantity Uom	S.F.
Potential Action	REPLACE
Urgency of Action	PRIORITY 3
Purpose of Action	LEVEL 2
Deficiency Photo1

Near Locker 5
Violations	No violations recorded.

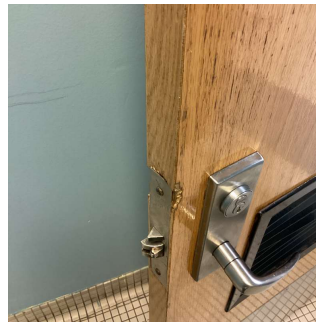
Main Entrance

Door(s)

Deficiency Photo1

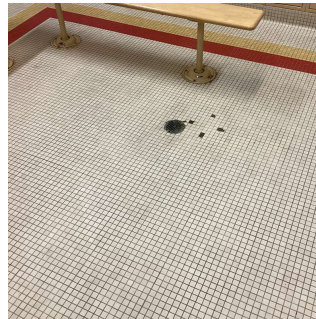
Instance on 4th Floor - Girls (80 Lockers)	Inspected
Condition	2 - Between Good and Fair
Deficiency	CERAMIC TILE: BROKEN/MISSING TILES
Deficiency Location/Instance	Center
Deficiency Quantity	10
Quantity Uom	S.F.
Potential Action	REPLACE
Urgency of Action	PRIORITY 3
Purpose of Action	LEVEL 2
Deficiency Photo1

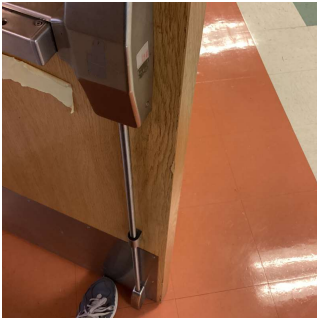
Question	Response
INTERIOR	
MULTI-PURPOSE ROOM	
Door(s)	
Deficiency Quantity	3
Quantity Uom	EACH
Potential Action	MAINTENANCE
Urgency of Action	PRIORITY 3
Purpose of Action	LEVEL 2
Deficiency Photo1

Main Entrance
Violations	No violations recorded.
Fixed Equipment	
Instance on 4th Floor (1600 SF)	Does not Exist
Floor Finish	
Instance on 4th Floor (1600 SF)	Inspected
Condition	2 - Between Good and Fair
Deficiency	WOOD: DAMAGED/DETERIORATED
Deficiency Location/Instance	Right and Left Side Near Windows
Deficiency Quantity	40
Quantity Uom	S.F.
Potential Action	REPLACE
Urgency of Action	PRIORITY 3
Purpose of Action	LEVEL 2
Deficiency Photo1

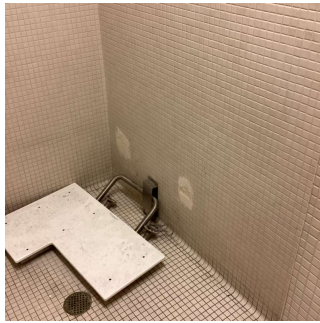
Question	Response
INTERIOR	
SHOWER ROOM	
Walls	
Deficiency Quantity	10
Quantity Uom	S.F.
Potential Action	REPLACE
Urgency of Action	PRIORITY 3
Purpose of Action	LEVEL 2
Deficiency Photo1	 
	Near Entrance
Violations	No violations recorded.
Instance on 5th Floor - Boys	Inspected
Condition	2 - Between Good and Fair
Deficiency	CERAMIC TILE: BROKEN/ MISSING
Deficiency Location/Instance	Right Side
Deficiency Quantity	10
Quantity Uom	S.F.
Potential Action	REPLACE
Urgency of Action	PRIORITY 3
Purpose of Action	LEVEL 2
Deficiency Photo1	 
	Right Side
Violations	No violations recorded.
Instance on 5th Floor - Girls	Inspected
Condition	2 - Between Good and Fair
Deficiency	CERAMIC TILE: BROKEN/ MISSING
Deficiency Location/Instance	Left Side
Deficiency Quantity	10
Quantity Uom	S.F.
Potential Action	REPLACE
Urgency of Action	PRIORITY 3
Purpose of Action	LEVEL 2

Violations	Left Side No violations recorded.
STAIRS/RAMPS: INTERIOR	
Do Letter Stair Signs Exist?	Inspected Yes
Ceiling	Inspected
Condition	2 - Between Good and Fair
Deficiency	TECTUM: DAMAGED/MISSING
Deficiency Location/Instance	Stairs D/7, E/4
Deficiency Quantity	20
Quantity Uom	S.F.
Potential Action	REPLACE
Urgency of Action	PRIORITY 3
Purpose of Action	LEVEL 2
Deficiency Photo1

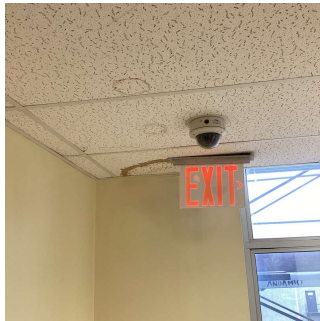
Violations	Stair D/7 No violations recorded.
Deficiency	ACOUSTIC TILES: DAMAGED/MISSING
Deficiency Location/Instance	Stairs E/7, F/7, G/7, 6
Deficiency Quantity	80
Quantity Uom	S.F.
Potential Action	REPLACE
Urgency of Action	PRIORITY 3
Purpose of Action	LEVEL 2

Question	Response
INTERIOR	
STAIRS/RAMPS: INTERIOR	
Ceiling	
Deficiency Photo1

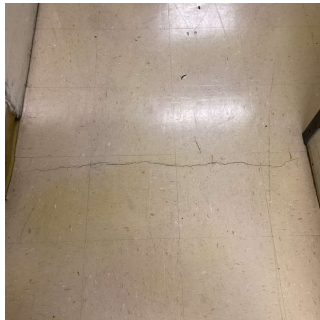
Stair C/6
Violations	No violations recorded.
Deficiency	TERRAZZO: CRACKS
Deficiency Location/Instance	Corridor near Room 721A
Deficiency Quantity	20
Quantity Uom	S.F.
Potential Action	REPLACE
Urgency of Action	PRIORITY 3
Purpose of Action	LEVEL 2

Stair G/7
Violations	No violations recorded.
Door(s)	Inspected
Condition	2 - Between Good and Fair
Deficiency	No deficiencies recorded
Partition	Does not Exist
Railings	Inspected
Condition	2 - Between Good and Fair
Deficiency	No deficiencies recorded
Stairs and Landings	Inspected
Condition	5 - Poor
Deficiency	VINYL TILES: DETERIORATED SUBSTRATE
Deficiency Location/Instance	Stairs C/6, 5, 4, D/4, G/5 and Others
Deficiency Quantity	150
Quantity Uom	S.F.
Potential Action	REPLACE
Urgency of Action	PRIORITY 3
Purpose of Action	LEVEL 2
Deficiency Photo1

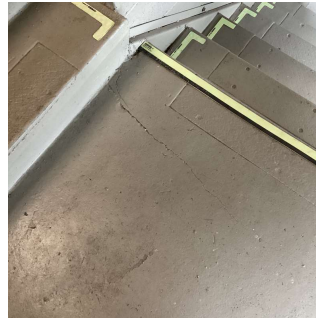
Stair D/8

CONCRETE: CRACKS/SPALLING - MAJOR

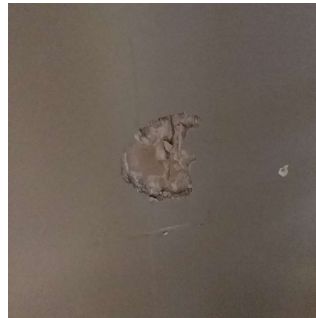
GYP SUM BOARD: DETERIORATED

Question	Response
INTERIOR	
STAIRS/RAMPS: INTERIOR	Inspected
Walls	Inspected
Violations	Stair F/6 No violations recorded.
TOILET ROOMS - STAFF	Inspected
Ceiling	Inspected
Condition	2 - Between Good and Fair
Deficiency	No deficiencies recorded
Door(s)	Inspected
Condition	5 - Poor
Deficiency	WOOD: DETERIORATED DOOR
Deficiency Location/Instance	Rooms 727, 711, 629, 551, 547
Deficiency Quantity	5
Quantity Uom	EACH
Potential Action	MAINTENANCE
Urgency of Action	PRIORITY 3
Purpose of Action	LEVEL 2
Deficiency Photo1

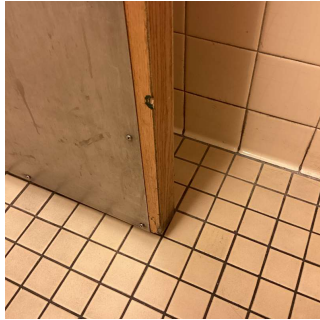
Violations	Room 711 No violations recorded.
Floor Finish	Inspected
Condition	2 - Between Good and Fair
Deficiency	No deficiencies recorded
Stalls	Inspected
Condition	2 - Between Good and Fair
Deficiency	No deficiencies recorded
Walls	Inspected
Condition	2 - Between Good and Fair
Deficiency	CERAMIC TILE: BROKEN/ MISSING
Deficiency Location/Instance	Rooms 711, 547
Deficiency Quantity	20
Quantity Uom	S.F.
Potential Action	REPLACE
