**NYC Department of Education**  
**Building Condition Assessment Survey 2023 - 2024**

Architectural Inspection

**Asset:** ELMHURST EDUCATIONAL CAMPUS - Q, 45-10 94TH STREET, New York, 11373

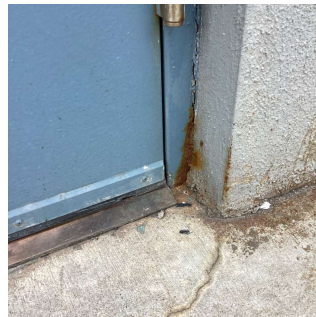
Facade C  
No violations recorded.

METAL: DETERIORATED DOOR AND FRAME - MINOR DETERIORATION

1  
EACH  
MAINTENANCE  
PRIORITY 3  
LEVEL 2

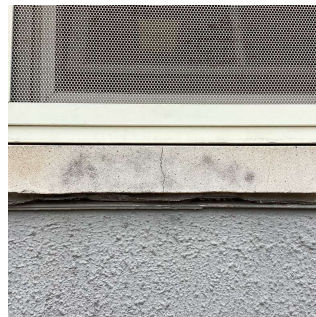
Facade A

STONE: DETERIORATED MASONRY SILLS - MINOR

REPAIR

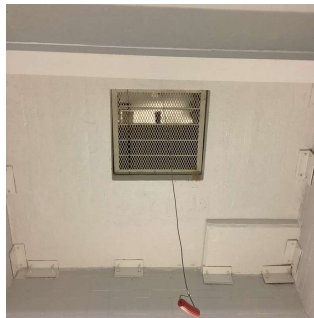
Roof 1 - Stair C/4

WATER INFILTRATION

1  
 EACH  
 REPAIR  
 PRIORITY 5  
 LEVEL 2

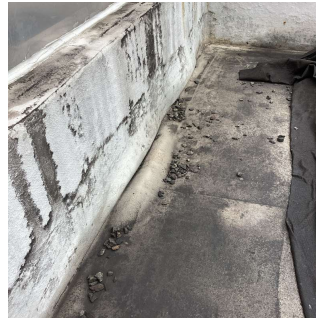
Roof 1

Deficiency	IRMA: FLASHING: BASE FLASHING DETERIORATED
------------	--

Potential Action	REPAIR
------------------	--------

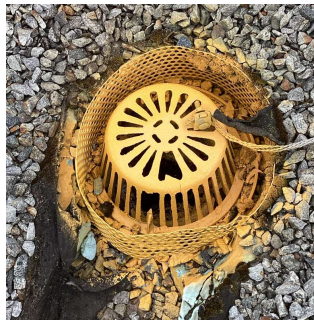
Roof 1  
No violations recorded.

DETERIORATED

2  
EACH  
REPLACE  
PRIORITY 4  
LEVEL 2

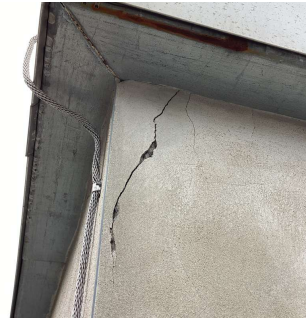
BH

**BULKHEAD/PENTHOUSE WALLS/EXTERIOR:  
CRACKS/SPALLING - MAJOR**

10  
S.F.  
REPLACE  
PRIORITY 4  
LEVEL 2

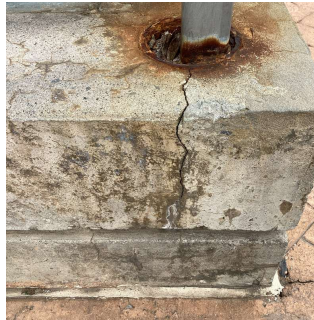
Facade D

Deficiency CAST IN PLACE CONCRETE: CRACKS/SPALLING - MAJOR

REPLACE

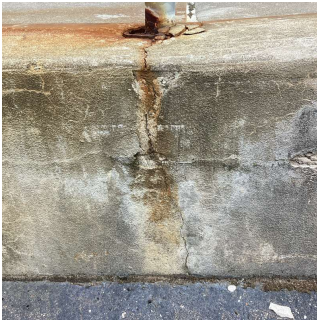
Deficiency	CAST IN PLACE CONCRETE: CRACKS/SPALLING - MINOR
------------	---

REPAIR

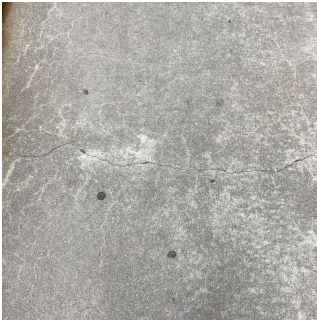
Violations	Facade C No violations recorded.
<b>RAILINGS</b>	Inspected
Condition	2 - Between Good and Fair
Deficiency	No deficiencies recorded
<b>STAIRS/RAMPS</b>	Inspected
Condition	3 - Fair
Deficiency	CONCRETE: CRACKS/SPALLING - MINOR
Roof Plan reference	<p>Q744</p>

Deficiency Quantity	30
Quantity Uom	S.F.
Potential Action	REPAIR
Urgency of Action	PRIORITY 3
Purpose of Action	LEVEL 2
Deficiency Photo1

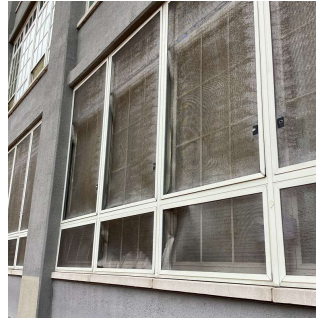
Facade A  
No violations recorded.

Deficiency DETERIORATED/TORN-OUT/MISSING

90  
S.F.  
REPLACE  
PRIORITY 4  
LEVEL 2

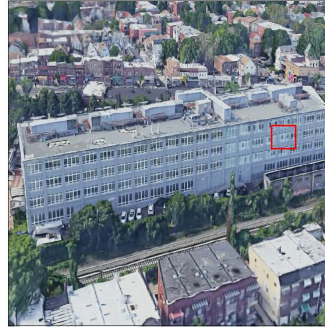
150  
S.F.  
REPLACE GLAZING  
PRIORITY 3  
LEVEL 2

Facade C - 3rd Floor Multi-purpose Room (throughout similar)  
No violations recorded.

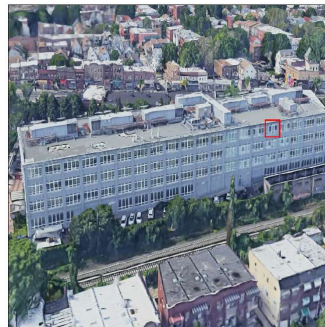
ALUMINUM - OTHER: DETERIORATED

Facade C - 4th Floor Multi-purpose Room  
No violations recorded.

REPLACE WINDOW  
PRIORITY 4  
LEVEL 2

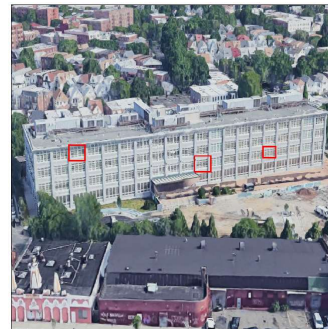
ALUMINUM - OTHER: BROKEN PANE

90  
S.F.  
MAINTENANCE  
PRIORITY 3  
LEVEL 2

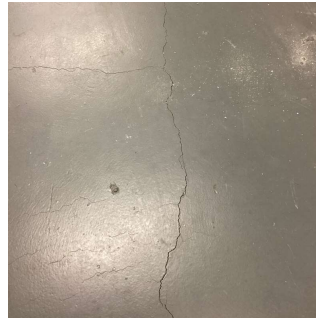
Electrical Panel Room

CINDER CONCRETE FLAT SLAB:  
CRACKED/SPALLED/REINFORCEMENT EXPOSED

REPAIR

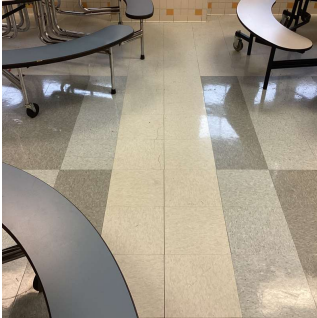
Instance on 1st Floor - Room 135	Inspected
Condition	2 - Between Good and Fair
Deficiency	VINYL TILES: DETERIORATED SUBSTRATE
Deficiency Location/Instance	Left Side Near Windows, Center, Near Entrance
Deficiency Quantity	50

Violations	Left Side Near Windows No violations recorded.
Instance on 1st Floor - Room 103	Inspected
Condition	2 - Between Good and Fair
Deficiency	VINYL TILES: DETERIORATED SUBSTRATE
Deficiency Location/Instance	Left Side, near Serving Area, Near Entrance, Center
Deficiency Quantity	50
Quantity Uom	S.F.
Potential Action	REPLACE
Urgency of Action	PRIORITY 3
Purpose of Action	LEVEL 2
Deficiency Photo1

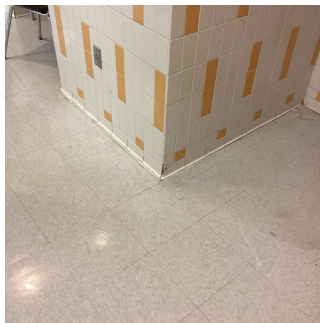
Condition	2 - Between Good and Fair
Deficiency	CERAMIC TILE: BROKEN/ MISSING
Deficiency Location/Instance	Near Entrance, Near Windows, Near Serving Area
Deficiency Quantity	30

Right Side Near Entrance
Violations	No violations recorded.
<b>Window Curtains/Shades/Blinds</b>	
Instance on 1st Floor - Room 103	Does not Exist
Instance on 1st Floor - Room 135	Does not Exist
<b>CLASSROOMS/CORRIDORS/ADMIN SPACES</b>	
<b>Ceiling</b>	Inspected
Condition	2 - Between Good and Fair
Deficiency	TECTUM: DAMAGED/MISSING
Deficiency Location/Instance	Corridor near Rooms 420, 411, B74, B40, B17 and others
Deficiency Quantity	140
Quantity Uom	S.F.
Potential Action	REPLACE
Urgency of Action	PRIORITY 3
Purpose of Action	LEVEL 2
Deficiency Photo1

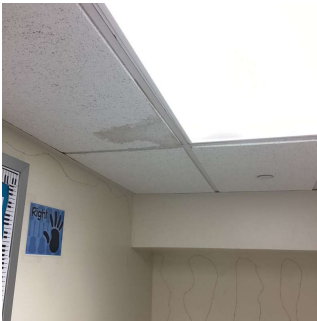
Corridor near Room B74
Violations	No violations recorded.
Deficiency	ACOUSTIC TILES: DAMAGED/MISSING
Deficiency Location/Instance	Rooms 445, 374, 231, B46, B25 and others
Deficiency Quantity	90
Quantity Uom	S.F.
Potential Action	REPLACE
Urgency of Action	PRIORITY 3
Purpose of Action	LEVEL 2

Violations	Room B25 No violations recorded.
<b>Door(s)</b>	Inspected
Condition	5 - Poor
Deficiency	WOOD: DETERIORATED DOOR
Deficiency Location/Instance	Rooms 474, 462, 343, 212, B25 and others
Deficiency Quantity	11
Quantity Uom	EACH
Potential Action	MAINTENANCE
Urgency of Action	PRIORITY 3
Purpose of Action	LEVEL 2
Deficiency Photo1	 
Violations	Room B25 No violations recorded.
<b>Floor Finish</b>	Inspected
Condition	2 - Between Good and Fair
Deficiency	CERAMIC TILE: BROKEN/MISSING TILES
Deficiency Location/Instance	Main Entrance Lobby
Deficiency Quantity	30
Quantity Uom	S.F.
Potential Action	REPLACE
Urgency of Action	PRIORITY 3
Purpose of Action	LEVEL 2

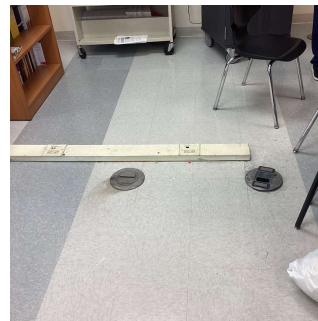
Room 374

VINYL TILES: TRIPPING HAZARD - ELECTRICAL OUTLET

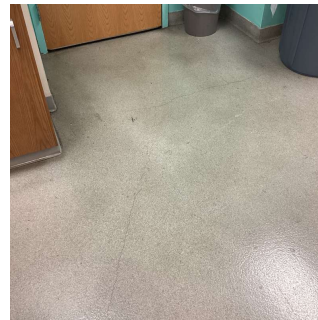
Room 445

EPOXY FLOORING: CRACKS/SPALLING

REPLACE

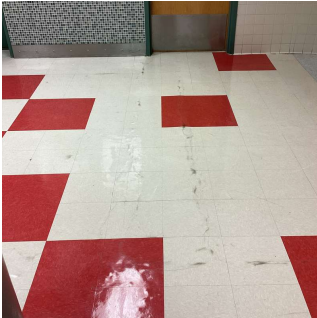
Question	Response
<b>INTERIOR</b>	
<b>CLASSROOMS/CORRIDORS/ADMIN SPACES</b>	
<b>Floor Finish</b>	
Deficiency	VINYL TILES: DETERIORATED SUBSTRATE
Deficiency Location/Instance	Corridor near Rooms 414, 408, 146, B68, B25 and others
Deficiency Quantity	400
Quantity Uom	S.F.
Potential Action	REPLACE
Urgency of Action	PRIORITY 3
Purpose of Action	LEVEL 2
Deficiency Photo1

Corridor near Room B25
Violations	No violations recorded.
<b>Walls</b>	
Condition	Inspected
Condition	2 - Between Good and Fair
Deficiency	CERAMIC TILE: BROKEN/ MISSING
Deficiency Location/Instance	Corridor near Room 122
Deficiency Quantity	10
Quantity Uom	S.F.
Potential Action	REPLACE
Urgency of Action	PRIORITY 3
Purpose of Action	LEVEL 2
Deficiency Photo1

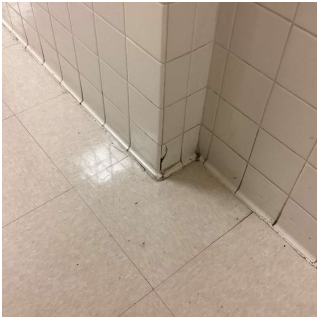
Corridor near Room 122
Violations	No violations recorded.
Deficiency	GYPSUM BOARD: DETERIORATED
Deficiency Location/Instance	Corridor near Rooms 414, 404, 205, B31, B25 and others
Deficiency Quantity	200

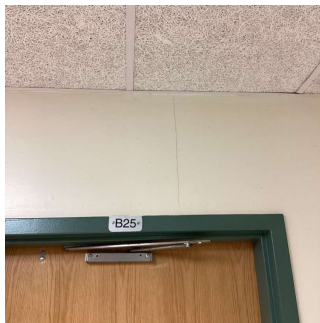
Quantity Uom	S.F.
Potential Action	REPLACE
Urgency of Action	PRIORITY 3
Purpose of Action	LEVEL 2

Violations	Corridor near Room B25 No violations recorded.
<b>Specialties</b>	Inspected
<b>Classroom Locker(s)</b>	Inspected
Condition	2 - Between Good and Fair
Deficiency	No deficiencies recorded
<b>Fixed Seating</b>	Does not Exist
<b>GYMNASIUM</b>	Does not Exist
<b>INTERIOR DOOR HARDWARE</b>	Inspected
Condition	3 - Fair
Deficiency	No deficiencies recorded
<b>INTERIOR GUARDS</b>	Inspected
Condition	2 - Between Good and Fair
Deficiency	No deficiencies recorded
<b>KITCHEN</b>	Inspected
Instance on 1st Floor	Inspected
<b>Ceiling</b>	
Instance on 1st Floor	Inspected
Condition	2 - Between Good and Fair
Deficiency	METAL PAN: DAMAGED/MISSING
Deficiency Location/Instance	Near Exit 5
Deficiency Quantity	10
Quantity Uom	S.F.
Potential Action	REPLACE
Urgency of Action	PRIORITY 3
Purpose of Action	LEVEL 2
Deficiency Photo1

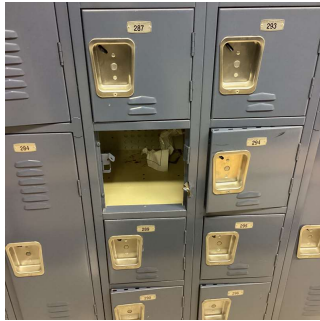
Deficiency	DAMAGED UNITS
Deficiency Location/Instance	Locker 288
Deficiency Quantity	1
Quantity Uom	EACH
Potential Action	REPLACE
Urgency of Action	PRIORITY 3
Purpose of Action	LEVEL 2

Locker 288	Locker 288
Violations	No violations recorded.
<b>Walls</b>	
Instance on 3rd Floor - Boys (116 Lockers)	Inspected
Condition	2 - Between Good and Fair
Deficiency	No deficiencies recorded
Instance on 3rd Floor - Girls (97 Lockers)	Inspected
Condition	2 - Between Good and Fair
Deficiency	No deficiencies recorded
Instance on 4th Floor - Boys (319 Lockers)	Inspected
Condition	2 - Between Good and Fair
Deficiency	No deficiencies recorded
Instance on 4th Floor - Girls (320 Lockers)	Inspected
Condition	2 - Between Good and Fair
Deficiency	No deficiencies recorded
Instance on 2nd Floor - Girls (320 Lockers)	Inspected
Condition	2 - Between Good and Fair
Deficiency	No deficiencies recorded
Instance on 2nd Floor - Boys (319 Lockers)	Inspected
Condition	2 - Between Good and Fair
Deficiency	No deficiencies recorded

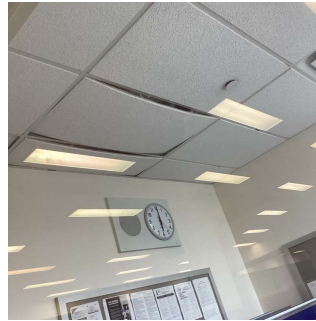
<b>MULTI-PURPOSE ROOM</b>	
	Inspected
Instance on 2nd Floor	Inspected
Instance on 3rd Floor	Inspected
Instance on 4th Floor	Inspected
<b>Ceiling</b>	
Instance on 2nd Floor	Inspected
Condition	2 - Between Good and Fair
Deficiency	ACOUSTIC TILES: DAMAGED/MISSING
Deficiency Location/Instance	Room 209
Deficiency Quantity	10
Quantity Uom	S.F.
Potential Action	REPLACE
Urgency of Action	PRIORITY 3
Purpose of Action	LEVEL 2

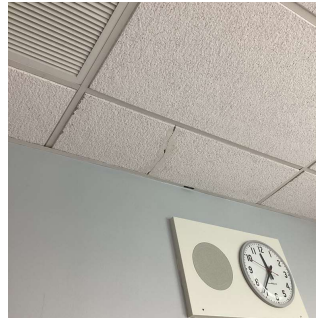
Room 309

ACOUSTIC TILES: DAMAGED/MISSING

REPLACE

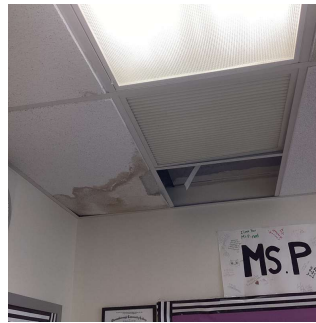
Room 409

ACOUSTIC TILES: DAMAGED/MISSING

REPLACE

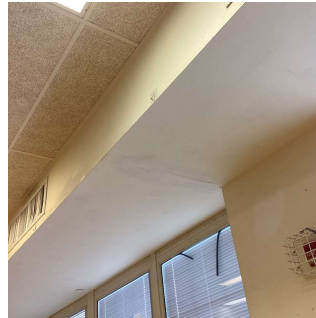
Near Windows

GYP SUM BOARD: DAMAGED/DETERIORATED

REPLACE

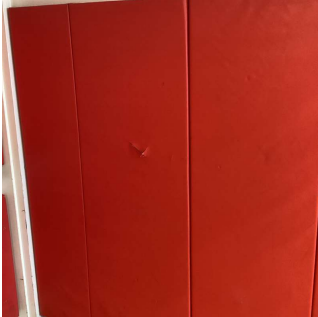
Violations	No violations recorded.
Deficiency	WALL PADDING: DETERIORATED

Question	Response
<b>INTERIOR</b>	
<b>MULTI-PURPOSE ROOM</b>	
<b>Walls</b>	
Deficiency Location/Instance	Near Left Side Entrance
Deficiency Quantity	80
Quantity Uom	S.F.
Potential Action	REPLACE
Urgency of Action	PRIORITY 3
Purpose of Action	LEVEL 2
Deficiency Photo1

Near Left Side Entrance
Violations	No violations recorded.
Instance on 4th Floor	Inspected
Condition	3 - Fair
Deficiency	GYPSUM BOARD: DETERIORATED
Deficiency Location/Instance	Center Columns, Near Entrance
Deficiency Quantity	40
Quantity Uom	S.F.
Potential Action	REPLACE
Urgency of Action	PRIORITY 3
Purpose of Action	LEVEL 2
Deficiency Photo1

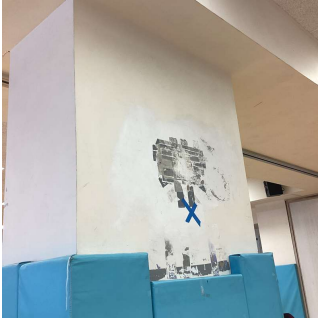
Center Columns
Violations	No violations recorded.
Deficiency	WALL PADDING: DETERIORATED
Deficiency Location/Instance	Left and Right Side Near Entrance, Near Windows
Deficiency Quantity	240
Quantity Uom	S.F.
Potential Action	REPLACE
Urgency of Action	PRIORITY 3
Purpose of Action	LEVEL 2

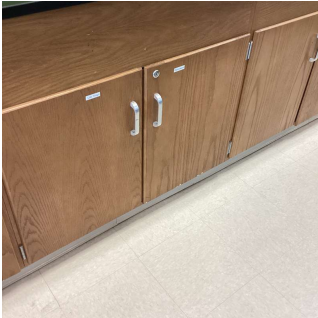
Question	Response
<b>INTERIOR</b>	
<b>SCIENCE LAB</b>	
<b>Fixed Equipment</b>	
Deficiency	CABINETS: MISSING/DAMAGED
Deficiency Location/Instance	Rooms 431A, 445
Deficiency Quantity	10
Quantity Uom	L.F.
Potential Action	REPLACE
Urgency of Action	PRIORITY 3
Purpose of Action	LEVEL 2
Deficiency Photo1

Violations	Room 431A No violations recorded.
<b>SCIENCE PREP ROOM</b>	Inspected
Instance on Rooms 443, 343, 243	Inspected
Alternative use	No
<b>Fixed Equipment</b>	
Instance on Rooms 443, 343, 243	Inspected
Condition	2 - Between Good and Fair
Deficiency	No deficiencies recorded
<b>SHOWER ROOM</b>	Does not Exist
<b>STAIRS/RAMPS: INTERIOR</b>	Inspected
Do Letter Stair Signs Exist?	Yes
<b>Ceiling</b>	
Condition	2 - Between Good and Fair
Deficiency	No deficiencies recorded
<b>Door(s)</b>	
Condition	2 - Between Good and Fair
Deficiency	No deficiencies recorded
<b>Partition</b>	
	Does not Exist
<b>Railings</b>	
Condition	2 - Between Good and Fair

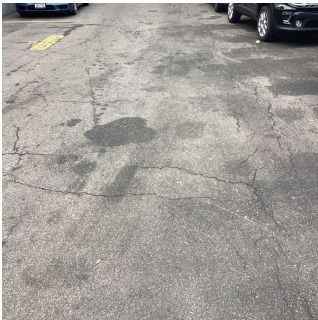
Question	Response
<b>SITE</b>	
<b>IRRIGATION SYSTEM</b>	Does not Exist
<b>PAVING</b>	Inspected
<b>Student Non-Use</b>	Inspected
Gravel Exists?	No
<b>Asphalt</b>	Inspected
Condition	4 - Between Fair and Poor
Deficiency	CRACKS - MAJOR
Deficiency Location/Instance	Parking Lot
Deficiency Quantity	1,000
Quantity Uom	S.F.
Potential Action	REPLACE
Urgency of Action	PRIORITY 3
Purpose of Action	LEVEL 2
Deficiency Photo1

Violations	Parking Lot No violations recorded.
<b>Concrete</b>	Inspected
Condition	3 - Fair
Deficiency	CRACKS - MAJOR
Deficiency Location/Instance	Parking Lot
Deficiency Quantity	100
Quantity Uom	S.F.
Potential Action	REPLACE
Urgency of Action	PRIORITY 3
Purpose of Action	LEVEL 2
Deficiency Photo1

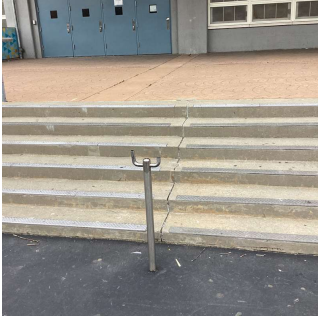
<b>Metal/Wood/Plastic</b>	Inspected
Condition	1 - Good
Deficiency	No deficiencies recorded
<b>Bleachers</b>	Inspected
<b>Concrete</b>	Does not Exist
<b>Metal/Wood/Plastic</b>	Inspected
Condition	1 - Good
Deficiency	No deficiencies recorded
<b>SITE WALLS (NOT RETAINING WALLS)</b>	Inspected
Condition	2 - Between Good and Fair
Deficiency	No deficiencies recorded
<b>STAIRS/RAMPS: EXTERIOR</b>	Inspected
<b>Railings</b>	Inspected
Condition	3 - Fair
Deficiency	DAMAGED
Deficiency Location/Instance	Near Main Entrance
Deficiency Quantity	10
Quantity Uom	L.F.

Question	Response
<b>SITE</b>	
<b>STAIRS/RAMPS: EXTERIOR</b>	
<b>Railings</b>	
Potential Action	REPLACE
Urgency of Action	PRIORITY 5
Purpose of Action	LEVEL 6
Deficiency Photo1

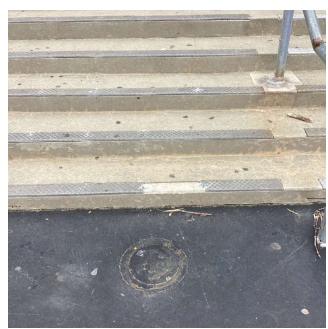
Near Main Entrance
Violations	No violations recorded.
Deficiency	CAST IN PLACE CONCRETE: CRACKS/SPALLING - MAJOR
Deficiency Location/Instance	Near Main Entrance
Deficiency Quantity	10
Quantity Uom	S.F.
Potential Action	REPLACE
Urgency of Action	PRIORITY 5
Purpose of Action	LEVEL 6

Question	Response
<b>SITE</b>	
<b>STAIRS/RAMPS: EXTERIOR</b>	
<b>Stairs/ramps</b>	
Deficiency Photo1
