**NYC Department of Education  
Building Condition Assessment Survey 2023 - 2024**

Architectural Inspection

**Asset: QUEENS HS FOR THE SCIENCES - QUEENS, 94-50 159 STREET, New York, 11433**

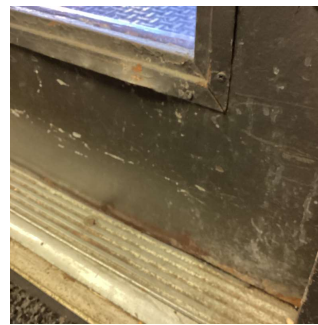
Facade A

Question	Response
<b>Architectural</b>	
<b>EXTERIOR</b>	Inspected
<b>AREAWAY</b>	Not Required
<b>AWNINGS AND CANOPIES</b>	Not Required
<b>CHIMNEY</b>	Inspected
Material Type(s)	Masonry
Condition	2 - Between Good and Fair
Deficiency	No deficiencies recorded
<b>COPING</b>	Inspected
Condition	2 - Between Good and Fair
Deficiency	No deficiencies recorded
<b>CORNICE</b>	Does not Exist
<b>DOORS</b>	Inspected
<b>DOORS AND FRAMES</b>	Inspected
Condition	3 - Fair
Deficiency	METAL: DETERIORATED DOOR AND FRAME - MAJOR DETERIORATION

4  
EACH  
REPLACE  
PRIORITY 4  
LEVEL 2

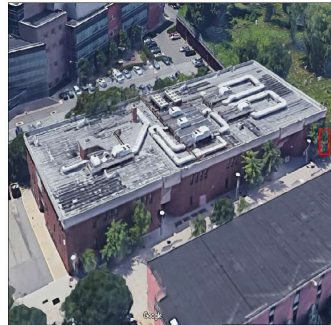
Violations	Facade B No violations recorded.
<b>EXTERIOR WALLS</b>	Inspected
Material Type(s)	Concrete, Masonry
Replacement Quantity	16,000
Replacement Uom	S.F.
Instance on All Facades	Inspected
Instance Condition	3 - Fair
Instance Quantity	16,000
Instance Quantity Uom	S.F.
Deficiency	BRICK: CRACKS/DISPLACED/SPALLED BRICK AT BUILDING CORNERS
Roof Plan reference	<p>Q774</p>

Deficiency Quantity	30
Quantity Uom	S.F.
Potential Action	REMOVE AND REBUILD
Urgency of Action	PRIORITY 4
Purpose of Action	LEVEL 2

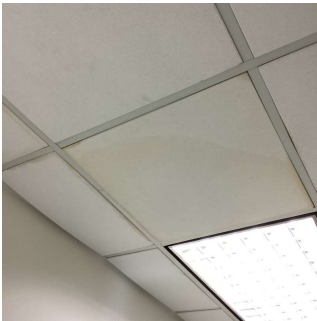
Violations	Basement - Room 111 No violations recorded.
<b>ROOF STRUCTURE</b>	
Condition	Inspected
Deficiency	2 - Between Good and Fair
Deficiency	No deficiencies recorded
<b>VAULTS-BUNKERS</b>	
Does not Exist	
<b>AUDITORIUM</b>	
Does not Exist	
<b>CAFETERIA</b>	
Does not Exist	
<b>CLASSROOMS/CORRIDORS/ADMIN SPACES</b>	
<b>Ceiling</b>	
Condition	Inspected
Condition	2 - Between Good and Fair
Deficiency	ACOUSTIC TILES: DAMAGED/MISSING - ACTIVE LEAK
Deficiency Location/Instance	Rooms 219, 222A
Deficiency Quantity	20
Quantity Uom	S.F.
Potential Action	REPLACE
Urgency of Action	PRIORITY 5

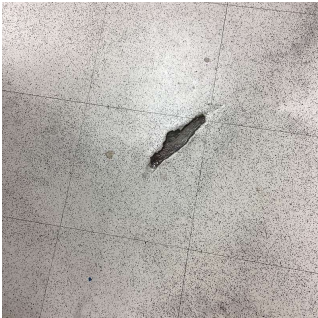
Room 228
Violations	No violations recorded.
<b>Walls</b>	Inspected
Condition	2 - Between Good and Fair
Deficiency	MASONRY: CRACKS/SPALLING
Deficiency Location/Instance	Rooms 001, 203, 234

Room 203A
Violations	No violations recorded.
<b>Door(s)</b>	Inspected
Condition	2 - Between Good and Fair
Deficiency	No deficiencies recorded
<b>Floor Finish</b>	Inspected
Condition	2 - Between Good and Fair
Deficiency	VINYL TILES: BROKEN/DETERIORATED/MISSING TILES
Deficiency Location/Instance	Rooms 213, 228, Corridor near Room 226
Deficiency Quantity	20
Quantity Uom	S.F.
Potential Action	REPLACE
Urgency of Action	PRIORITY 3
Purpose of Action	LEVEL 2
Deficiency Photo1

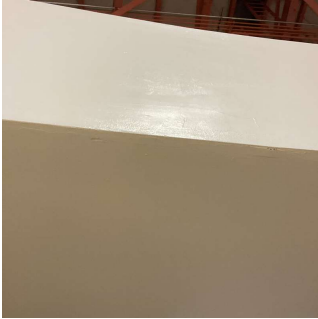
Question	Response
<b>INTERIOR</b>	
<b>CLASSROOMS/CORRIDORS/ADMIN SPACES</b>	Inspected
<b>Walls</b>	Inspected
Violations	Room 001 No violations recorded.
<b>Specialties</b>	Does not Exist
<b>GYMNASIUM</b>	Inspected
Instance on 2nd Floor - HPE Building	Inspected
<b>Ceiling</b>	
Instance on 2nd Floor - HPE Building	Inspected
Condition	2 - Between Good and Fair
Deficiency	GYPSUM BOARD: DAMAGED/DETERIORATED
Deficiency Location/Instance	Near Entrance
Deficiency Quantity	10
Quantity Uom	S.F.
Potential Action	REPLACE
Urgency of Action	PRIORITY 3
Purpose of Action	LEVEL 2
Deficiency Photo1

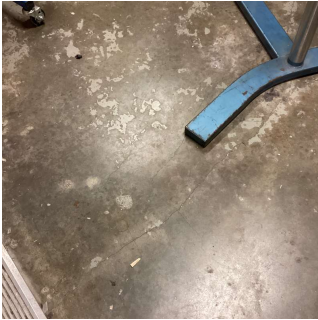
Violations	Near Entrance No violations recorded.
Deficiency	CONCRETE: CRACKS
Deficiency Location/Instance	Storage Room, columns Running Track
Deficiency Quantity	50
Quantity Uom	S.F.
Potential Action	REPLACE
Urgency of Action	PRIORITY 3
Purpose of Action	LEVEL 2
Deficiency Photo1

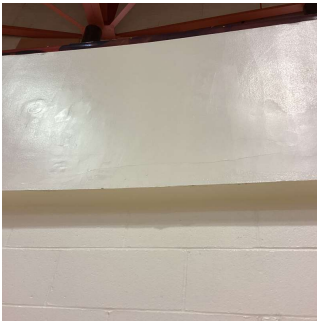
Violations	Storage Room No violations recorded.
<b>Seating</b>	
Instance on 2nd Floor - HPE Building	Inspected
Condition	2 - Between Good and Fair
Deficiency	No deficiencies recorded
<b>Sliding-folding Partition</b>	
Instance on 2nd Floor - HPE Building	Does not Exist
<b>Stage</b>	
Instance on 2nd Floor - HPE Building	Does not Exist
<b>Walls</b>	
Instance on 2nd Floor - HPE Building	Inspected
Condition	2 - Between Good and Fair
Deficiency	GYPSUM BOARD: DETERIORATED
Deficiency Location/Instance	Near Storage Room, Entrances
Deficiency Quantity	50

Quantity Uom	S.F.
Potential Action	REPLACE
Urgency of Action	PRIORITY 3
Purpose of Action	LEVEL 2

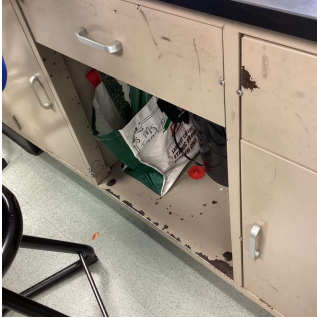
Room 222
Violations	No violations recorded.
<b>SCIENCE PREP ROOM</b>	Inspected

Near Windows
Violations	No violations recorded.
<b>Window Curtains/Shades/Blinds</b>	
Instance on Basement	Does not Exist
<b>SCIENCE DEMO ROOM</b>	Does not Exist
<b>SCIENCE LAB</b>	Inspected
Instance on Room 221	Inspected
Alternative use	Yes
Instance on Rooms 218, 219	Inspected
Alternative use	No
Instance on Rooms 222, 224	Inspected
Alternative use	No
<b>Fixed Equipment</b>	
Instance on Rooms 222, 224	Inspected
Condition	3 - Fair
Deficiency	CABINETS: MISSING/DAMAGED
Deficiency Location/Instance	Rooms 222, 224
Deficiency Quantity	10
Quantity Uom	L.F.
Potential Action	REPLACE
Urgency of Action	PRIORITY 3
Purpose of Action	LEVEL 2
Deficiency Photo1

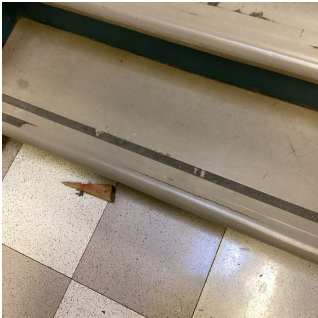
Question	Response
<b>INTERIOR</b>	
<b>STAIRS/RAMPS: INTERIOR</b>	
<b>Stairs and Landings</b>	
Violations	Stair B/1 No violations recorded.
Deficiency	VINYL TILES: WORN-OUT TREAD/NOSINGS
Deficiency Location/Instance	Stairs B/1, D/2, Track 2/1
Deficiency Quantity	20
Quantity Uom	S.F.
Potential Action	REPLACE
Urgency of Action	PRIORITY 3
Purpose of Action	LEVEL 2
Deficiency Photo1

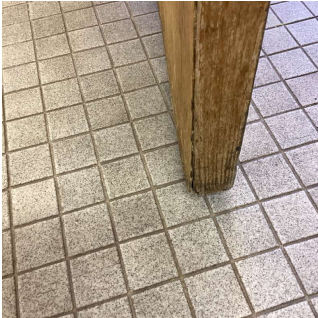
Violations	Boys 2nd Floor - HPE Building No violations recorded.
<b>Floor Finish</b>	Inspected
Condition	2 - Between Good and Fair
Deficiency	CERAMIC TILE: BROKEN/MISSING TILES
Deficiency Location/Instance	Boys Locker Room
Deficiency Quantity	10

Violations	Girls 2nd Floor - HPE Building No violations recorded.
<b>Door(s)</b>	Inspected
Condition	5 - Poor
Deficiency	WOOD: DETERIORATED DOOR
Deficiency Location/Instance	Boys 2nd Floor - HPE Building, Girls 2nd Floor - HPE Building
Deficiency Quantity	2
Quantity Uom	EACH
Potential Action	MAINTENANCE
Urgency of Action	PRIORITY 3
Purpose of Action	LEVEL 2
Deficiency Photo1

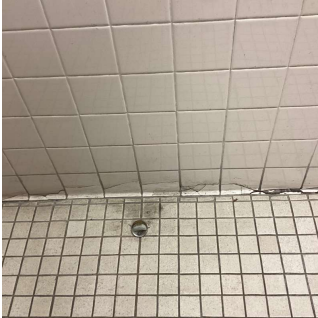
Boys 2nd Floor
Violations	No violations recorded.
<b>LIFE SAFETY</b>	Inspected
<b>F.D. HOLDING AREA</b>	Does not Exist
<b>STEEL STAIRS</b>	Does not Exist
<b>SITE</b>	Does not Exist
<b>ARTWORK</b>	Does not Exist

Question	Response
<b>INTERIOR</b>	
<b>TOILET ROOMS - STUDENTS</b>	
<b>Stalls</b>	Inspected
	Boys 2nd Floor
Violations	No violations recorded.
<b>Walls</b>	Inspected
Condition	2 - Between Good and Fair
Deficiency	CERAMIC TILE: BROKEN/ MISSING
Deficiency Location/Instance	Girls 1st, 2nd Floor, Boys 1st, 2nd Floor, Girls Shower Room, and others
Deficiency Quantity	50
Quantity Uom	S.F.
Potential Action	REPLACE
Urgency of Action	PRIORITY 3
Purpose of Action	LEVEL 2
Deficiency Photo1
