NYC Department of Education
Building Condition Assessment Survey 2023 - 2024

Architectural Inspection

Asset: P.S. 199 ANNEX (@ ST. TERESA'S) - QUEENS, 50-15 44TH STREET, New York, 11377

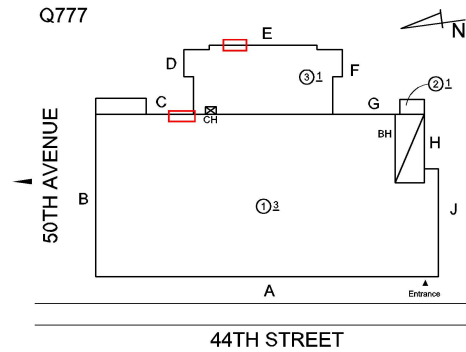
Deficiency

CAST STONE: CRACKED/BROKEN PIECES

REPLACE-IN-KIND

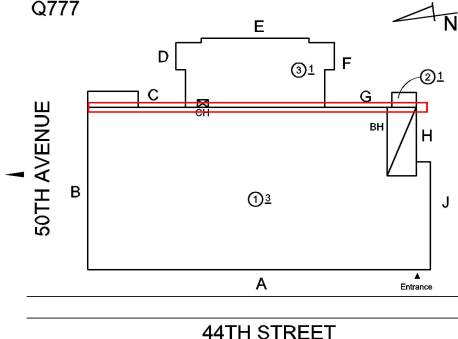
Deficiency

CAST STONE: DETERIORATED TRANSVERSE JOINTS

Question	Response
EXTERIOR	
COPING	
Roof Plan reference	Q777

Deficiency Quantity	40
Quantity Uom	L.F.
Potential Action	MAINTENANCE
Urgency of Action	PRIORITY 3
Purpose of Action	LEVEL 2
Deficiency Photo1	No photo recorded
Violations	No violations recorded.
CORNICE	
Condition	Inspected
Deficiency	2 - Between Good and Fair
DOORS	
Condition	Inspected
DOORS AND FRAMES	
Condition	Inspected
Deficiency	3 - Fair
Roof Plan reference	Q777

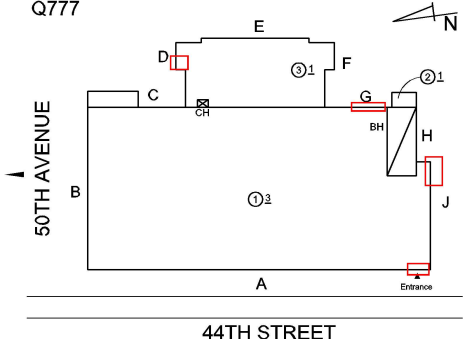
Question	Response
EXTERIOR	
EXTERIOR WALLS	Inspected
Material Type(s)	Masonry
Replacement Quantity	15,500
Replacement Uom	S.F.
Instance on All Facades	Inspected
Instance Condition	4 - Between Fair and Poor
Instance Quantity	15,500
Instance Quantity Uom	S.F.
Deficiency	BRICK: DETERIORATED JOINTS
Roof Plan reference	<p>Q777</p>

Deficiency Quantity	80
Quantity Uom	S.F.
Potential Action	REPOINT
Urgency of Action	PRIORITY 4
Purpose of Action	LEVEL 2
Deficiency Photo1

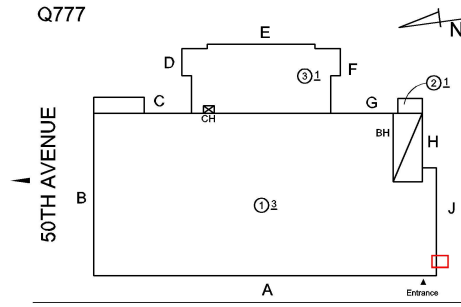
44TH STREET

Deficiency

STONE: CHIPPED/SPALLED/BROKEN PIECES - MINOR

REPAIR

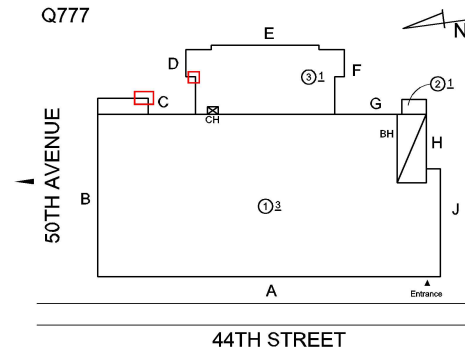
Deficiency

BRICK: MINOR CRACKS AND SPALLING

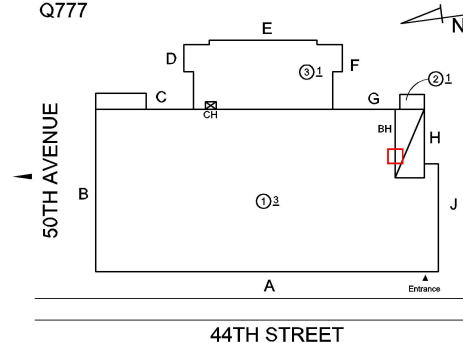
Deficiency

BULKHEAD/PENTHOUSE WALLS/EXTERIOR: CRACKS/SPALLING - MINOR

Question	Response
EXTERIOR	
ROOF	
Specialties	
BULKHEAD/PENTHOUSE	
Potential Action	REPAIR
Urgency of Action	PRIORITY 3
Purpose of Action	LEVEL 2
Deficiency Photo1

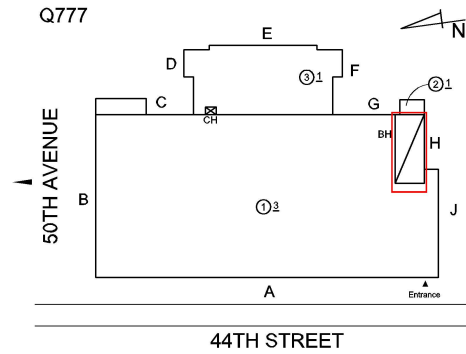
Violations	BH
Deficiency	No violations recorded.
Deficiency	BULKHEAD/PENTHOUSE WALLS/INTERIOR: GLAZED BLOCK CRACKS/SPALLING

40
 S.F.
 REPLACE
 PRIORITY 3
 LEVEL 2

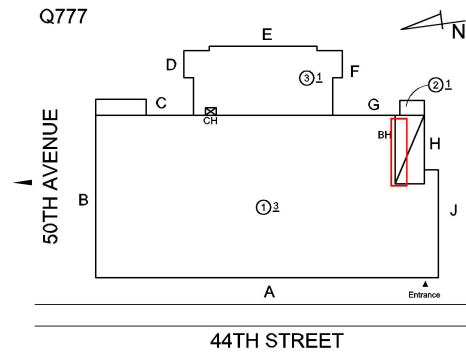
Deficiency **BULKHEAD/PENTHOUSE WALLS/EXTERIOR: DETERIORATED JOINTS**

60
 S.F.
 REPOINT
 PRIORITY 3
 LEVEL 2

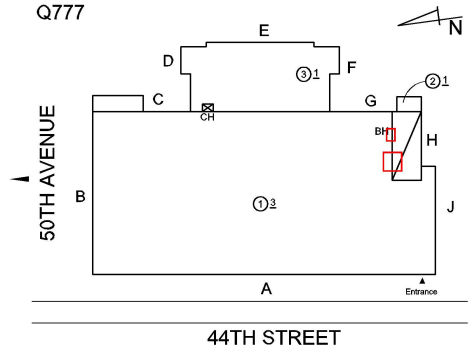
Violations	BH No violations recorded.
Deficiency	BULKHEAD/PENTHOUSE WALLS/EXTERIOR: DETERIORATED JOINTS
Roof Plan reference	Q777

Deficiency Quantity	20
Quantity Uom	S.F.
Potential Action	REPOINT
Urgency of Action	PRIORITY 4
Purpose of Action	LEVEL 2
Deficiency Photo1

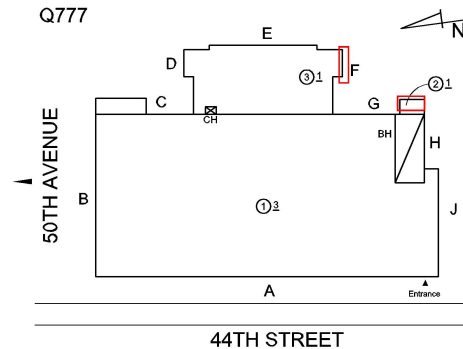
Deficiency

CONCRETE: WORN-OUT TREAD/RISER/NOSING

Deficiency Quantity	10
Quantity Uom	S.F.
Potential Action	REPLACE
Urgency of Action	PRIORITY 4
Purpose of Action	LEVEL 2

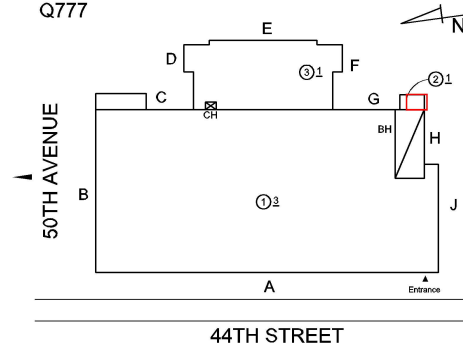
Deficiency

CONCRETE: CRACKS/SPALLING - MAJOR

REPLACE

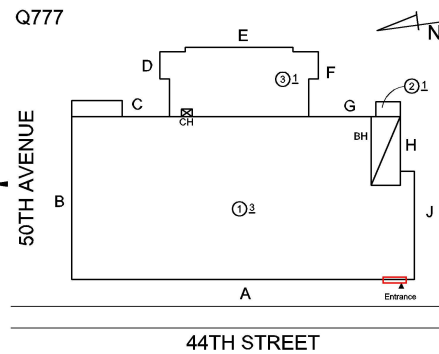
Facade A - above Main Entrance
No violations recorded.

Question	Response
EXTERIOR	
WINDOWS	
EXTERIOR GUARDS	
Elevation	 
Deficiency Quantity	30
Quantity Uom	S.F.
Potential Action	REPLACE
Urgency of Action	PRIORITY 4
Purpose of Action	LEVEL 2
Deficiency Photo1	 
Violations	Facade J No violations recorded.
LINTELS	Inspected
Condition	2 - Between Good and Fair
Deficiency	No deficiencies recorded
WINDOWS	Inspected
Material Type(s)	Aluminum
Instance on Aluminum - Double Hung: All Facades	Inspected
Instance Condition	3 - Fair
Instance Quantity	5,500
Instance Quantity Uom	S.F.
Are these windows insulated	Yes
Installation Year	1985
Source of Installation	Custodial Staff
Deficiency	ALUMINUM - DOUBLE HUNG: AIR/WATER INFILTRATION

50
L.F.
REPLACE TRIM, SILLS OR WEATHERSTRIPPING
PRIORITY 5
LEVEL 2

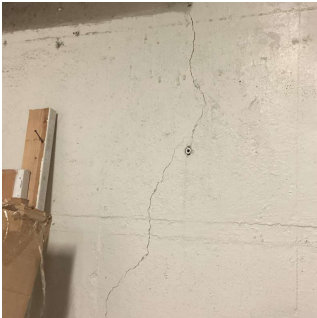
Question	Response
INTERIOR	
STRUCTURAL	
COLUMNS/BEAMS/BEARING WALLS	
Violations	Boiler Room No violations recorded.
Deficiency	STEEL COLUMNS/BEAMS: DETERIORATED CONCRETE FIREPROOFING
Deficiency Location/Instance	Ash Hoist Vault
Deficiency Quantity	10
Quantity Uom	S.F.
Potential Action	REPLACE
Urgency of Action	PRIORITY 4
Purpose of Action	LEVEL 5
Deficiency Photo1	 
Violations	Ash Hoist Vault No violations recorded.
FLOOR STRUCTURE	
Condition	Inspected 3 - Fair
Deficiency	CONCRETE SLAB ON GRADE: THRU CRACKS
Deficiency Location/Instance	Boiler Room
Deficiency Quantity	40
Quantity Uom	S.F.
Potential Action	REPLACE
Urgency of Action	PRIORITY 4
Purpose of Action	LEVEL 5
Deficiency Photo1	 
Violations	Boiler Room No violations recorded.
FOUNDATION WALLS	
Material Type(s)	Inspected Concrete
Condition	3 - Fair
Deficiency	CONCRETE: CRACKED/SPALLED/REINFORCEMENT EXPOSED
Deficiency Location/Instance	Boiler Room

Question	Response
INTERIOR	
STRUCTURAL	
FOUNDATION WALLS	
Deficiency Quantity	60
Quantity Uom	S.F.
Potential Action	REPAIR
Urgency of Action	PRIORITY 3
Purpose of Action	LEVEL 5
Deficiency Photo1

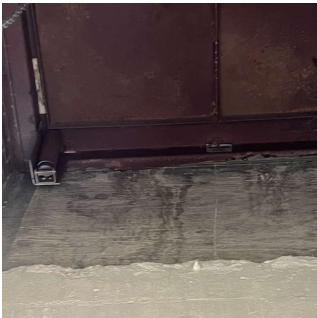
Violations	Basement - Above Boiler Room Stairwell No violations recorded.
Vault/Ash Hoist Doors and Framing	Inspected
Condition	5 - Poor
Deficiency	WATER INFILTRATION
Deficiency Location/Instance	Ash Hoist Vault
Deficiency Quantity	10
Quantity Uom	S.F.
Potential Action	REPAIR
Urgency of Action	PRIORITY 5
Purpose of Action	LEVEL 2
Deficiency Photo1

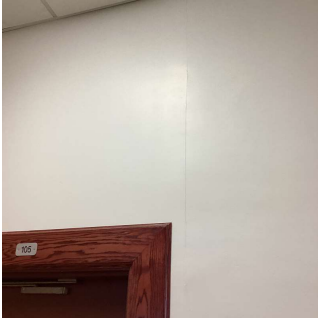
Question	Response
INTERIOR	
CLASSROOMS/CORRIDORS/ADMIN SPACES	
Walls	Inspected
Condition	2 - Between Good and Fair
Deficiency	GYPSUM BOARD: DETERIORATED
Deficiency Location/Instance	Corridor near Rooms 105, 201, 203, 310
Deficiency Quantity	40
Quantity Uom	S.F.
Potential Action	REPLACE
Urgency of Action	PRIORITY 3
Purpose of Action	LEVEL 2
Deficiency Photo1

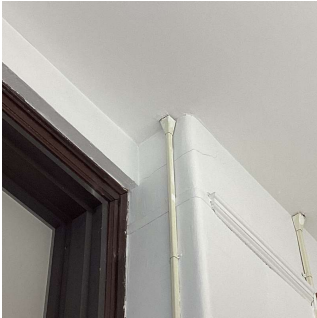
Question	Response
INTERIOR	
LIBRARY	
Floor Finish	
Violations	No violations recorded.
Walls	
Instance on Room 301	Inspected
Condition	2 - Between Good and Fair
Deficiency	PLASTER: CRACKS/SPALLING
Deficiency Location/Instance	Near Windows
Deficiency Quantity	10
Quantity Uom	S.F.
Potential Action	REPLACE
Urgency of Action	PRIORITY 3
Purpose of Action	LEVEL 2
Deficiency Photo1

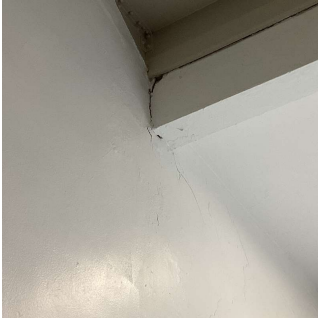
Question	Response
INTERIOR	
STAIRS/RAMPS: INTERIOR	
Walls	Inspected
Condition	2 - Between Good and Fair
Deficiency	PLASTER: CRACKS/SPALLING
Deficiency Location/Instance	Stair B/3
Deficiency Quantity	10
Quantity Uom	S.F.
Potential Action	REPLACE
Urgency of Action	PRIORITY 3
Purpose of Action	LEVEL 2
Deficiency Photo1

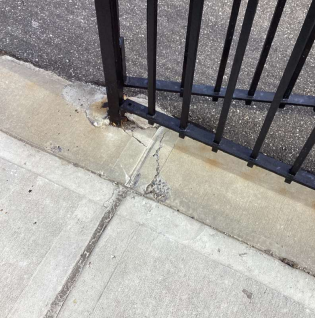
Question	Response
SITE	
FENCES	
Deficiency Photo1

Violations	44th Street No violations recorded.
Deficiency	WROUGHT IRON: DAMAGED/DETERIORATED
Deficiency Location/Instance	44th Street
Deficiency Quantity	200
Quantity Uom	S.F.
Potential Action	REPLACE
Urgency of Action	PRIORITY 3
Purpose of Action	LEVEL 2
Deficiency Photo1

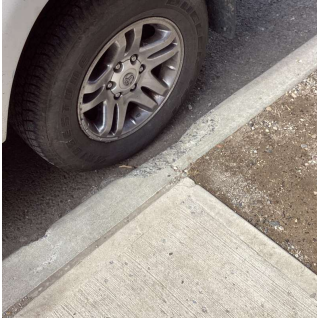
Question	Response
SITE	
PAVING	
DOT Sidewalk	
Concrete	
Potential Action	REPLACE
Urgency of Action	PRIORITY 3
Purpose of Action	LEVEL 2
Deficiency Photo1

44th Street
Violations	No violations recorded.
Pavers	Does not Exist
PLAYGROUNDS	Does not Exist
PLAYING SURFACE	Does not Exist
RETAINING WALLS	Does not Exist
SEATING	Does not Exist
SITE WALLS (NOT RETAINING WALLS)	Does not Exist
STAIRS/RAMPS: EXTERIOR	Does not Exist
ARTWORK	Does not Exist
