NYC Department of Education
Building Condition Assessment Survey 2023 - 2024

Architectural Inspection

Asset: **JOHN ADAMS HS ANNEX - QUEENS, 120-27 141ST STREET, New York, 11436**

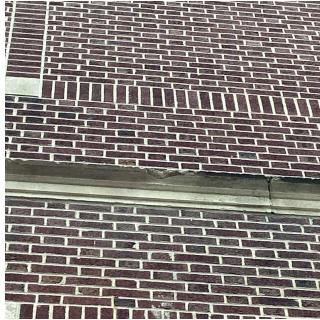
Question	Response
EXTERIOR	
CORNICE	
Deficiency Photo1

Violations	Facade B No violations recorded.
DOORS	Inspected
DOORS AND FRAMES	Inspected
Condition	5 - Poor
Deficiency	METAL: DETERIORATED DOOR AND FRAME - MAJOR DETERIORATION
Roof Plan reference	<p>Q781</p>

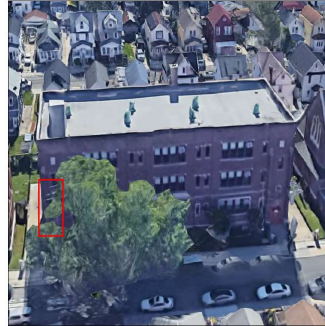
BRICK: WATER INFILTRATION IN INSTRUCTIONAL SPACE

EXTERIOR WALLS

REPAIR

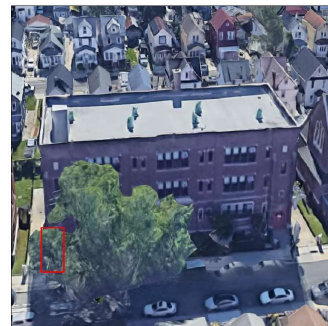
BRICK: CRACKS/DISPLACED/SPALLED BRICK AT BUILDING CORNERS

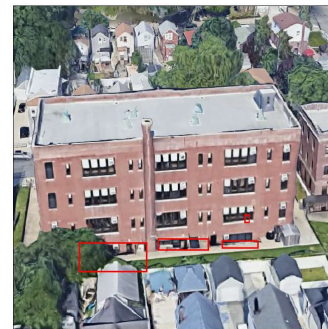
BRICK: DETERIORATED MASONRY SILLS - MINOR

30
L.F.
REPAIR
PRIORITY 3
LEVEL 2

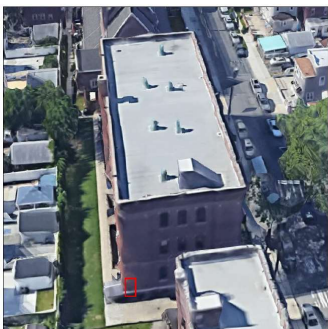
Question	Response
EXTERIOR	
EXTERIOR WALLS	
Violations	Facade C No violations recorded.
Deficiency	STONE: CHIPPED/SPALLED/BROKEN PIECES - MINOR
Roof Plan reference	<p>Q781</p>

Deficiency Quantity	10
Quantity Uom	S.F.
Potential Action	REPAIR
Urgency of Action	PRIORITY 3
Purpose of Action	LEVEL 2
Deficiency Photo1

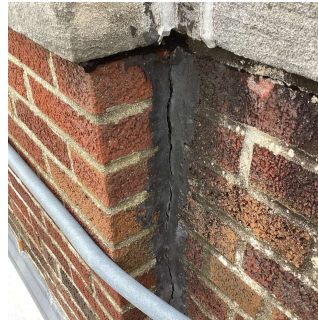
Roof 1

Deficiency **BRICK: MINOR CRACKS, SPALLING**

REPAIR

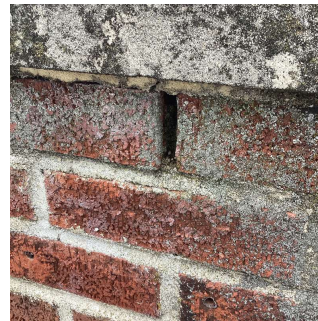
Roof 1

Deficiency	BRICK: DETERIORATED JOINTS
------------	----------------------------

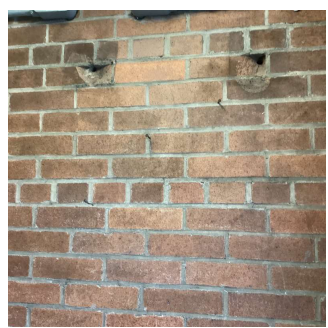
Question	Response
EXTERIOR	
ROOF	
Roofing	
ROOFING	
Instance Quantity	7,000
Instance Quantity Uom	S.F.
Does the roof have major mechanical equipment sitting on Dunnage Steel less than 18" above the Roofing?	No
Does this roof instance have a Sustainable Roof System?	Yes
Sustainable Roof Type	White Roof
Sustainable Roof Location (Roof Number)	Roof 1
Do solar panels exist on these roofs?	No
Is/Are the roof(s) suitable for Solar Panel installation?	No
Installation Year	2010
Source of Installation	Custodial Staff
Deficiency	No deficiencies recorded
ROOFING DRAINS	Inspected
Condition	2 - Between Good and Fair
Deficiency	No deficiencies recorded
Specialties	Inspected
BULKHEAD/PENTHOUSE	Inspected
Condition	2 - Between Good and Fair
Deficiency	BULKHEAD/PENTHOUSE WALLS/INTERIOR: BRICK CRACKS/SPALLING
Roof Plan reference	 
Deficiency Quantity	10
Quantity Uom	S.F.
Potential Action	REPLACE
Urgency of Action	PRIORITY 3
Purpose of Action	LEVEL 2

Violations	Roof 1 - Bulkhead No violations recorded.
CUPOLA/ SPIRES/ TOWERS	Does not Exist
DORMER	Does not Exist

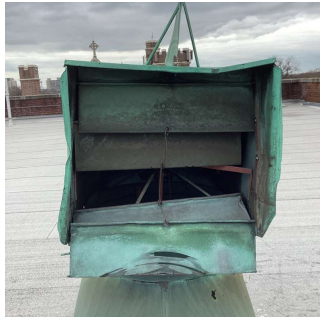
Question	Response
EXTERIOR	
ROOF	
Specialties	
DUNNAGE STEEL	Does not Exist
SKYLIGHT/ROOF VENT	Inspected
Material Type(s)	Other
Condition	3 - Fair
Deficiency	SHAFT VENTS DAMAGED
Roof Plan reference	<p>Q781</p>

Question	Response
EXTERIOR	
ROOF	
Specialties	
SKYLIGHT/ROOF VENT	
Deficiency Photo1

Violations	Roof 1 No violations recorded.
ROOF/GRAVITY TANK	Does not Exist
STAIRS/RAMPS: EXTERIOR	Inspected
BUILDING CHEEK/FLANK WALLS	Inspected
Condition	2 - Between Good and Fair
Deficiency	STONE: CRACKS/SPALLING - MINOR
Roof Plan reference	<p>Q781</p>

Deficiency Quantity	5
Quantity Uom	EACH
Potential Action	MAINTENANCE
Urgency of Action	PRIORITY 3
Purpose of Action	LEVEL 2

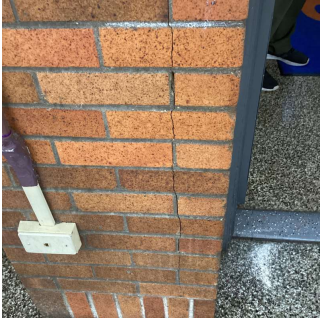
Question	Response
EXTERIOR	
WINDOWS	
WINDOWS	
Are these windows insulated	Yes
Installation Year	1990
Source of Installation	Custodial Staff
Deficiency	No deficiencies recorded
INTERIOR	Inspected
POOLS	Does not Exist
STRUCTURAL	Inspected
COLUMNS/BEAMS/BEARING WALLS	Inspected
Condition	3 - Fair
Deficiency	STEEL COLUMNS/BEAMS: DETERIORATED MASONRY FIREPROOFING
Deficiency Location/Instance	Basement - South Multi-Purpose Room
Deficiency Quantity	30
Quantity Uom	S.F.
Potential Action	REPLACE
Urgency of Action	PRIORITY 3
Purpose of Action	LEVEL 5
Deficiency Photo1

Violations	Basement - South Multi-Purpose Room No violations recorded.
FLOOR STRUCTURE	Inspected
Condition	2 - Between Good and Fair
Deficiency	No deficiencies recorded
FOUNDATION WALLS	Inspected
Material Type(s)	Masonry
Condition	4 - Between Fair and Poor
Deficiency	BRICK: CRACKED/SPALLED
Deficiency Location/Instance	Basement - Boiler Room
Deficiency Quantity	30

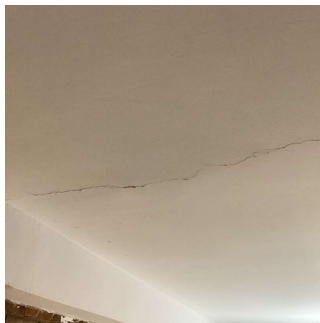
Question	Response
INTERIOR	
STRUCTURAL	
ROOF STRUCTURE	Inspected
Deficiency Photo1

Roof 1
Violations	No violations recorded.
VAULTS-BUNKERS	
Foundation Walls	Inspected
Condition	2 - Between Good and Fair
Deficiency	No deficiencies recorded
Slab Structure	Inspected
Condition	2 - Between Good and Fair
Deficiency	No deficiencies recorded
Vault/Ash Hoist Doors and Framing	Inspected
Condition	2 - Between Good and Fair
Deficiency	No deficiencies recorded
AUDITORIUM	
Does not Exist	
CAFETERIA	
Does not Exist	
CLASSROOMS/CORRIDORS/ADMIN SPACES	
Ceiling	Inspected
Condition	2 - Between Good and Fair
Deficiency	PLASTER: CRACKS/SPALLING
Deficiency Location/Instance	Rooms 106, 306
Deficiency Quantity	20
Quantity Uom	S.F.
Potential Action	REPLACE
Urgency of Action	PRIORITY 3
Purpose of Action	LEVEL 2
Deficiency Photo1

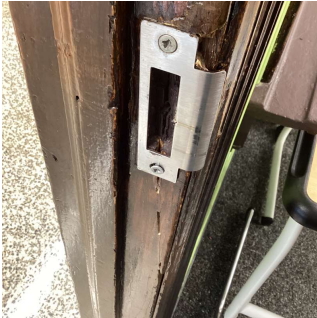
Violations	Near Multi-Purpose Room - South No violations recorded.
Door(s)	Inspected
Condition	2 - Between Good and Fair
Deficiency	WOOD: DETERIORATED DOOR AND FRAME
Deficiency Location/Instance	Room 202
Deficiency Quantity	1
Quantity Uom	EACH
Potential Action	MAINTENANCE
Urgency of Action	PRIORITY 3
Purpose of Action	LEVEL 2
Deficiency Photo1

Violations	Room 202 No violations recorded.
Floor Finish	Inspected
Condition	2 - Between Good and Fair
Deficiency	TERRAZZO: CRACKS
Deficiency Location/Instance	Near Main Office, Rooms 103, 106, 109, 303
Deficiency Quantity	50
Quantity Uom	S.F.
Potential Action	REPLACE
Urgency of Action	PRIORITY 3
Purpose of Action	LEVEL 2

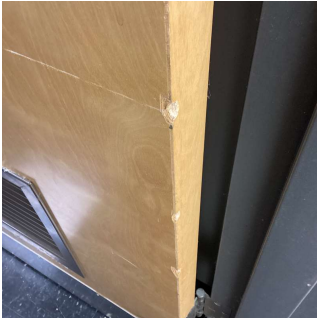
Near Storage Room
Violations	No violations recorded.
Door(s)	
Instance on Basement	Inspected
Condition	3 - Fair
Deficiency	WOOD: DETERIORATED DOOR
Deficiency Location/Instance	Entrance
Deficiency Quantity	1
Quantity Uom	EACH
Potential Action	MAINTENANCE
Urgency of Action	PRIORITY 3
Purpose of Action	LEVEL 2
Deficiency Photo1

Entrance
Violations	No violations recorded.
Floor Finish	
Instance on Basement	Inspected
Condition	2 - Between Good and Fair
Deficiency	No deficiencies recorded
Walls	
Instance on Basement	Inspected
Condition	2 - Between Good and Fair
Deficiency	GYPSON BOARD: DETERIORATED
Deficiency Location/Instance	Near sink
Deficiency Quantity	10

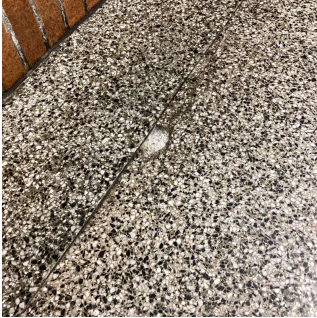
Question	Response
INTERIOR	
MULTI-PURPOSE ROOM	
Ceiling	
Potential Action	REPLACE
Urgency of Action	PRIORITY 3
Purpose of Action	LEVEL 2
Deficiency Photo1	 
	Near Windows
Violations	No violations recorded.
Door(s)	
Instance on Basement- North	Inspected
Condition	2 - Between Good and Fair
Deficiency	No deficiencies recorded
Instance on Basement - South	Inspected
Condition	2 - Between Good and Fair
Deficiency	No deficiencies recorded
Fixed Equipment	
Instance on Basement- North	Does not Exist
Instance on Basement - South	Does not Exist
Floor Finish	
Instance on Basement - South	Inspected
Condition	2 - Between Good and Fair
Deficiency	TERRAZZO: CRACKS
Deficiency Location/Instance	Near Windows
Deficiency Quantity	10
Quantity Uom	S.F.
Potential Action	REPLACE
Urgency of Action	PRIORITY 3
Purpose of Action	LEVEL 2
Deficiency Photo1

Near Windows
Violations	No violations recorded.
Sliding-folding Partition	
Instance on Basement - South	Does not Exist

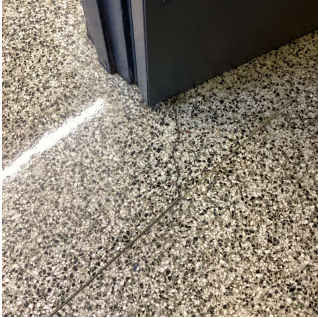
Question	Response
INTERIOR	
STAIRS/RAMPS: INTERIOR	
Door(s)	Inspected
Condition	2 - Between Good and Fair
Deficiency	No deficiencies recorded
Partition	Does not Exist
Railings	Inspected
Condition	2 - Between Good and Fair
Deficiency	No deficiencies recorded
Stairs and Landings	Inspected
Condition	2 - Between Good and Fair
Deficiency	TERRAZZO: CRACKS
Deficiency Location/Instance	Stair B/2, 3
Deficiency Quantity	20
Quantity Uom	S.F.
Potential Action	REPLACE
Urgency of Action	PRIORITY 3
Purpose of Action	LEVEL 2
Deficiency Photo1

Stair B/2
Violations	No violations recorded.
Walls	Inspected
Condition	2 - Between Good and Fair
Deficiency	No deficiencies recorded
TOILET ROOMS - STAFF	
Ceiling	Inspected
Condition	2 - Between Good and Fair
Deficiency	No deficiencies recorded
Door(s)	Inspected
Condition	5 - Poor
Deficiency	WOOD: DETERIORATED DOOR
Deficiency Location/Instance	Staff 1st Floor
Deficiency Quantity	1
Quantity Uom	EACH

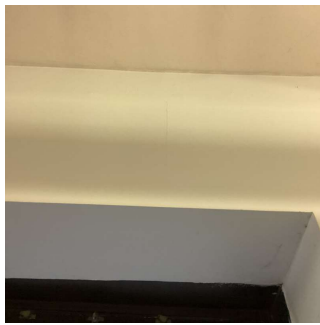
Question	Response
INTERIOR	
TOILET ROOMS - STUDENTS	
Walls	
Deficiency Photo1

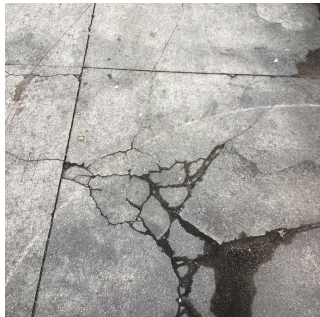
Violations	Near Exit Stair A No violations recorded.
Deficiency	DAMAGED/DETERIORATED/MISSING SECTIONS
Deficiency Location/Instance	Near Church, Back of the building, Main Entrance
Deficiency Quantity	550
Quantity Uom	S.F.
Potential Action	REPLACE
Urgency of Action	PRIORITY 3
Purpose of Action	LEVEL 2
Deficiency Photo1

Violations	Near Church No violations recorded.
Pavers	Does not Exist
DOT Sidewalk	Inspected
Asphalt	Does not Exist
Concrete	Inspected
Condition	3 - Fair
Deficiency	DAMAGED/DETERIORATED/MISSING SECTIONS
Deficiency Location/Instance	141st Street
Deficiency Quantity	400
Quantity Uom	S.F.
Potential Action	REPLACE
Urgency of Action	PRIORITY 3
Purpose of Action	LEVEL 2
