NYC Department of Education
Building Condition Assessment Survey 2023 - 2024

Architectural Inspection

Asset: PS 150 ANNEX - QUEENS, 41-12 44TH STREET, New York, 11104

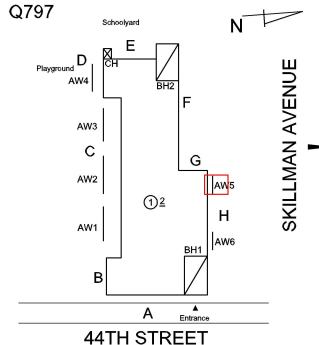
Question	Response
Architectural	
EXTERIOR	Inspected
AREAWAY	Inspected
Instance on AW1 - AW6	Inspected
Instance Condition	3 - Fair
Instance Quantity	6
Instance Quantity Uom	EACH
Deficiency	AREAWAY WALLS: CRACKS AND SPALLING
Roof Plan reference	Q797

Question	Response
EXTERIOR	
AREAWAY	
Quantity Uom	S.F.
Potential Action	REPLACE
Urgency of Action	PRIORITY 4
Purpose of Action	LEVEL 2
Deficiency Photo1

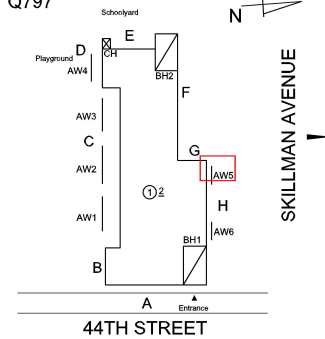
Violations	AW5 No violations recorded.
Deficiency	AREAWAY SLAB: CRACKS AND SPALLING
Roof Plan reference	Q797

Deficiency Quantity	10
Quantity Uom	S.F.
Potential Action	REPLACE
Urgency of Action	PRIORITY 4
Purpose of Action	LEVEL 2
Deficiency Photo1

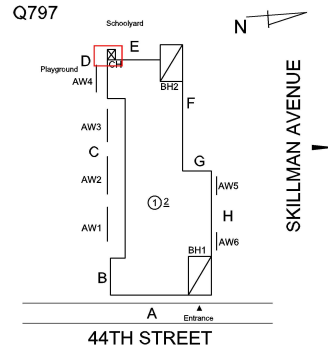
Violations	AW5 No violations recorded.
AWNINGS AND CANOPIES	Does not Exist
CHIMNEY	Inspected
Material Type(s)	Masonry
Condition	3 - Fair
Deficiency	BRICK: DETERIORATED JOINTS

150
 S.F.
 REPOINT
 PRIORITY 3
 LEVEL 2

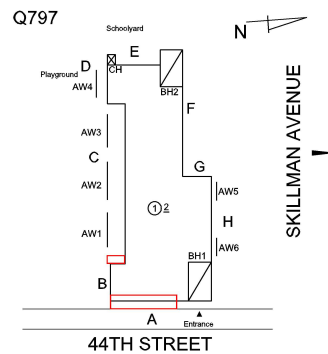
CAST STONE: DETERIORATED TRANSVERSE JOINTS

10
 L.F.
 MAINTENANCE
 PRIORITY 3
 LEVEL 2

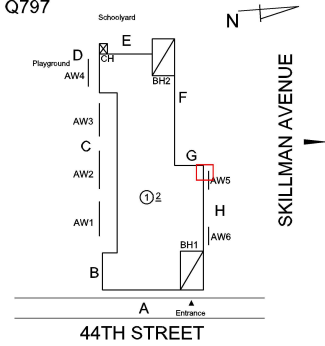
Violations	Roof 1 No violations recorded.
CORNICE	Does not Exist
DOORS	Inspected
DOORS AND FRAMES	Inspected
Condition	4 - Between Fair and Poor
Deficiency	METAL: DETERIORATED DOOR AND FRAME - MAJOR DETERIORATION
Roof Plan reference	Q797

Deficiency Quantity	1
Quantity Uom	EACH
Potential Action	REPLACE
Urgency of Action	PRIORITY 4
Purpose of Action	LEVEL 2
Deficiency Photo1

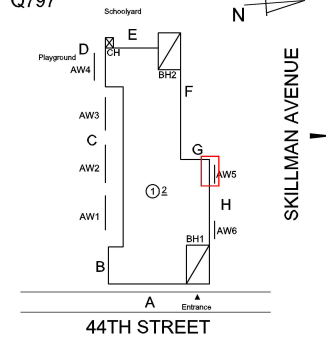
STEEL: MAJOR RUSTING

10
 L.F.
 REPLACE
 PRIORITY 4
 LEVEL 2

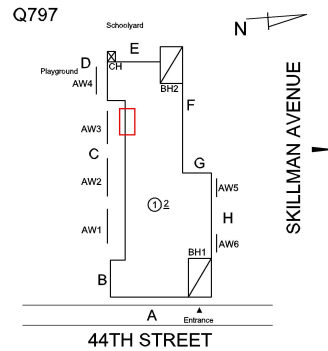
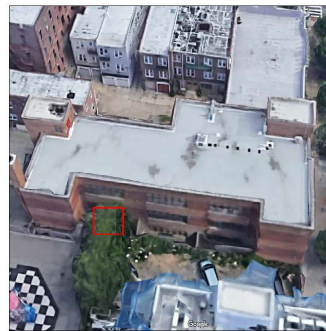
Material Type(s)	Inspected
Replacement Quantity	Masonry
Replacement Uom	15,000
	S.F.
Instance on All Facades	Inspected
Instance Condition	3 - Fair
Instance Quantity	15,000
Instance Quantity Uom	S.F.
Deficiency	BRICK: DETERIORATED MASONRY SILLS - MAJOR

REMOVE AND REPLACE

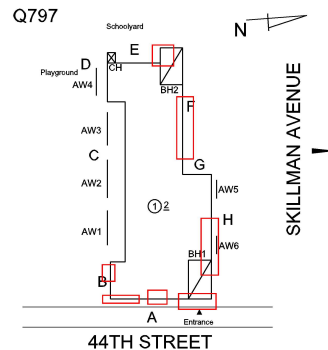
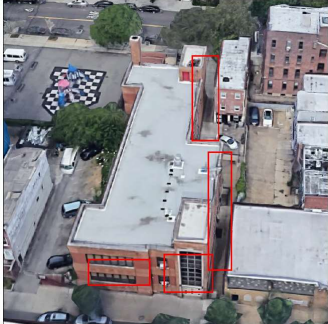
BRICK: DETERIORATED JOINTS

Deficiency Quantity	100
Quantity Uom	S.F.
Potential Action	REPOINT
Urgency of Action	PRIORITY 3
Purpose of Action	LEVEL 2
Deficiency Photo1

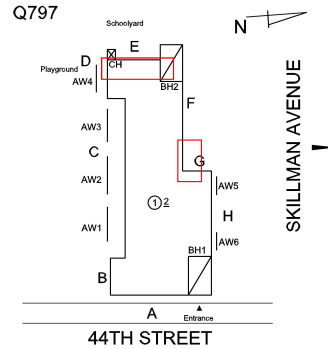
Violations	Facade A No violations recorded.
EXTERIOR SOFFITS	Inspected
Condition	2 - Between Good and Fair
Deficiency	No deficiencies recorded
LOADING DOCK	Does not Exist
LOUVER	Inspected
Condition	2 - Between Good and Fair
Deficiency	No deficiencies recorded
PARAPETS	Inspected
Material Type(s)	Masonry
Replacement Quantity	3,500
Replacement Uom	C.F.
Instance on Roof 1	Inspected
Instance Condition	3 - Fair
Instance Quantity	3,500
Instance Quantity Uom	C.F.
Deficiency	BRICK: DETERIORATED JOINTS

40
S.F.
REPOINT
PRIORITY 3
LEVEL 2

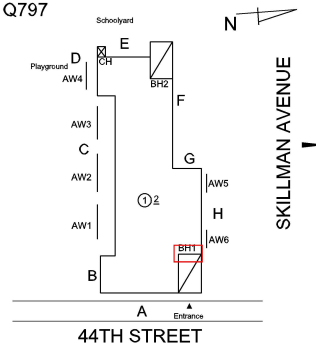
Deficiency BULKHEAD/PENTHOUSE WALLS/EXTERIOR: CRACKS/SPALLING - MINOR

Deficiency Quantity	15
Quantity Uom	S.F.
Potential Action	REPAIR
Urgency of Action	PRIORITY 3
Purpose of Action	LEVEL 2
Deficiency Photo1

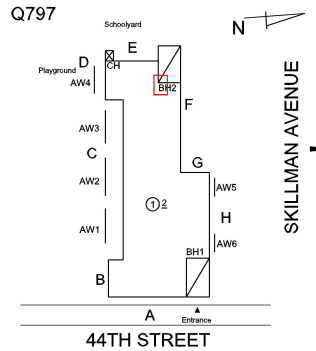
Deficiency	BULKHEAD/PENTHOUSE WALLS/INTERIOR: BRICK CRACKS/SPALLING
------------	---

Deficiency Quantity	10
Quantity Uom	S.F.
Potential Action	REPLACE
Urgency of Action	PRIORITY 3
Purpose of Action	LEVEL 2
Deficiency Photo1

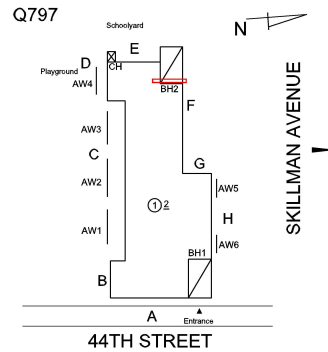
Deficiency	BULKHEAD/PENTHOUSE CEILING: PLASTER DAMAGED/DETERIORATED
------------	---

10
S.F.
REPLACE
PRIORITY 3
LEVEL 2

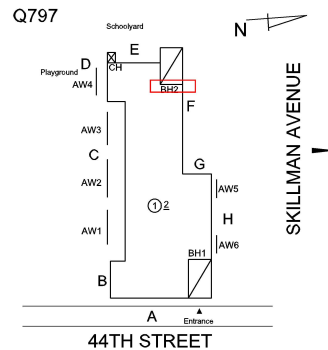
Deficiency **BULKHEAD/PENTHOUSE WALLS/EXTERIOR:
CRACKS/SPALLING - MAJOR**

15
S.F.
REPLACE
PRIORITY 4
LEVEL 2

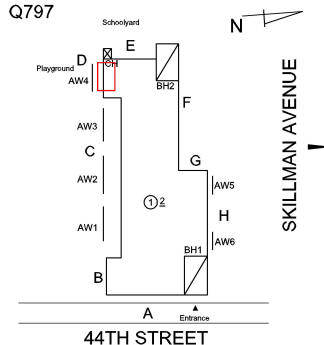
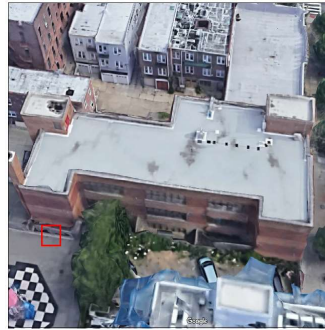
WINDOWS

Are these windows insulated	No
Installation Year	1956
Source of Installation	Custodial Staff
Deficiency	STEEL: DETERIORATED
Roof Plan reference	Q797

REPLACE WINDOW

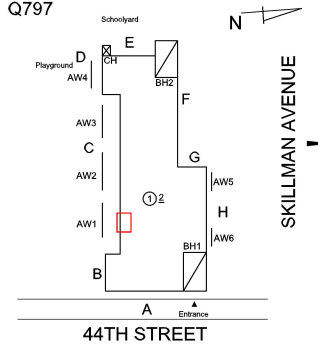
ALUMINUM - DOUBLE HUNG: BROKEN PANE

Question	Response
EXTERIOR	
WINDOWS	
WINDOWS	
Elevation	 
Deficiency Quantity	60
Quantity Uom	S.F.
Potential Action	MAINTENANCE
Urgency of Action	PRIORITY 3
Purpose of Action	LEVEL 2
Deficiency Photo1	 
Violations	Facade C No violations recorded.
INTERIOR	Inspected
POOLS	Does not Exist
STRUCTURAL	Inspected
COLUMNS/BEAMS/BEARING WALLS	Inspected
Condition	2 - Between Good and Fair
Deficiency	No deficiencies recorded
FLOOR STRUCTURE	Inspected
Condition	2 - Between Good and Fair
Deficiency	No deficiencies recorded
FOUNDATION WALLS	Inspected
Material Type(s)	Concrete
Condition	4 - Between Fair and Poor
Deficiency	CONCRETE: CRACKED/SPALLED/REINFORCEMENT EXPOSED
Deficiency Location/Instance	Basement - Boiler Room
Deficiency Quantity	30
Quantity Uom	S.F.
Potential Action	REPAIR
Urgency of Action	PRIORITY 4
Purpose of Action	LEVEL 5
