**NYC Department of Education  
Building Condition Assessment Survey 2023 - 2024**

Architectural Inspection

Q798

**Asset: BACCALAUREATE SCL FOR GLOBAL ED-Q, 34-12 36TH AVENUE, New York, 11106**

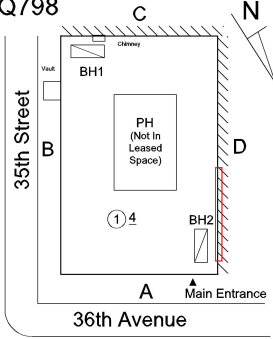
Question	Response
<b>EXTERIOR</b>	
<b>COPING</b>	Inspected
Condition	3 - Fair
Deficiency	TERRA COTTA: DETERIORATED TRANSVERSE JOINTS
Roof Plan reference	<p>Q798</p>

Deficiency Quantity	30
Quantity Uom	L.F.
Potential Action	MAINTENANCE
Urgency of Action	PRIORITY 3
Purpose of Action	LEVEL 2
Deficiency Photo1	No photo recorded
Violations	No violations recorded.
Deficiency	METAL: DETERIORATED TRANSVERSE JOINTS
Roof Plan reference	<p>Q798</p>

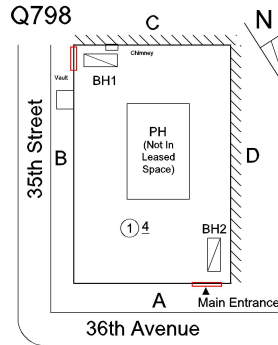
METAL: DETERIORATED DOOR AND FRAME - MINOR DETERIORATION

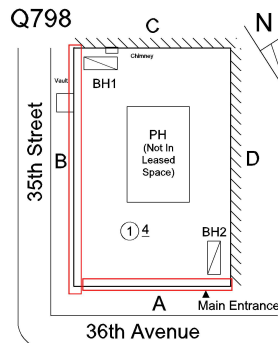
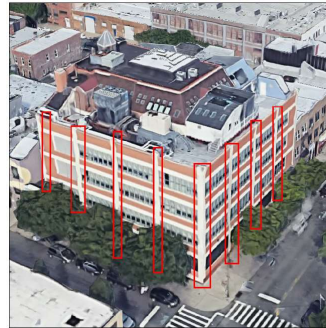
STUCCO CEMENT SURFACE: CRACKS, SPALLING

REPLACE

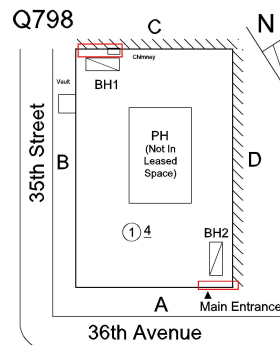
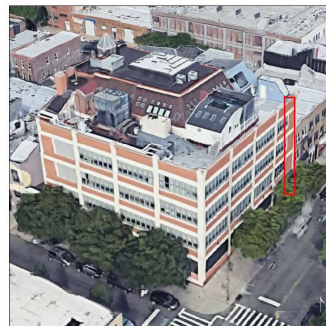
STUCCO CEMENT SURFACE: WATER INFILTRATION IN INSTRUCTIONAL SPACE

Question	Response
<b>EXTERIOR</b>	
<b>EXTERIOR WALLS</b>	
Potential Action	REPAIR
Urgency of Action	PRIORITY 5
Purpose of Action	LEVEL 2
Deficiency Photo1	 
	Facade A - Stair B/2 (Facade A - Stair B/1, Facade C - Stair A/2 similar)
Violations	No violations recorded.
<b>EXTERIOR SOFFITS</b>	
Condition	Inspected
Deficiency	2 - Between Good and Fair
Deficiency	No deficiencies recorded
<b>LOADING DOCK</b>	
	Does not Exist
<b>LOUVER</b>	
Condition	Inspected
	3 - Fair
Deficiency	BROKEN/ DENTED BLADES
Roof Plan reference	Q798  
Elevation	 
Deficiency Quantity	10
Quantity Uom	S.F.
Potential Action	REPLACE
Urgency of Action	PRIORITY 4
Purpose of Action	LEVEL 2

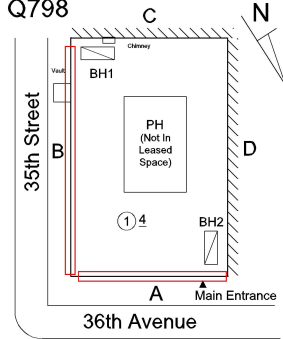
Violations	Facade B No violations recorded.
<b>PARAPETS</b>	Inspected
Material Type(s)	Concrete
Replacement Quantity	2,800
Replacement Uom	C.F.
Instance on All Facades	Inspected
Instance Condition	3 - Fair
Instance Quantity	2,800
Instance Quantity Uom	C.F.
Deficiency	CONCRETE: MINOR CRACKS, SPALLING
Roof Plan reference	<p>Q798</p>

Deficiency Quantity	100
Quantity Uom	S.F.
Potential Action	REPAIR
Urgency of Action	PRIORITY 3
Purpose of Action	LEVEL 2
Deficiency Photo1

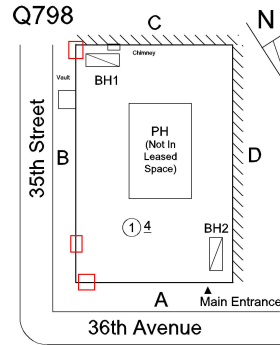
Violations	Roof 1- Facade A No violations recorded.
Deficiency	CONCRETE: MAJOR DETERIORATION/CRACKS

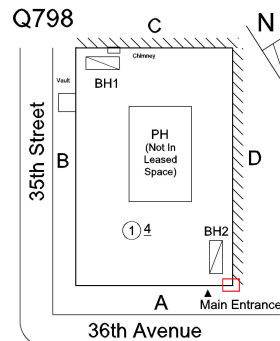
RAILINGS/PANELS: DETERIORATED, MAJOR RUSTING

Question	Response
<b>EXTERIOR</b>	
<b>ROOF</b>	
<b>Roofing</b>	
<b>ROOF BARRIER/FENCE</b>	
Deficiency Quantity	10
Quantity Uom	S.F.
Potential Action	REPLACE
Urgency of Action	PRIORITY 4
Purpose of Action	LEVEL 2
Deficiency Photo1

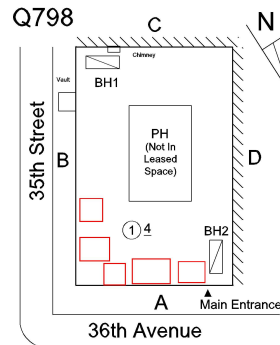
Roof 1
Instance Quantity	10,000
Instance Quantity Uom	S.F.
Does the roof have major mechanical equipment sitting on Dunnage Steel less than 18" above the Roofing?	No
Does this roof instance have a Sustainable Roof System?	Yes
Sustainable Roof Type	White Roof
Sustainable Roof Location (Roof Number)	Roof 1
Do solar panels exist on these roofs?	No
Is/Are the roof(s) suitable for Solar Panel installation?	No
Installation Year	2002
Source of Installation	Custodial Staff
Deficiency	MODIFIED BITUMEN: ROOFING: MAJOR ACTIVE ROOF LEAKS IN INSTRUCTIONAL SPACE

REPLACE ROOFING WITHOUT MAJOR EQUIPMENT REMOVAL

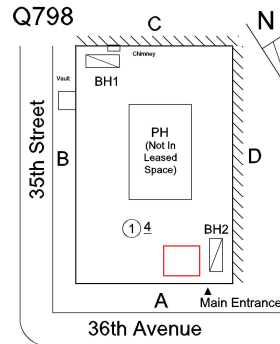
MODIFIED BITUMEN: ROOFING: DELAMINATION

REPLACE ROOFING WITHOUT MAJOR EQUIPMENT REMOVAL

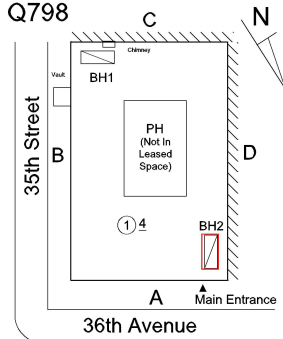
Violations	Roof 1 No violations recorded.
<b>ROOFING DRAINS</b>	Inspected
Condition	2 - Between Good and Fair
Deficiency	No deficiencies recorded
<b>Specialties</b>	Inspected
<b>BULKHEAD/PENTHOUSE</b>	Inspected
Condition	4 - Between Fair and Poor
Deficiency	BULKHEAD/PENTHOUSE WALLS/EXTERIOR: CRACKS/SPALLING - MAJOR
Roof Plan reference	Q798

Deficiency Quantity	20
Quantity Uom	S.F.
Potential Action	REPLACE
Urgency of Action	PRIORITY 4
Purpose of Action	LEVEL 2
Deficiency Photo1

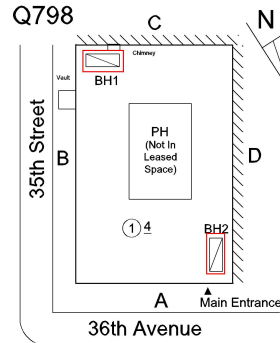
Violations	BH1 No violations recorded.
Deficiency	BULKHEAD/PENTHOUSE WALLS/EXTERIOR: WATER INFILTRATION

200  
S.F.  
REPAIR  
PRIORITY 5  
LEVEL 2

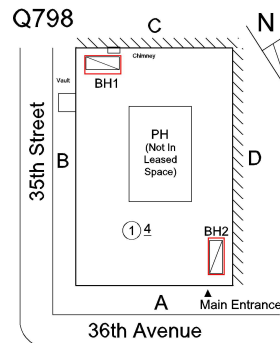
Deficiency **BULKHEAD/PENTHOUSE WALLS/INTERIOR: PLASTER CRACKS/SPALLING**

100  
S.F.  
REPLACE  
PRIORITY 3  
LEVEL 2

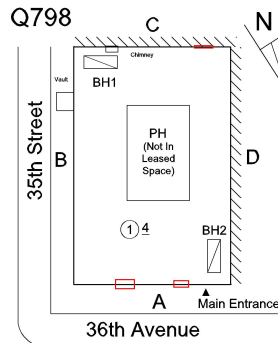
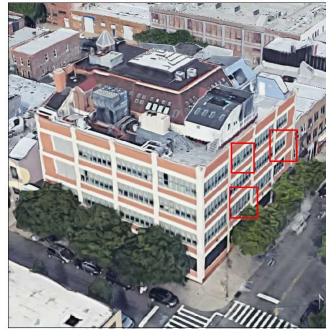
ALUMINUM - DOUBLE HUNG: DETERIORATED

150  
S.F.  
REPLACE WINDOW  
PRIORITY 4  
LEVEL 2

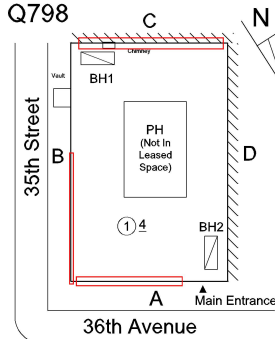
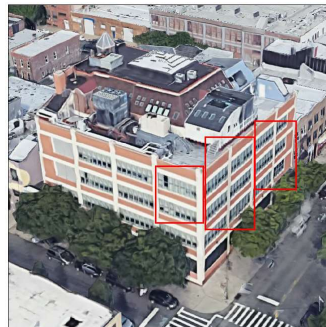
ALUMINUM - DOUBLE HUNG: AIR/WATER INFILTRATION  
Q798

Question	Response
<b>EXTERIOR</b>	
<b>WINDOWS</b>	
<b>WINDOWS</b>	
Potential Action	REPLACE TRIM, SILLS OR WEATHERSTRIPPING
Urgency of Action	PRIORITY 5
Purpose of Action	LEVEL 2
Deficiency Photo1	 
Violations	Facade A - Room 400 (Facade A - Rooms 202, 203, 300, 302, 303, 400, 403, Boys and Girls Locker Rooms, Facade B - Rooms 304, 403, Facade C - Rooms 310, 410) No violations recorded.
<b>INTERIOR</b>	Inspected
<b>POOLS</b>	Does not Exist
<b>STRUCTURAL</b>	Inspected
<b>COLUMNS/BEAMS/BEARING WALLS</b>	Inspected
Condition	3 - Fair
Deficiency	STEEL COLUMNS/BEAMS: DETERIORATED CONCRETE FIREPROOFING
Deficiency Location/Instance	Roof 1 - BH2, Room 407, Basement - Room 006
Deficiency Quantity	40
Quantity Uom	S.F.
Potential Action	REPLACE
Urgency of Action	PRIORITY 3
Purpose of Action	LEVEL 5
Deficiency Photo1	 
Violations	Roof 1 - BH1 No violations recorded.
Deficiency	STEEL COLUMNS/BEAMS: DETERIORATED CONCRETE FIREPROOFING
