NYC Department of Education
Building Condition Assessment Survey 2023 - 2024

Architectural Inspection

Asset: CAMBRIA HEIGHTS ACADEMY - QUEENS, 188-04 91ST AVENUE, New York, 11423

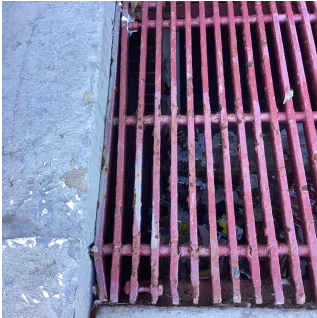
AREAWAY GRATINGS: MAJOR RUSTING / OR BROKEN

REPLACE

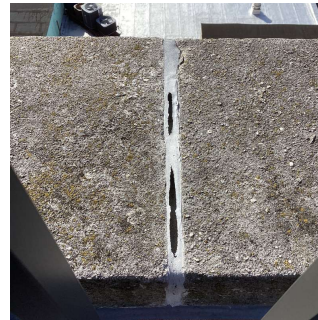
Violations	Roof 1 No violations recorded.
Deficiency	CAST STONE: DETERIORATED TRANSVERSE JOINTS

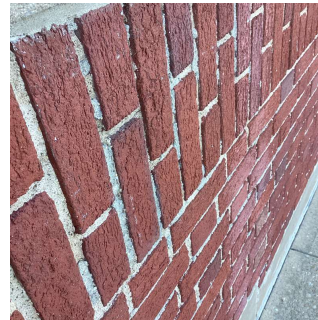
Facade D

Question	Response
EXTERIOR	
EXTERIOR WALLS	
Material Type(s)	Masonry
Replacement Quantity	13,500
Replacement Uom	S.F.
Instance on All Facades	Inspected
Instance Condition	3 - Fair
Instance Quantity	13,500
Instance Quantity Uom	S.F.
Deficiency	STONE: CRACKS AT BUILDING CORNERS
Roof Plan reference	
Elevation	
Deficiency Quantity	10
Quantity Uom	S.F.
Potential Action	REPLACE
Urgency of Action	PRIORITY 4
Purpose of Action	LEVEL 2
Deficiency Photo1	
Violations	Facade A No violations recorded.
Deficiency	BRICK: DETERIORATED JOINTS

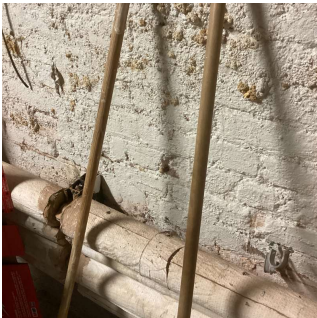
Basement - Electrical Panel Room
Violations	No violations recorded.
Deficiency	MASONRY BEARING WALL: CRACKED/SPALLED
Deficiency Location/Instance	Basement - Boiler Room, Water Meter Room, Electrical Panel Room
Deficiency Quantity	100
Quantity Uom	S.F.
Potential Action	RESTITCH
Urgency of Action	PRIORITY 3
Purpose of Action	LEVEL 5
Deficiency Photo1

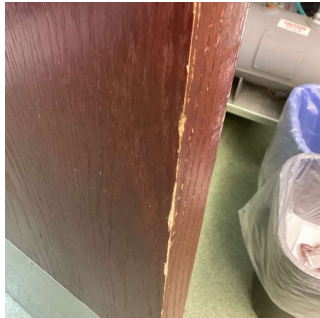
Room 303
Violations	No violations recorded.
Floor Finish	
	Inspected
Condition	2 - Between Good and Fair

Question	Response
INTERIOR	
CAFETERIA	
Floor Finish	
Instance on Basement	Inspected
Condition	2 - Between Good and Fair
Deficiency	No deficiencies recorded
Sliding-folding Partition	
Instance on Basement	Does not Exist
Stage	
Instance on Basement	Does not Exist
Walls	
Instance on Basement	Inspected
Condition	2 - Between Good and Fair
Deficiency	No deficiencies recorded
Window Curtains/Shades/Blinds	
Instance on Basement	Does not Exist
CLASSROOMS/CORRIDORS/ADMIN SPACES	
	Inspected
Ceiling	
Condition	2 - Between Good and Fair
Deficiency	No deficiencies recorded
Door(s)	
Condition	5 - Poor
Deficiency	WOOD: DETERIORATED DOOR
Deficiency Location/Instance	Rooms 209, 210, 303, 305A, 310
Deficiency Quantity	5
Quantity Uom	EACH
Potential Action	MAINTENANCE
Urgency of Action	PRIORITY 3
Purpose of Action	LEVEL 2
Deficiency Photo1

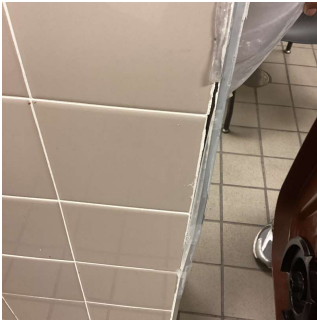
Violations	Near Room 011 No violations recorded.
LIBRARY	Inspected
Instance on Room 204	Inspected

Question	Response
INTERIOR	
INTERIOR GUARDS	
Deficiency Photo1	 
Violations	Stair A/2 No violations recorded.
KITCHEN	Inspected
Instance on Basement	Inspected
Ceiling	
Instance on Basement	Inspected
Condition	2 - Between Good and Fair
Deficiency	No deficiencies recorded
Door(s)	
Instance on Basement	Inspected
Condition	2 - Between Good and Fair
Deficiency	No deficiencies recorded
Floor Finish	
Instance on Basement	Inspected
Condition	2 - Between Good and Fair
Deficiency	No deficiencies recorded
Walls	
Instance on Basement	Inspected
Condition	2 - Between Good and Fair
Deficiency	CERAMIC TILE: BROKEN/ MISSING
Deficiency Location/Instance	Near Room 011
Deficiency Quantity	10
Quantity Uom	S.F.
Potential Action	REPLACE
Urgency of Action	PRIORITY 3
Purpose of Action	LEVEL 2
Deficiency Photo1

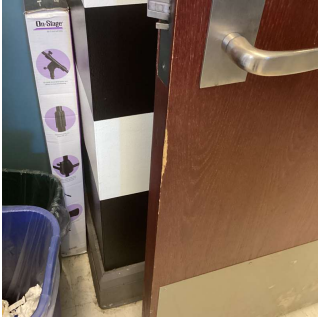
Question	Response
INTERIOR	
LIBRARY	
Built-in Furnishing	
Instance on Room 204	Does not Exist
Ceiling	
Instance on Room 204	Inspected
Condition	2 - Between Good and Fair
Deficiency	No deficiencies recorded
Door(s)	
Instance on Room 204	Inspected
Condition	3 - Fair
Deficiency	WOOD: DETERIORATED DOOR
Deficiency Location/Instance	Entrance
Deficiency Quantity	1
Quantity Uom	EACH
Potential Action	MAINTENANCE
Urgency of Action	PRIORITY 3
Purpose of Action	LEVEL 2
Deficiency Photo1

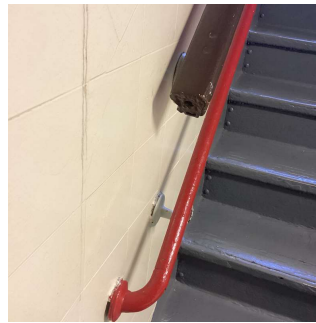
Stair B/Basement

Railings

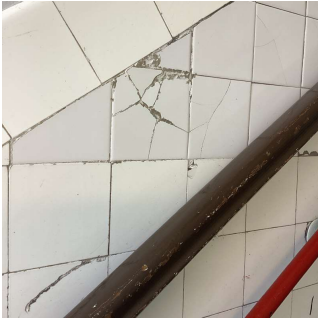
Question	Response
INTERIOR	
STAIRS/RAMPS: INTERIOR	
Stairs and Landings	Inspected
Violations	Stair B/Basement No violations recorded.
Walls	Inspected
Condition	2 - Between Good and Fair
Deficiency	CERAMIC TILE: BROKEN/ MISSING
Deficiency Location/Instance	Stairs A/3, B/Basement, 1, 2, 3, and others
Deficiency Quantity	100
Quantity Uom	S.F.
Potential Action	REPLACE
Urgency of Action	PRIORITY 3
Purpose of Action	LEVEL 2
Deficiency Photo1

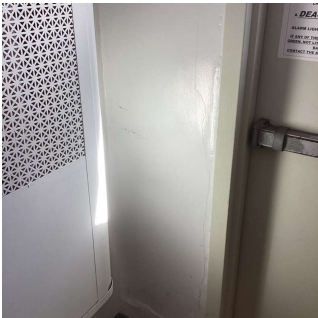
Violations	Stair B/Basement, 1 No violations recorded.
Deficiency	PLASTER: CRACKS/SPALLING
Deficiency Location/Instance	Stairs A/3, B/Basement, 1, 2, 3, and others
Deficiency Quantity	120
Quantity Uom	S.F.
Potential Action	REPLACE
Urgency of Action	PRIORITY 3
Purpose of Action	LEVEL 2
Deficiency Photo1

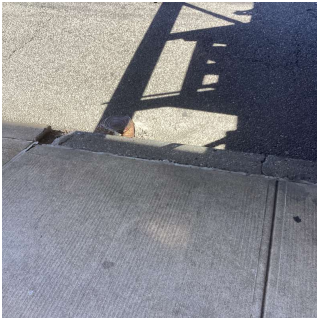
Question	Response
SITE	
PAVING	Inspected
Student Non-Use	Inspected
Gravel Exists?	No
Asphalt	Does not Exist
Concrete	Inspected
Condition	2 - Between Good and Fair
Deficiency	No deficiencies recorded
Pavers	Does not Exist
Student Use	Does not Exist
Site Sidewalks & Walkways	Inspected
Asphalt	Does not Exist
Concrete	Inspected
Condition	2 - Between Good and Fair
Deficiency	No deficiencies recorded
Pavers	Does not Exist
DOT Sidewalk	Inspected
Asphalt	Does not Exist
Concrete	Inspected
Condition	3 - Fair
Deficiency	DAMAGED/DETERIORATED/MISSING SECTIONS
Deficiency Location/Instance	91st Avenue, 188th Street
Deficiency Quantity	200
Quantity Uom	S.F.
Potential Action	REPLACE
Urgency of Action	PRIORITY 3
Purpose of Action	LEVEL 2
Deficiency Photo1	 
	188th Street
Violations	No violations recorded.
Deficiency	DAMAGED CURBS
Deficiency Location/Instance	91st Avenue, 188th Street
Deficiency Quantity	70
Quantity Uom	L.F.
Potential Action	REPLACE

Question	Response
SITE	
PAVING	
DOT Sidewalk	
Concrete	
Deficiency Photo1

Violations	188th Street
	No violations recorded.
Pavers	Does not Exist
PLAYGROUNDS	Does not Exist
PLAYING SURFACE	Does not Exist
RETAINING WALLS	Does not Exist
SEATING	Does not Exist
SITE WALLS (NOT RETAINING WALLS)	Does not Exist
STAIRS/RAMPS: EXTERIOR	Does not Exist
ARTWORK	Does not Exist
