NYC Department of Education
Building Condition Assessment Survey 2023 - 2024

Architectural Inspection

Asset: P.S. 224 ANNEX - QUEENS, 221-21 CORBETT ROAD, New York, 11361

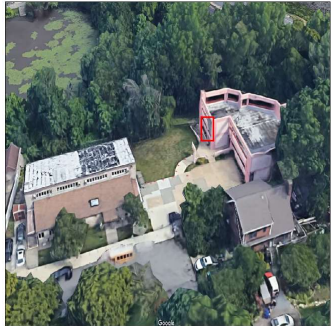
Elevation

Violations	<p>Facade D</p> <p>No violations recorded.</p>
EXTERIOR WALLS	
Material Type(s)	Masonry
Replacement Quantity	14,000
Replacement Uom	S.F.
Instance on All Facades	Inspected
Instance Condition	4 - Between Fair and Poor
Instance Quantity	14,000
Instance Quantity Uom	S.F.
Deficiency	GLASS BLOCK: CHIPPED/ BROKEN PIECES
Roof Plan reference

Deficiency Quantity	20
Quantity Uom	S.F.
Potential Action	REPLACE-IN-KIND

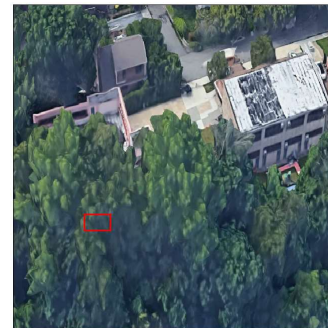
Elevation

STUCCO CEMENT SURFACE: CRACKS, SPALLING

REPLACE

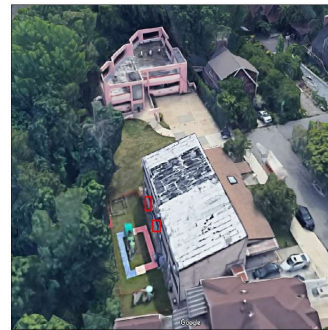
Elevation

STONE: CHIPPED/SPALLED/BROKEN PIECES - MAJOR

REPLACE

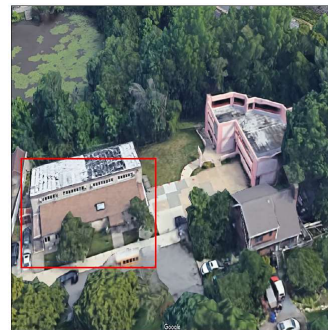
Elevation

Question	Response
EXTERIOR	
WINDOWS	
WINDOWS	
Instance Quantity	500
Instance Quantity Uom	S.F.
Are these windows insulated	Yes
Installation Year	2012
Source of Installation	Custodial Staff
Deficiency	No deficiencies recorded
Instance on Wood: West Building	Inspected
Instance Condition	5 - Poor
Instance Quantity	900
Instance Quantity Uom	S.F.
Are these windows insulated	No
Installation Year	1986
Source of Installation	Custodial Staff
Deficiency	WOOD: DETERIORATED

400
S.F.
REPLACE WINDOW
PRIORITY 4
LEVEL 2

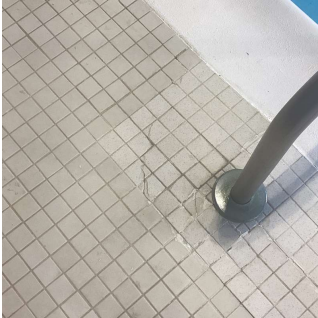
Question	Response
EXTERIOR	Inspected
WINDOWS	Inspected
WINDOWS	
Violations	Facade D - Room 279 No violations recorded.
INTERIOR	Inspected
POOLS	Inspected
Instance on East Building - Basement	Inspected
CEILING	
Instance on East Building - Basement	Does not Exist
DECK/FLOOR	
Instance on East Building - Basement	Inspected
Condition	3 - Fair
Deficiency	CERAMIC TILES: BROKEN/MISSING/WORN TILES
Deficiency Location/Instance	Pool Area
Deficiency Quantity	20
Quantity Uom	S.F.
Potential Action	REPLACE
Urgency of Action	PRIORITY 4
Purpose of Action	LEVEL 2
Deficiency Photo1

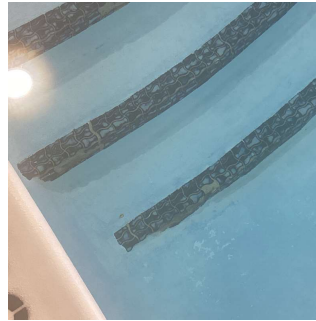
Violations	Pool Area No violations recorded.
DIVING BOARD/PLATFORM	
Instance on East Building - Basement	Does not Exist
POOL LINING	
Instance on East Building - Basement	Inspected
Condition	3 - Fair
Deficiency	TILE: BROKEN/MISSING/WORN TILES
Deficiency Location/Instance	Large Pool
Deficiency Quantity	20
Quantity Uom	S.F.
Potential Action	REPLACE
Urgency of Action	PRIORITY 4

POOL LINING

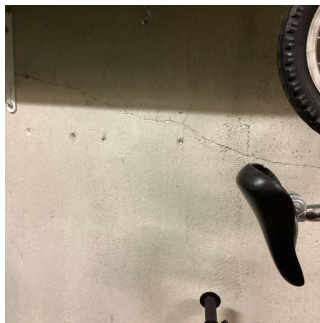
Violations	Pool Area No violations recorded.
STRUCTURAL	
COLUMNS/BEAMS/BEARING WALLS	
Condition	Inspected
Deficiency	2 - Between Good and Fair
Deficiency	No deficiencies recorded
FLOOR STRUCTURE	
Condition	Inspected
Deficiency	3 - Fair
Deficiency Location/Instance	METAL DECK AND CONCRETE: DETERIORATED Basement - West Building Electrical Panel Room
Deficiency Quantity	30
Quantity Uom	S.F.
Potential Action	REPAIR
Urgency of Action	PRIORITY 4
Purpose of Action	LEVEL 5
Deficiency Photo1	 
Violations	Electrical Panel Room No violations recorded.
FOUNDATION WALLS	
Material Type(s)	Inspected
Condition	Concrete
Condition	3 - Fair
Deficiency	CONCRETE: CRACKED/SPALLED/REINFORCEMENT EXPOSED
Deficiency Location/Instance	Basement - West Building
Deficiency Quantity	50
Quantity Uom	S.F.
Potential Action	REPAIR
Urgency of Action	PRIORITY 3
Purpose of Action	LEVEL 5

Question	Response
INTERIOR	
STRUCTURAL	
FOUNDATION WALLS	
Deficiency Photo1

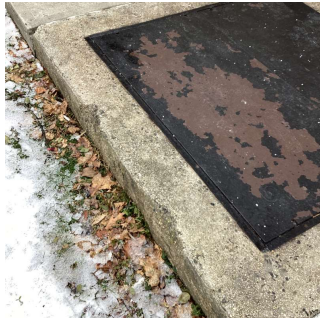
Violations	West Building No violations recorded.
ROOF STRUCTURE	
Condition	Inspected
Deficiency	2 - Between Good and Fair
VAULTS-BUNKERS	
Condition	Inspected
Deficiency	No deficiencies recorded
FOUNDATION WALLS	
Condition	Inaccessible
SLAB STRUCTURE	
Condition	Inspected
Deficiency	2 - Between Good and Fair
Deficiency Location/Instance	CONCRETE: CRACKS/SPALLED/REINFORCEMENT EXPOSED
Deficiency Quantity	Facade A
Quantity Uom	20
Potential Action	S.F.
Urgency of Action	REPAIR
Purpose of Action	PRIORITY 3
Deficiency Photo1	LEVEL 5
Violations

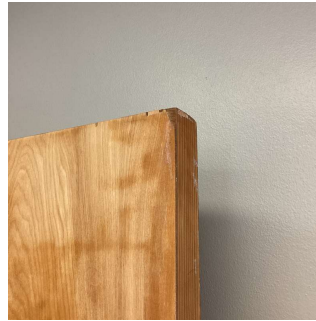
Room 270
Violations	No violations recorded.
Door(s)	Inspected
Condition	5 - Poor
Deficiency	WOOD: DETERIORATED DOOR
Deficiency Location/Instance	Rooms 270, E, F, G
Deficiency Quantity	4
Quantity Uom	EACH
Potential Action	MAINTENANCE
Urgency of Action	PRIORITY 3
Purpose of Action	LEVEL 2

Door(s)

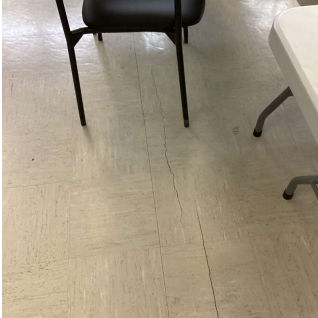
Question	Response
INTERIOR	
MULTI-PURPOSE ROOM	
Floor Finish	
Quantity Uom	S.F.
Potential Action	REPLACE
Urgency of Action	PRIORITY 3
Purpose of Action	LEVEL 2
Deficiency Photo1

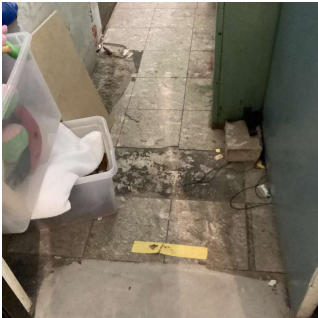
Violations	Center No violations recorded.
Deficiency	VINYL TILES: BROKEN/DETERIORATED/MISSING TILES
Deficiency Location/Instance	Near Exits 7, 10, Storage Room
Deficiency Quantity	60
Quantity Uom	S.F.
Potential Action	REPLACE
Urgency of Action	PRIORITY 3
Purpose of Action	LEVEL 2
Deficiency Photo1

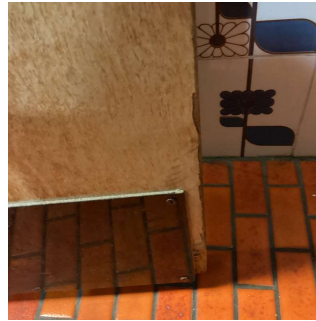
Inside Room A

Door(s)
