NYC Department of Education
Building Condition Assessment Survey 2023 - 2024

Architectural Inspection

Q823

Asset: REGION 5 SUPERINTENDENT - QUEENS, 82-01 ROCKAWAY BLVD, New York, 11416

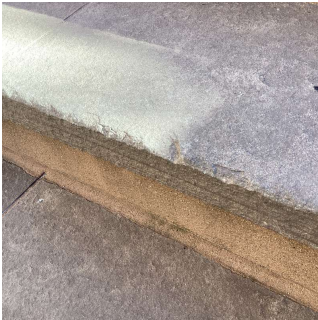
Violations	Facade A No violations recorded.
RAILINGS	Inspected
Condition	2 - Between Good and Fair
Deficiency	No deficiencies recorded
STAIRS/RAMPS	Inspected
Condition	3 - Fair
Deficiency	STONE: WORN-OUT TREAD/RISER/NOSING
Roof Plan reference	Q823
Deficiency Quantity	10
Quantity Uom	S.F.
Potential Action	REPLACE
Urgency of Action	PRIORITY 4
Purpose of Action	LEVEL 2
Deficiency Photo1

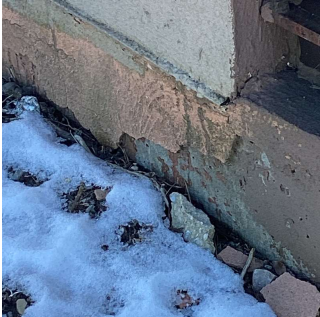
Question	Response
INTERIOR	
STRUCTURAL	Inspected
COLUMNS/BEAMS/BEARING WALLS	Inspected
Condition	2 - Between Good and Fair
Deficiency	No deficiencies recorded
FLOOR STRUCTURE	Inspected
Condition	2 - Between Good and Fair
Deficiency	No deficiencies recorded
FOUNDATION WALLS	Inspected
Material Type(s)	Concrete
Condition	3 - Fair
Deficiency	CONCRETE: CRACKED/SPALLED/REINFORCEMENT EXPOSED
Deficiency Location/Instance	Facade C
Deficiency Quantity	30
Quantity Uom	S.F.
Potential Action	REPAIR
Urgency of Action	PRIORITY 3
Purpose of Action	LEVEL 5
Deficiency Photo1

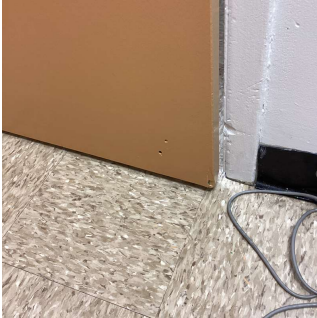
Question	Response
INTERIOR	
CLASSROOMS/CORRIDORS/ADMIN SPACES	
Door(s)	Inspected
Condition	5 - Poor
Deficiency	WOOD: DETERIORATED DOOR
Deficiency Location/Instance	Room 420A
Deficiency Quantity	1
Quantity Uom	EACH
Potential Action	MAINTENANCE
Urgency of Action	PRIORITY 3
Purpose of Action	LEVEL 2
Deficiency Photo1

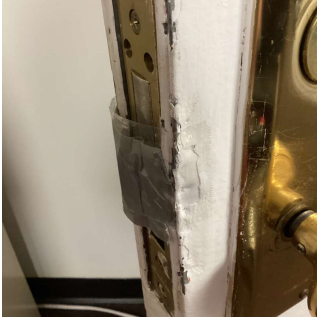
Violations	Room 420A No violations recorded.
Deficiency	METAL: DETERIORATED DOOR
Deficiency Location/Instance	Rooms 101, 206, 304, 308
Deficiency Quantity	4
Quantity Uom	EACH
Potential Action	MAINTENANCE
Urgency of Action	PRIORITY 3
Purpose of Action	LEVEL 2
Deficiency Photo1

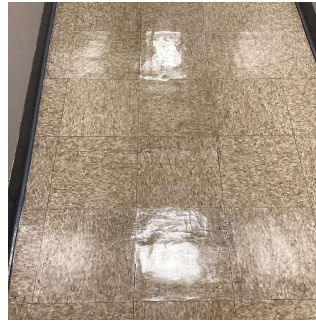
Corridor near Room 202

Violations	Room 304 No violations recorded.
Floor Finish	Inspected
Condition	2 - Between Good and Fair
Deficiency	VINYL TILES: DETERIORATED SUBSTRATE
Deficiency Location/Instance	Corridor near Rooms 202, 206
Deficiency Quantity	120
Quantity Uom	S.F.
Potential Action	REPLACE
Urgency of Action	PRIORITY 3
Purpose of Action	LEVEL 2

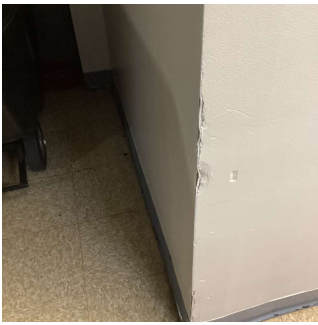
Question	Response
INTERIOR	
CLASSROOMS/CORRIDORS/ADMIN SPACES	
Walls	
Deficiency Photo1

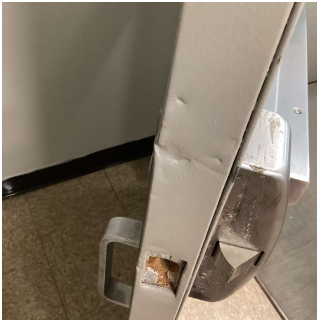
Question	Response
INTERIOR	
STAIRS/RAMPS: INTERIOR	
Door(s)	
Deficiency Photo1

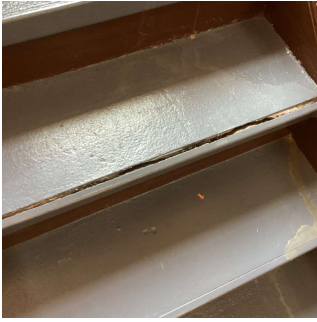
Violations	Stair A/4 No violations recorded.
Partition	Does not Exist
Railings	Inspected
Condition	2 - Between Good and Fair
Deficiency	No deficiencies recorded
Stairs and Landings	Inspected
Condition	2 - Between Good and Fair
Deficiency	CONCRETE: WORN-OUT TREAD/NOSINGS
Deficiency Location/Instance	Stair B/3
Deficiency Quantity	10
Quantity Uom	S.F.
Potential Action	REPLACE
Urgency of Action	PRIORITY 3
Purpose of Action	LEVEL 2
Deficiency Photo1

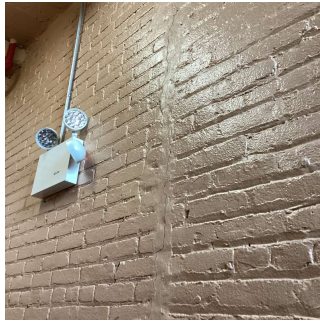
Violations	Stair B/3 No violations recorded.
Walls	Inspected
Condition	2 - Between Good and Fair
Deficiency	BRICK: CRACKS/SPALLING
Deficiency Location/Instance	Stair B/2
Deficiency Quantity	20
Quantity Uom	S.F.
Potential Action	REPLACE
Urgency of Action	PRIORITY 3
Purpose of Action	LEVEL 2

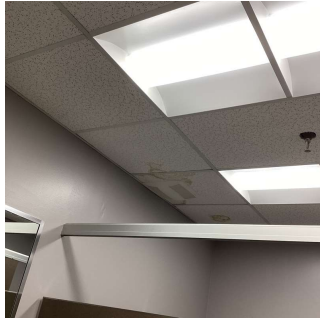
Violations	Stair B/2 No violations recorded.
TOILET ROOMS - STAFF	
Ceiling	Inspected
Condition	3 - Fair
Deficiency	ACOUSTIC TILES: DAMAGED/MISSING - ACTIVE LEAK
Deficiency Location/Instance	Women 2nd Floor
Deficiency Quantity	10
Quantity Uom	S.F.
Potential Action	REPLACE
Urgency of Action	PRIORITY 5
Purpose of Action	LEVEL 2
Deficiency Photo1

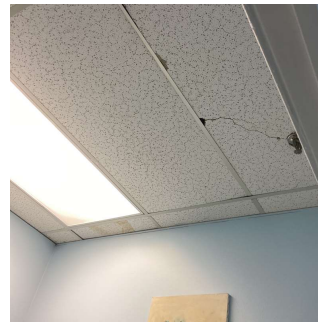
Room 460B

Violations	Women 2nd Floor No violations recorded.
Deficiency	ACOUSTIC TILES: DAMAGED/MISSING
Deficiency Location/Instance	Rooms 160A, 460B
Deficiency Quantity	20
Quantity Uom	S.F.
Potential Action	REPLACE
Urgency of Action	PRIORITY 3
Purpose of Action	LEVEL 2

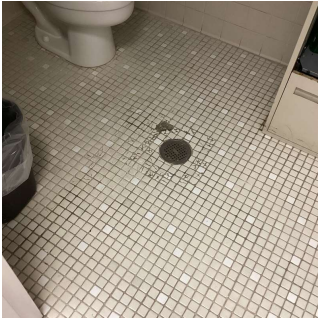
Question	Response
INTERIOR	
TOILET ROOMS - STAFF	
Door(s)	Inspected
	Room 160B
Violations	No violations recorded.
Floor Finish	Inspected
Condition	3 - Fair
Deficiency	CERAMIC TILE: BROKEN/MISSING TILES
Deficiency Location/Instance	Rooms 160B, 204, 302A, 302B
Deficiency Quantity	40
Quantity Uom	S.F.
Potential Action	REPLACE
Urgency of Action	PRIORITY 3
Purpose of Action	LEVEL 2
Deficiency Photo1

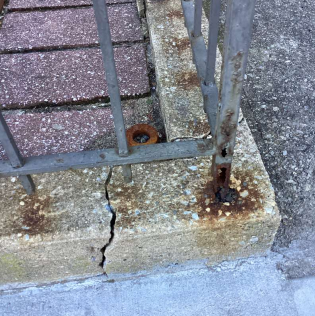
Deficiency	No deficiencies recorded
Culverts - Concrete Covering	Does not Exist
Drainage System for Soil	Does not Exist
DRINKING FOUNTAINS	Does not Exist
FENCES	Inspected
Condition	4 - Between Fair and Poor
Deficiency	WROUGHT IRON: DAMAGED/DETERIORATED
Deficiency Location/Instance	Rockaway Boulevard, 83rd Street

Question	Response
SITE	
FENCES	
Deficiency Quantity	80
Quantity Uom	S.F.
Potential Action	REPLACE
Urgency of Action	PRIORITY 3
Purpose of Action	LEVEL 2
Deficiency Photo1	 
Violations	Rockaway Boulevard No violations recorded.
Deficiency	CHAIN LINK: RUST - MAJOR
Deficiency Location/Instance	83rd Street
Deficiency Quantity	400
Quantity Uom	S.F.
Potential Action	REPLACE
Urgency of Action	PRIORITY 3
Purpose of Action	LEVEL 2
Deficiency Photo1	 
Violations	83rd Street No violations recorded.
Deficiency	WROUGHT IRON: RUST - MAJOR
Deficiency Location/Instance	83rd Street, Rockaway Boulevard
Deficiency Quantity	160
Quantity Uom	S.F.
Potential Action	REPLACE
Urgency of Action	PRIORITY 3
Purpose of Action	LEVEL 2

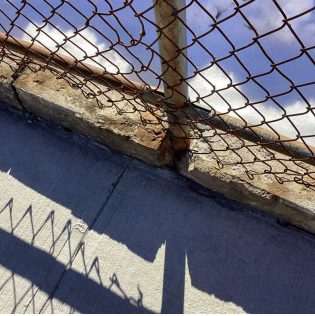
Violations	83rd Street No violations recorded.
Deficiency	CONCRETE CURB: DAMAGED/DETERIORATED
Deficiency Location/Instance	82nd Street, 83rd Street, 95th Avenue, Rockaway Boulevard
Deficiency Quantity	150
Quantity Uom	S.F.
Potential Action	REPLACE
Urgency of Action	PRIORITY 3
Purpose of Action	LEVEL 2
Deficiency Photo1

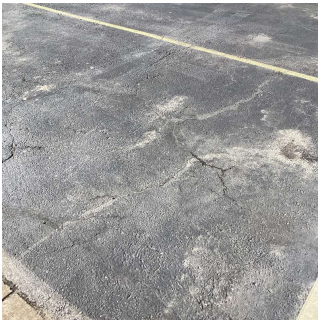
Question	Response
SITE	
IRRIGATION SYSTEM	Does not Exist
PAVING	Inspected
Student Non-Use	Inspected
Gravel Exists?	Yes
Asphalt	Inspected
Condition	4 - Between Fair and Poor
Deficiency	CRACKS - MAJOR
Deficiency Location/Instance	Near Main Entrance , Center, 82nd Street
Deficiency Quantity	3,000
Quantity Uom	S.F.
Potential Action	REPLACE
Urgency of Action	PRIORITY 3
Purpose of Action	LEVEL 2
Deficiency Photo1

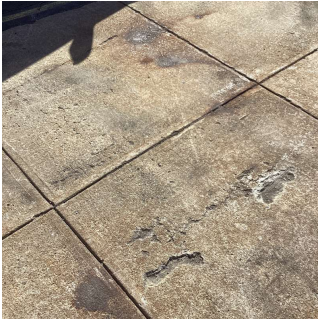
Violations	Near Main Entrance No violations recorded.
Concrete	Inspected
Condition	3 - Fair
Deficiency	DAMAGED/DETERIORATED/MISSING SECTIONS
Deficiency Location/Instance	Near Main Entrance
Deficiency Quantity	100
Quantity Uom	S.F.
Potential Action	REPLACE
Urgency of Action	PRIORITY 3
Purpose of Action	LEVEL 2
Deficiency Photo1

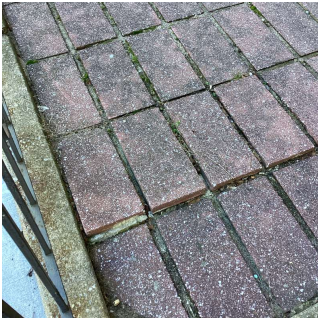
Violations	Near Main Entrance No violations recorded.
Pavers	Inspected
Condition	2 - Between Good and Fair
Deficiency	HEAVING
Deficiency Location/Instance	83rd Street
Deficiency Quantity	10

Question	Response
SITE	
PAVING	Inspected
Student Non-Use	
Pavers	
Quantity Uom	S.F.
Potential Action	REPLACE
Urgency of Action	PRIORITY 3
Purpose of Action	LEVEL 2
Deficiency Photo1

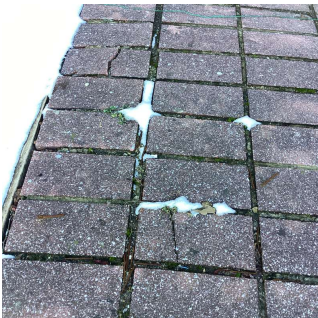
83rd Street
Violations	No violations recorded.
Deficiency	DAMAGED/MISSING
Deficiency Location/Instance	83rd Street
Deficiency Quantity	10
Quantity Uom	S.F.
Potential Action	REPLACE
Urgency of Action	PRIORITY 3
Purpose of Action	LEVEL 2
Deficiency Photo1

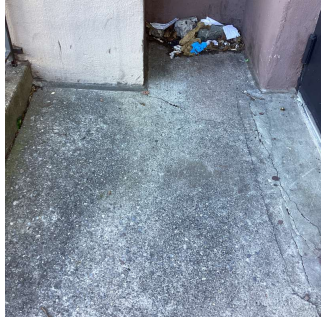
83rd Street
Violations	No violations recorded.
Student Use	Does not Exist
Site Sidewalks & Walkways	Inspected
Asphalt	Does not Exist
Concrete	Inspected
Condition	2 - Between Good and Fair
Deficiency	DAMAGED/DETERIORATED/MISSING SECTIONS
Deficiency Location/Instance	Near 83rd Street
Deficiency Quantity	25
Quantity Uom	S.F.
Potential Action	REPLACE
Urgency of Action	PRIORITY 3
Purpose of Action	LEVEL 2

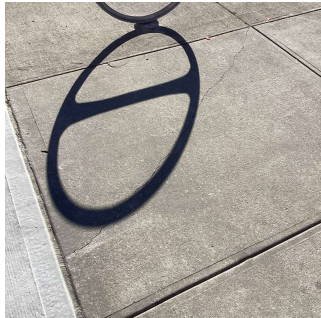
Violations	Near 83rd Street No violations recorded.
Pavers	Does not Exist
DOT Sidewalk	Inspected
Asphalt	Does not Exist
Concrete	Inspected
Condition	3 - Fair
Deficiency	DAMAGED/DETERIORATED/MISSING SECTIONS
Deficiency Location/Instance	83rd Street, 95th street, Rockaway Boulevard
Deficiency Quantity	350
Quantity Uom	S.F.
Potential Action	REPLACE
Urgency of Action	PRIORITY 3
Purpose of Action	LEVEL 2
Deficiency Photo1
