NYC Department of Education
Building Condition Assessment Survey 2023 - 2024

Architectural Inspection

Q834

Asset: P.S. 34 MINISCHOOL - QUEENS, 104-12 SPRINGFIELD BLVD, New York, 11428

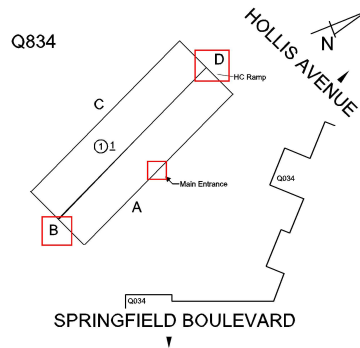
Question	Response
Architectural	
EXTERIOR	Inspected
AREAWAY	Does not Exist
AWNINGS AND CANOPIES	Does not Exist
CHIMNEY	Does not Exist
COPING	Does not Exist
CORNICE	Does not Exist
DOORS	Inspected
DOORS AND FRAMES	Inspected
Condition	5 - Poor
Deficiency	METAL CLAD; DETERIORATED DOOR AND FRAME - MAJOR DETERIORATION

6
EACH
REPLACE
PRIORITY 4
LEVEL 2

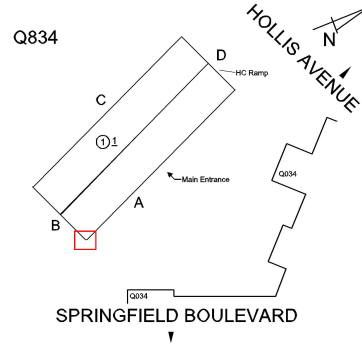
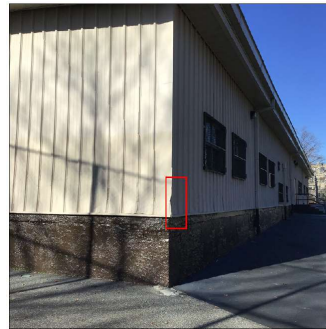
EXTERIOR WALLS

METAL PANEL: DAMAGED TRIM

Deficiency Quantity

10

REPLACE

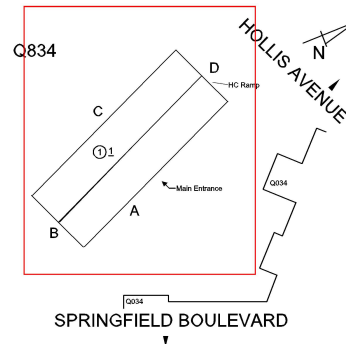
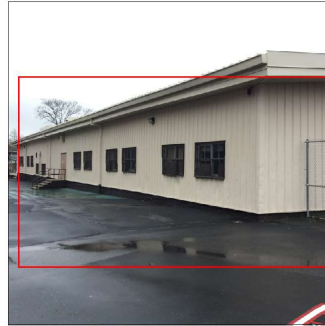
EXTERIOR WALLS

METAL PANEL: SEVERE DENTS

Deficiency Quantity

2,000

REPLACE

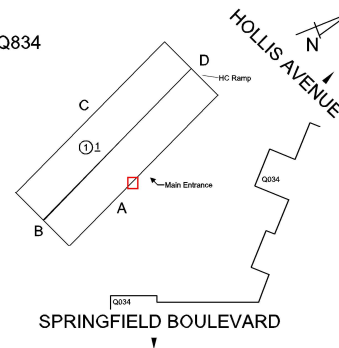
BROKEN/ DENTED BLADES

Question	Response
EXTERIOR	
LOUVER	
Elevation	 
Deficiency Quantity	10
Quantity Uom	S.F.
Potential Action	REPLACE
Urgency of Action	PRIORITY 4
Purpose of Action	LEVEL 2
Deficiency Photo1	 
Violations	Facade A No violations recorded.
PARAPETS	Does not Exist
PLAZA DECK	Does not Exist
ROOF	Inspected
Roofing	Inspected
Replacement Quantity	11,500
Replacement Uom	S.F.
ROOF HATCH/SMOKE HATCH	Does not Exist
LEADERS, GUTTERS, DOWNSPOUTS, SCUPPERS	Inspected
Condition	3 - Fair
Deficiency	DAMAGED/MISSING
Roof Plan reference	 
Deficiency Quantity	20
Quantity Uom	L.F.

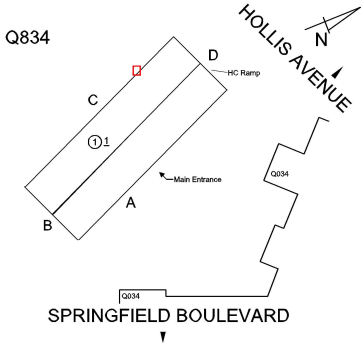
Violations	Facade C No violations recorded.
Deficiency	CLOGGED
Roof Plan reference

Deficiency Quantity	1
Quantity Uom	EACH
Potential Action	MAINTENANCE
Urgency of Action	PRIORITY 5
Purpose of Action	LEVEL 2
Deficiency Photo1

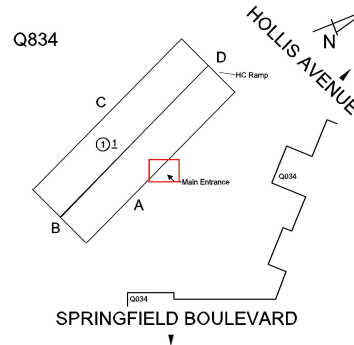
Condition	3 - Fair
Deficiency	RUST - MAJOR

Deficiency Quantity	10
Quantity Uom	L.F.
Potential Action	REPLACE
Urgency of Action	PRIORITY 4
Purpose of Action	LEVEL 2

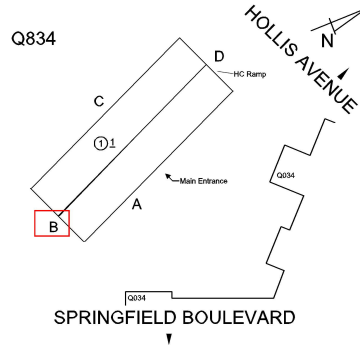
CONCRETE: CRACKS/SPALLING - MINOR

Deficiency Quantity

10

REPAIR

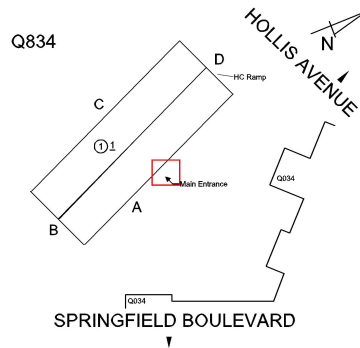
STAIRS/RAMPS

CONCRETE: WORN-OUT TREAD/RISER/NOSING

10
 S.F.
 REPLACE
 PRIORITY 4
 LEVEL 2

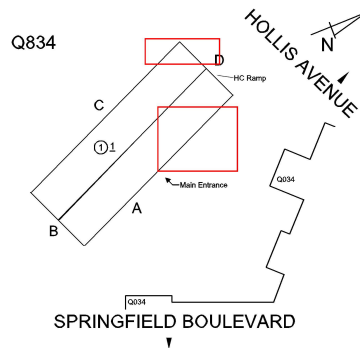
DETERIORATED/TORN-OUT/MISSING

Question	Response
EXTERIOR	
WINDOWS	
EXTERIOR GUARDS	
Elevation	 
Deficiency Quantity	200
Quantity Uom	S.F.
Potential Action	REPLACE
Urgency of Action	PRIORITY 4
Purpose of Action	LEVEL 2
Deficiency Photo1	 
Violations	Facade A No violations recorded.
LINTELS	Does not Exist
WINDOWS	Inspected
Material Type(s)	Aluminum
Instance on Aluminum - Double Hung: Facades A, C	Inspected
Instance Condition	3 - Fair
Instance Quantity	850
Instance Quantity Uom	S.F.
Are these windows insulated	No
Installation Year	1971
Source of Installation	Custodial Staff
Deficiency	No deficiencies recorded
INTERIOR	Inspected
POOLS	Does not Exist
STRUCTURAL	Inspected
COLUMNS/BEAMS/BEARING WALLS	Inspected
Condition	2 - Between Good and Fair
Deficiency	No deficiencies recorded
FLOOR STRUCTURE	Inspected
Condition	2 - Between Good and Fair
Deficiency	No deficiencies recorded
FOUNDATION WALLS	Inspected
