NYC Department of Education
Building Condition Assessment Survey 2023 - 2024

Architectural Inspection

Q848

Asset: P.S. 81 ANNEX (OLD 75) - QUEENS, 511 SENECA AVENUE, New York, 11385

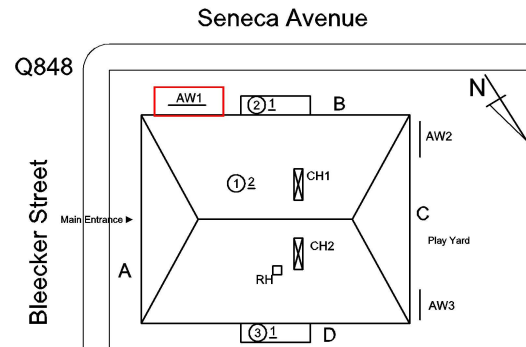
Deficiency

AREAWAY STAIRS: DETERIORATED TREADS/RISERS/NOSINGS

REPAIR

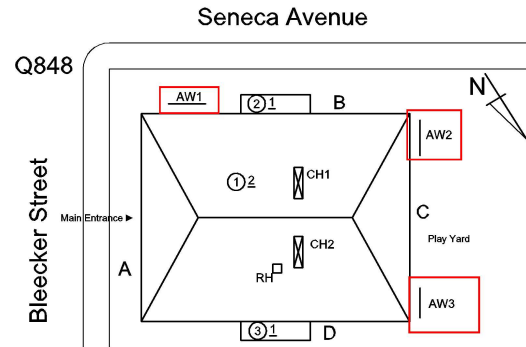
AREAWAY WALLS: CRACKS AND SPALLING

AREAWAY

30
S.F.
REPAIR
PRIORITY 3
LEVEL 2

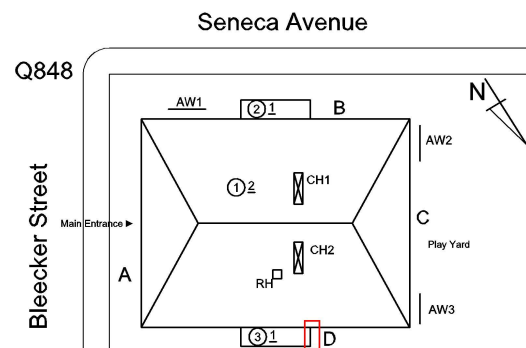
METAL: DETERIORATED DOOR AND FRAME - MAJOR DETERIORATION

Quantity Uom	EACH
Potential Action	REPLACE
Urgency of Action	PRIORITY 4
Purpose of Action	LEVEL 2
Deficiency Photo1

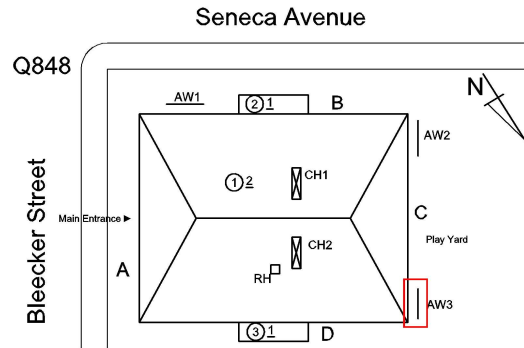
Deficiency	METAL: DETERIORATED DOOR AND FRAME - MINOR DETERIORATION
------------	--

Deficiency Quantity	1
Quantity Uom	EACH
Potential Action	MAINTENANCE
Urgency of Action	PRIORITY 3
Purpose of Action	LEVEL 2
Deficiency Photo1

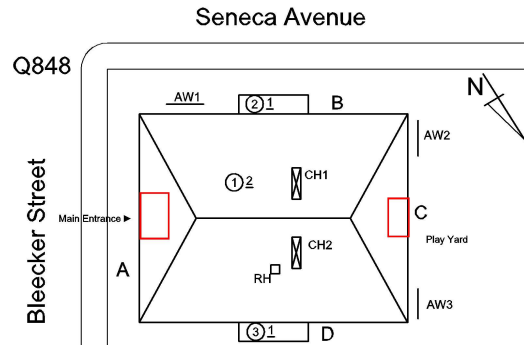
Deficiency	No deficiencies recorded
ROOFING DRAINS	Does not Exist
Specialties	Inspected
BULKHEAD/PENTHOUSE	Does not Exist
CUPOLA/ SPIRES/ TOWERS	Does not Exist
DORMER	Inspected
Condition	3 - Fair
Deficiency	DAMAGED COVERING

20
S.F.
REPAIR COVERING
PRIORITY 4
LEVEL 2

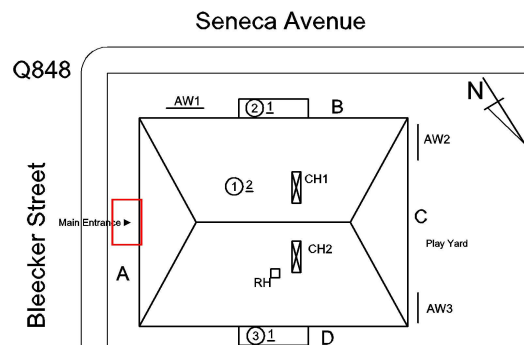
STONE: CRACKS/SPALLING - MINOR

10
S.F.
REPAIR

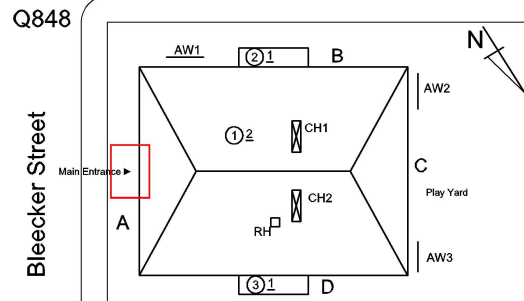
Seneca Avenue

STONE: DETERIORATED JOINTS

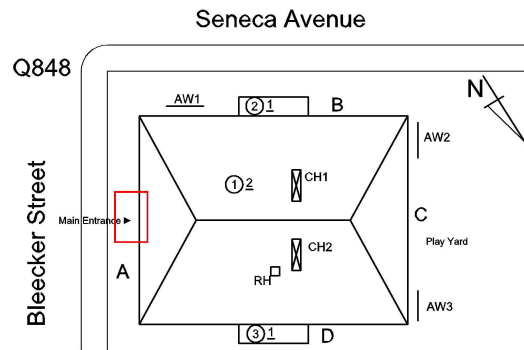
CONCRETE: WORN-OUT TREAD/RISER/NOSING

STAIRS/RAMPS

10
S.F.
REPLACE
PRIORITY 4
LEVEL 2

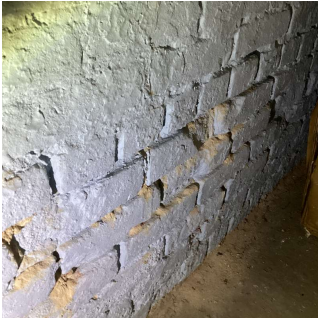
Question	Response
INTERIOR	
STRUCTURAL	
FLOOR STRUCTURE	Inspected
Violations	Attic No violations recorded.
FOUNDATION WALLS	Inspected
Material Type(s)	Masonry
Condition	4 - Between Fair and Poor
Deficiency	BRICK: DETERIORATED JOINTS
Deficiency Location/Instance	Basement - Electrical Panel Room, Oil Tank Room, Storage
Deficiency Quantity	100
Quantity Uom	S.F.
Potential Action	REPOINT
Urgency of Action	PRIORITY 4
Purpose of Action	LEVEL 5
Deficiency Photo1

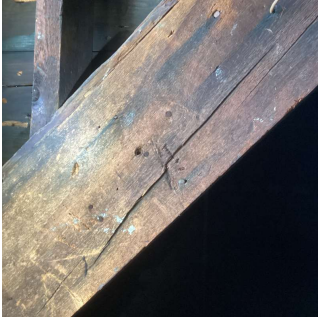
Violations	Basement - Electrical Panel Room No violations recorded.
ROOF STRUCTURE	Inspected
Condition	3 - Fair
Deficiency	WOOD COLUMNS AND BEAMS: DETERIORATED
Deficiency Location/Instance	Attic
Deficiency Quantity	50
Quantity Uom	S.F.
Potential Action	REPAIR
Urgency of Action	PRIORITY 3
Purpose of Action	LEVEL 5
Deficiency Photo1

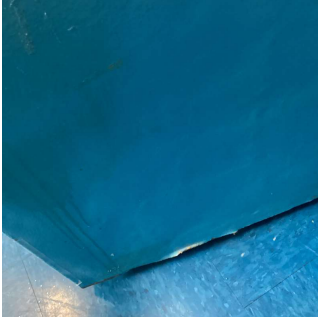
Room 102A
Violations	No violations recorded.
Deficiency	METAL CLAD WOOD: DETERIORATED DOOR

Question	Response
INTERIOR	
CLASSROOMS/CORRIDORS/ADMIN SPACES	
Door(s)	
Deficiency Location/Instance	Room 104A
Deficiency Quantity	1
Quantity Uom	EACH
Potential Action	MAINTENANCE
Urgency of Action	PRIORITY 3
Purpose of Action	LEVEL 2
Deficiency Photo1

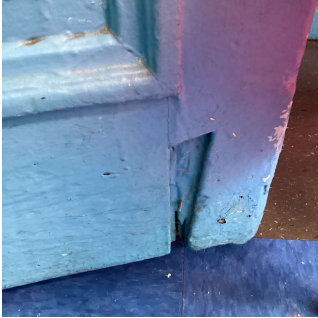
Violations	Room 104A No violations recorded.
Deficiency	WOOD: DETERIORATED DOOR
Deficiency Location/Instance	Room 250, Main Entrance
Deficiency Quantity	3
Quantity Uom	EACH
Potential Action	MAINTENANCE
Urgency of Action	PRIORITY 3
Purpose of Action	LEVEL 2
Deficiency Photo1

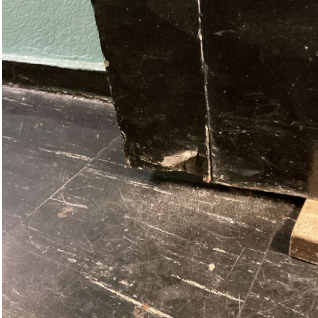
Question	Response
INTERIOR	
KITCHEN	Inspected
Walls	
Instance on Basement	Not Required
LIBRARY	Does not Exist
LOCKER ROOM	Does not Exist
MULTI-PURPOSE ROOM	Does not Exist
SCIENCE DEMO ROOM	Does not Exist
SCIENCE LAB	Does not Exist
SCIENCE PREP ROOM	Does not Exist
SHOWER ROOM	Does not Exist
STAIRS/RAMPS: INTERIOR	Inspected
Do Letter Stair Signs Exist?	Yes
Ceiling	Inspected
Condition	2 - Between Good and Fair
Deficiency	No deficiencies recorded
Door(s)	Inspected
Condition	5 - Poor
Deficiency	METAL CLAD WOOD: DETERIORATED DOOR
Deficiency Location/Instance	Stair B/1
Deficiency Quantity	2
Quantity Uom	EACH
Potential Action	MAINTENANCE
Urgency of Action	PRIORITY 3
Purpose of Action	LEVEL 2
Deficiency Photo1

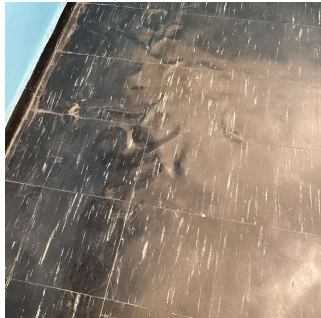
Question	Response
INTERIOR	
STAIRS/RAMPS: INTERIOR	
Stairs and Landings	
Violations	Stair B/Basement No violations recorded.
Deficiency	VINYL TILES: BROKEN/DETERIORATED/MISSING TILES
Deficiency Location/Instance	Stair B/1
Deficiency Quantity	50
Quantity Uom	S.F.
Potential Action	REPLACE
Urgency of Action	PRIORITY 3
Purpose of Action	LEVEL 2
Deficiency Photo1

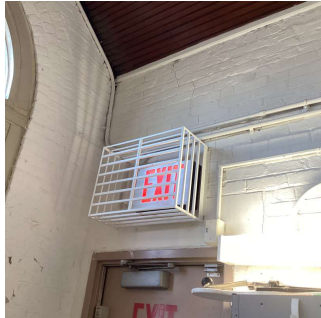
Violations	Stair B/1 No violations recorded.
Walls	Inspected
Condition	2 - Between Good and Fair
Deficiency	BRICK: CRACKS/SPALLING
Deficiency Location/Instance	Stair B/1
Deficiency Quantity	10
Quantity Uom	S.F.
Potential Action	REPLACE
Urgency of Action	PRIORITY 3
Purpose of Action	LEVEL 2
Deficiency Photo1

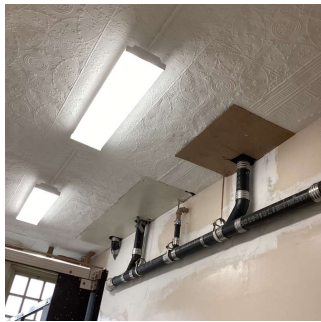
Violations	Room 250 No violations recorded.
TOILET ROOMS - STUDENTS	Inspected
Ceiling	Inspected
Condition	3 - Fair
Deficiency	PLASTER: CRACKS/SPALLING
Deficiency Location/Instance	Room 105A
Deficiency Quantity	20
Quantity Uom	S.F.
Potential Action	REPLACE
Urgency of Action	PRIORITY 3
Purpose of Action	LEVEL 2
Deficiency Photo1

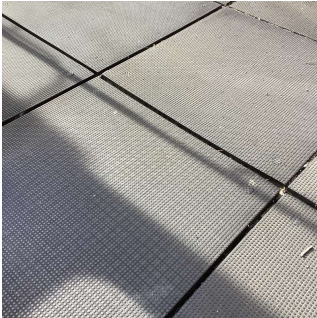
Question	Response
SITE	
PLAYGROUNDS	
Play Equipment	
Deficiency	No deficiencies recorded
Safety Surfacing	
Instance on Rear of the Building	Inspected
Condition	3 - Fair
Deficiency	DETERIORATED/MISSING
Deficiency Location/Instance	Around Play Equipment
Deficiency Quantity	70
Quantity Uom	S.F.
Potential Action	REPLACE
Urgency of Action	PRIORITY 3
Purpose of Action	LEVEL 2
Deficiency Photo1

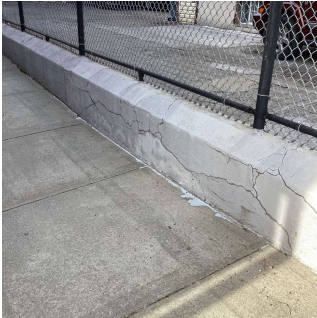
Violations	Around play equipment No violations recorded.
Unpaved Area	
Instance on Rear of the Building	Does not Exist
PLAYING SURFACE	
Does not Exist	
RETAINING WALLS	
Inspected	
Are there any Retaining Walls 6' OR higher facing public street/sidewalk?	No
Condition	3 - Fair
Deficiency	CAST IN PLACE CONCRETE: CRACKS/SPALLING - MAJOR
Deficiency Location/Instance	Near Exits 1, 2
Deficiency Quantity	50
Quantity Uom	S.F.
Potential Action	REPLACE
Urgency of Action	PRIORITY 3
Purpose of Action	LEVEL 2
Deficiency Photo1
