**NYC Department of Education**  
**Building Condition Assessment Survey 2023 - 2024**

Architectural Inspection

**Asset:** I.S. 77 - QUEENS, 976 SENECA AVENUE, New York, 11385

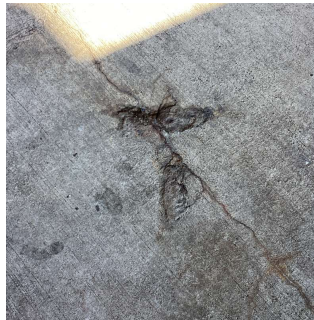
Facade F

Instance Quantity Uom	S.F.
<b>EXTERIOR SOFFITS</b>	
Condition	Inspected
Deficiency	2 - Between Good and Fair
Deficiency	No deficiencies recorded
<b>LOADING DOCK</b>	
Condition	Inspected
Deficiency	3 - Fair
Deficiency	DETERIORATED CONCRETE PLATFORM WITH CRACKED, SPALLED CONCRETE OR EXPOSED REINFORCING

10  
S.F.  
REPAIR  
PRIORITY 3  
LEVEL 2

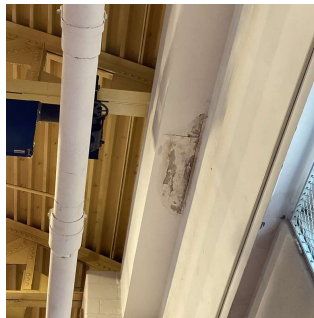
Roof 6 - Gymnasium

Installation Year	2003
Source of Installation	Custodial Staff
Deficiency	METAL: ROOFING: MAJOR ACTIVE ROOF LEAKS IN INSTRUCTIONAL SPACE

100  
S.F.  
REPLACE  
PRIORITY 5  
LEVEL 2

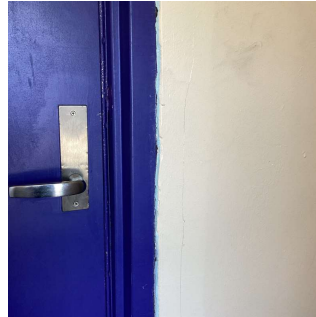
BH

**BULKHEAD/PENTHOUSE WALLS/INTERIOR: PLASTER  
CRACKS/SPALLING**

Deficiency Quantity	25
Quantity Uom	S.F.
Potential Action	REPLACE
Urgency of Action	PRIORITY 3
Purpose of Action	LEVEL 2
Deficiency Photo1

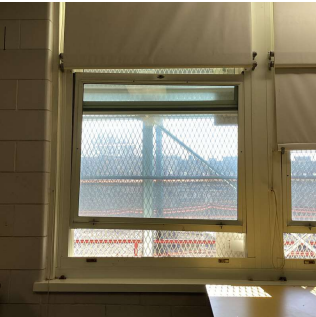
Question	Response
<b>EXTERIOR</b>	
<b>WINDOWS</b>	
<b>WINDOWS</b>	Inspected
Material Type(s)	Aluminum
Instance on Aluminum - Double Hung: 2003 Addition	Inspected
Instance Condition	3 - Fair
Instance Quantity	4,000
Instance Quantity Uom	S.F.
Are these windows insulated	No
Installation Year	2003
Source of Installation	Custodial Staff
Deficiency	ALUMINUM - DOUBLE HUNG: INOPERABLE BALANCE
Roof Plan reference

Deficiency Quantity	20
Quantity Uom	EACH
Potential Action	REPLACE BALANCES
Urgency of Action	PRIORITY 3
Purpose of Action	LEVEL 2
Deficiency Photo1

Violations	Facade E - Cafeteria (similar throughout) No violations recorded.
Instance on Aluminum - Double Hung: Original Building	Inspected
Instance Condition	3 - Fair
Instance Quantity	14,000

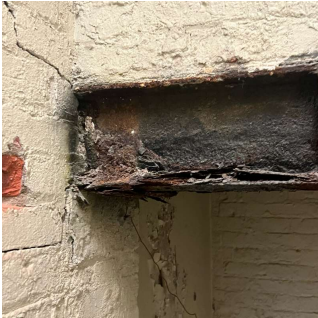
Deficiency Quantity	20
Quantity Uom	EACH
Potential Action	REPLACE BALANCES
Urgency of Action	PRIORITY 3
Purpose of Action	LEVEL 2
Deficiency Photo1	 
Violations	Facade A - Library (similar throughout) No violations recorded.
<b>INTERIOR</b>	
<b>POOLS</b>	
Does not Exist	
<b>STRUCTURAL</b>	
<b>COLUMNS/BEAMS/BEARING WALLS</b>	
Inspected	
Condition	3 - Fair
Deficiency	STEEL COLUMNS/BEAMS: MAJOR RUSTING
Deficiency Location/Instance	Basement - Stairs to Exit 17

Question	Response
<b>INTERIOR</b>	
<b>STRUCTURAL</b>	
<b>COLUMNS/BEAMS/BEARING WALLS</b>	
Deficiency Quantity	10
Quantity Uom	S.F.
Potential Action	REPLACE
Urgency of Action	PRIORITY 4
Purpose of Action	LEVEL 5
Deficiency Photo1

Basement - Stairs to Exit 17
Violations	No violations recorded.
Deficiency	STEEL COLUMNS/BEAMS: DETERIORATED MASONRY FIREPROOFING
Deficiency Location/Instance	Boiler Room
Deficiency Quantity	20
Quantity Uom	S.F.
Potential Action	REPLACE
Urgency of Action	PRIORITY 3
Purpose of Action	LEVEL 5
Deficiency Photo1

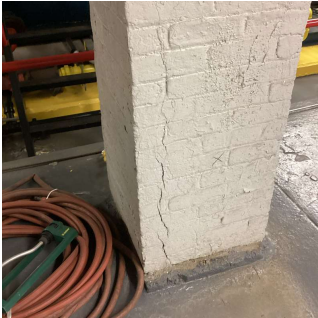
Boiler Room
Violations	No violations recorded.
<b>FLOOR STRUCTURE</b>	
Condition	Inspected
	4 - Between Fair and Poor
Deficiency	CLAY TILE: PLASTER MISSING
Deficiency Location/Instance	Basement - Stairs to Exit 17
Deficiency Quantity	20
Quantity Uom	S.F.
Potential Action	REPLACE
Urgency of Action	PRIORITY 4
Purpose of Action	LEVEL 5

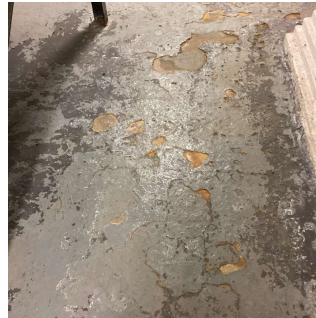
Basement - outside Oil Tank Room

**CONCRETE SLAB ON GRADE: THRU CRACKS**

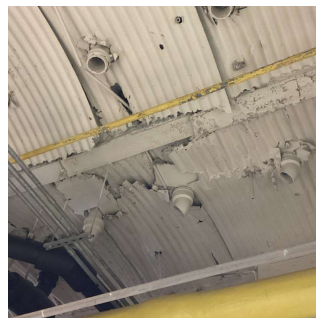
Basement - Firemans Work Room

**CINDER CONCRETE ARCH: METAL PAN DETERIORATED, SPALLED**

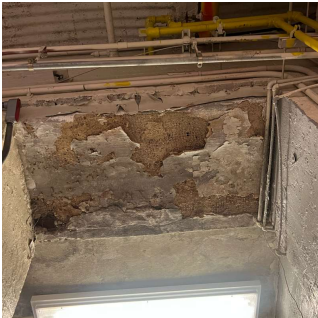
Yes	Potential Falling Debris	Deteriorated concrete floor slab is a potential falling debris hazard.	INTERIOR   STRUCTURAL   FLOOR STRUCTURE	Basement - Stairs to Exit 17, Storage Room B08, Electrical Panel Room near Ash Hoist Vault	Joseph Mateo	Custodian

Question	Response
<b>INTERIOR</b>	
<b>STRUCTURAL</b>	
<b>FLOOR STRUCTURE</b>	
Violations	No violations recorded.
Deficiency	CONCRETE: CRACKS/SPALLED/REINFORCEMENT EXPOSED
Deficiency Location/Instance	Basement - Storage Room B08, Electrical Room, Stairs to Exit 17
Deficiency Quantity	50
Quantity Uom	S.F.
Potential Action	REPAIR
Urgency of Action	PRIORITY 5
Purpose of Action	LEVEL 6
Deficiency Photo1

Violations	Basement - Stairs to Exit 17 No violations recorded.
Deficiency	CONCRETE: CRACKS/SPALLED/REINFORCEMENT EXPOSED
Deficiency Location/Instance	Rooms 360, 361, 460
Deficiency Quantity	50
Quantity Uom	S.F.
Potential Action	REPAIR
Urgency of Action	PRIORITY 3
Purpose of Action	LEVEL 5
Deficiency Photo1	 
Violations	Room 460 No violations recorded.
Deficiency	CINDER CONCRETE FLAT SLAB: CRACKED/SPALLED/REINFORCEMENT EXPOSED
Deficiency Location/Instance	Basement - Firemans Work Room, East Storage Area
Deficiency Quantity	40

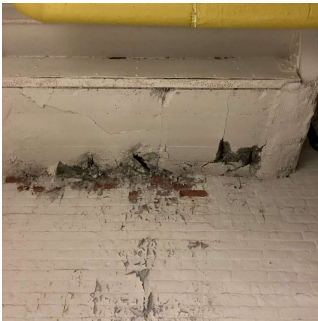
Quantity Uom	S.F.
Potential Action	REPAIR
Urgency of Action	PRIORITY 4
Purpose of Action	LEVEL 5

Violations	Basement - Firemans Work Room No violations recorded.
<b>FOUNDATION WALLS</b>	
Material Type(s)	Inspected Masonry
Condition	4 - Between Fair and Poor
Deficiency	BRICK: WATER INFILTRATION IN NON- INSTRUCTIONAL SPACE
Deficiency Location/Instance	Basement - Gas Meter Room
Deficiency Quantity	100
Quantity Uom	S.F.
Potential Action	INSTALL WATERPROOFING
Urgency of Action	PRIORITY 5
Purpose of Action	LEVEL 5
Deficiency Photo1

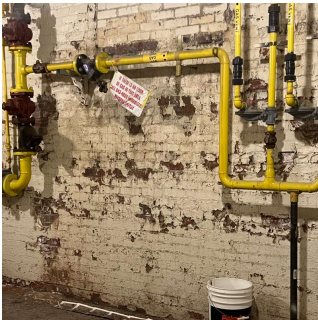
Violations	Basement - Gas Meter Room 35665541R
Deficiency	BRICK: CRACKED/SPALLED
Deficiency Location/Instance	Basement - Fire Pump Room, Firemans Work Room, East Storage Room, Electrical Panel Room near Ash Hoist Vault
Deficiency Quantity	80
Quantity Uom	S.F.
Potential Action	RESTITCH
Urgency of Action	PRIORITY 4
Purpose of Action	LEVEL 5

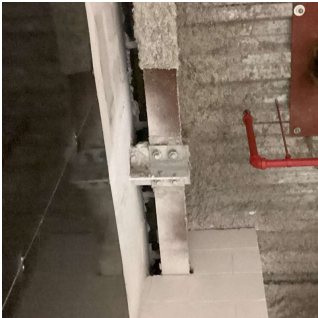
Question	Response
<b>INTERIOR</b>	
<b>STRUCTURAL</b>	
<b>FOUNDATION WALLS</b>	Inspected
Violations	No violations recorded.
<b>ROOF STRUCTURE</b>	Inspected
Condition	3 - Fair
Deficiency	STEEL COLUMNS/BEAMS: DETERIORATED/MISSING SPRAY-ON FIREPROOFING
Deficiency Location/Instance	Roof 1 - Mechanical Room 460, Roof 3 - Mechanical Rooms 360A, 361
Deficiency Quantity	40
Quantity Uom	S.F.
Potential Action	REPLACE
Urgency of Action	PRIORITY 3
Purpose of Action	LEVEL 5
Deficiency Photo1

Violations	Roof 1 - Mechanical Room 460 No violations recorded.
<b>VAULTS-BUNKERS</b>	Inspected
<b>Foundation Walls</b>	Inspected
Condition	4 - Between Fair and Poor
Deficiency	WATER INFILTRATION IN NON- INSTRUCTIONAL SPACE
Deficiency Location/Instance	Ash Hoist Vault, Vault near Gas Meter Room
Deficiency Quantity	200
Quantity Uom	S.F.
Potential Action	INSTALL WATERPROOFING
Urgency of Action	PRIORITY 5
Purpose of Action	LEVEL 5
Deficiency Photo1

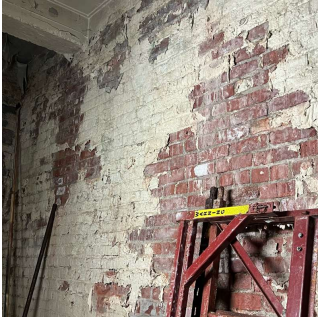
Violations	Ash Hoist Vault No violations recorded.
Deficiency	CRACKS, SPALLING
Deficiency Location/Instance	Ash Hoist Vault, Vault near Gas Meter Room
Deficiency Quantity	40

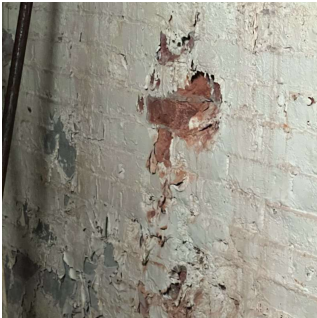
Question	Response
<b>INTERIOR</b>	
<b>STRUCTURAL</b>	
<b>VAULTS-BUNKERS</b>	
<b>Foundation Walls</b>	
Quantity Uom	S.F.
Potential Action	REPAIR
Urgency of Action	PRIORITY 4
Purpose of Action	LEVEL 5
Deficiency Photo1

Violations	Ash Hoist Vault No violations recorded.
<b>Slab Structure</b>	Inspected
Condition	3 - Fair
Deficiency	STEEL COLUMNS/BEAMS: DETERIORATED CONCRETE FIREPROOFING
Deficiency Location/Instance	Ash Hoist Vault
Deficiency Quantity	30
Quantity Uom	S.F.
Potential Action	REPAIR
Urgency of Action	PRIORITY 3
Purpose of Action	LEVEL 5
Deficiency Photo1

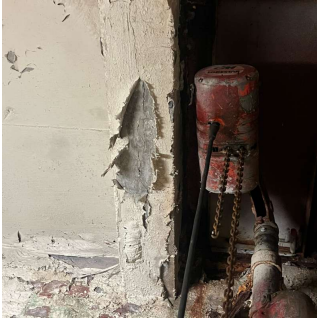
Violations	Ash Hoist Vault No violations recorded.
<b>Vault/Ash Hoist Doors and Framing</b>	Inspected
Condition	5 - Poor
Deficiency	DETERIORATED/DAMAGED VAULT/ASH HOIST DOORS AND FRAMING
Deficiency Location/Instance	Ash Hoist Vault
Deficiency Quantity	2
Quantity Uom	EACH
Potential Action	REPLACE
Urgency of Action	PRIORITY 4
Purpose of Action	LEVEL 2

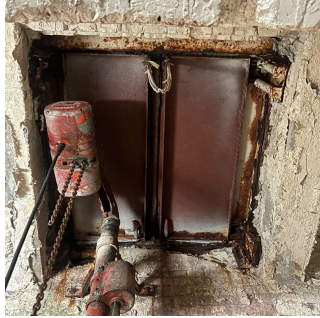
Question	Response
<b>INTERIOR</b>	
<b>STRUCTURAL</b>	
<b>VAULTS-BUNKERS</b>	
<b>Vault/Ash Hoist Doors and Framing</b>	
Deficiency Photo1

Violations	Ash Hoist Vault No violations recorded.
Deficiency	WATER INFILTRATION
Deficiency Location/Instance	Ash Hoist Vault
Deficiency Quantity	10
Quantity Uom	S.F.
Potential Action	REPAIR
Urgency of Action	PRIORITY 5
Purpose of Action	LEVEL 2
Deficiency Photo1

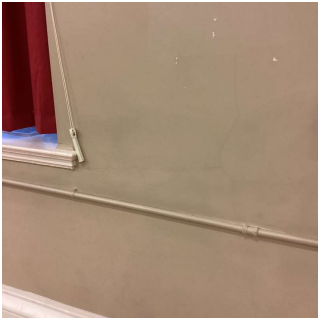
Question	Response
<b>INTERIOR</b>	
<b>AUDITORIUM</b>	
<b>Walls</b>	
Violations	Exit 11 Vestibule No violations recorded.
Deficiency	PLASTER: CRACKS/SPALLING
Deficiency Location/Instance	Left Side, Exit 11 Vestibule
Deficiency Quantity	30
Quantity Uom	S.F.
Potential Action	REPLACE
Urgency of Action	PRIORITY 3
Purpose of Action	LEVEL 2
Deficiency Photo1

Violations	Left Side No violations recorded.
<b>Window Curtains/Shades/Blinds</b>	
Instance on Ground Floor (550 Seats)	Inspected
Condition	5 - Poor
Deficiency	INOPERABLE CURTAINS
Deficiency Location/Instance	Left and Right Side
Deficiency Quantity	8
Quantity Uom	EACH
Potential Action	MAINTENANCE
Urgency of Action	PRIORITY 3
Purpose of Action	LEVEL 2
Deficiency Photo1	No photo recorded
Violations	No violations recorded.
<b>CAFETERIA</b>	
Instance on Ground Floor - Staff (600 SF)	Inspected
Instance on Ground Floor - Students	Inspected
<b>Ceiling</b>	
Instance on Ground Floor - Students	Inspected

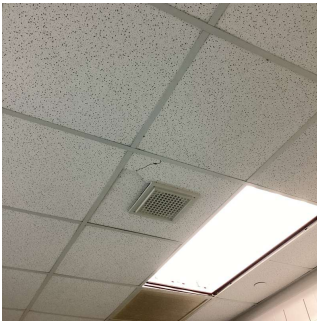
Condition	2 - Between Good and Fair
Deficiency	ACOUSTIC TILES: DAMAGED/MISSING
Deficiency Location/Instance	Near Serving area, Left Side Near Windows, Center
Deficiency Quantity	40
Quantity Uom	S.F.
Potential Action	REPLACE
Urgency of Action	PRIORITY 3
Purpose of Action	LEVEL 2

Violations	Near Serving area No violations recorded.
<b>Door(s)</b>	
Instance on Ground Floor - Staff (600 SF)	Inspected
Condition	2 - Between Good and Fair
Deficiency	No deficiencies recorded
Instance on Ground Floor - Students	Inspected
Condition	2 - Between Good and Fair
Deficiency	No deficiencies recorded
<b>Fixed Equipment</b>	
Instance on Ground Floor - Students	Does not Exist
Instance on Ground Floor - Staff (600 SF)	Does not Exist
<b>Floor Finish</b>	
Instance on Ground Floor - Students	Inspected
Condition	2 - Between Good and Fair
Deficiency	VINYL TILES: BROKEN/DETERIORATED/MISSING TILES
Deficiency Location/Instance	Near Entrance, Right and Left Near Windows, Center, Near Exit 8 and others
Deficiency Quantity	60
Quantity Uom	S.F.
Potential Action	REPLACE
Urgency of Action	PRIORITY 3
Purpose of Action	LEVEL 2
Deficiency Photo1

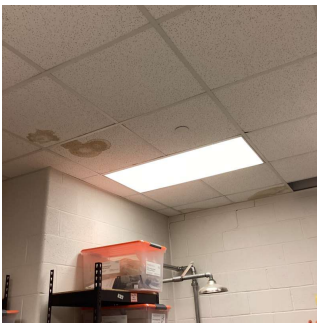
Deficiency	ACOUSTIC TILES: DAMAGED/MISSING
Deficiency Location/Instance	Corridor near Rooms 376, 111, Room 376
Deficiency Quantity	30
Quantity Uom	S.F.
Potential Action	REPLACE
Urgency of Action	PRIORITY 3
Purpose of Action	LEVEL 2

Room 376
Violations	No violations recorded.
<b>Door(s)</b>	Inspected
Condition	5 - Poor
Deficiency	WOOD: DETERIORATED DOOR
Deficiency Location/Instance	Rooms 409, 405, 402, 376, 311 and others
Deficiency Quantity	24
Quantity Uom	EACH
Potential Action	MAINTENANCE
Urgency of Action	PRIORITY 3
Purpose of Action	LEVEL 2
Deficiency Photo1

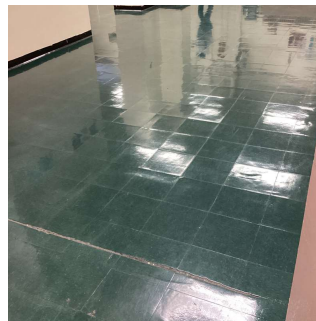
Corridor near Room 315

**VINYL TILES: BROKEN/DETERIORATED/MISSING TILES**

REPLACE

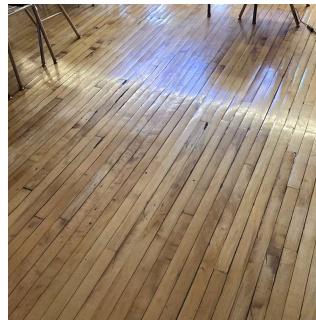
Room 409

**WOOD: DAMAGED/DETERIORATED**

REPLACE

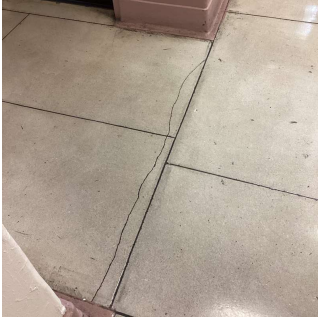
Question	Response
<b>INTERIOR</b>	
<b>CLASSROOMS/CORRIDORS/ADMIN SPACES</b>	
<b>Floor Finish</b>	
Deficiency	TERRAZZO: CRACKS
Deficiency Location/Instance	Corridor near Rooms 411, 402, 401, 307, Corridor near Auditorium and others
Deficiency Quantity	1,400
Quantity Uom	S.F.
Potential Action	REPLACE
Urgency of Action	PRIORITY 3
Purpose of Action	LEVEL 2
Deficiency Photo1

Corridor near Room 401
Violations	No violations recorded.
<b>Walls</b>	
Condition	Inspected
	2 - Between Good and Fair
Deficiency	STONE MOLDINGS: CRACKS/SPALLING
Deficiency Location/Instance	Main Entrance Lobby
Deficiency Quantity	10
Quantity Uom	L.F.
Potential Action	REPLACE
Urgency of Action	PRIORITY 3
Purpose of Action	LEVEL 2
Deficiency Photo1

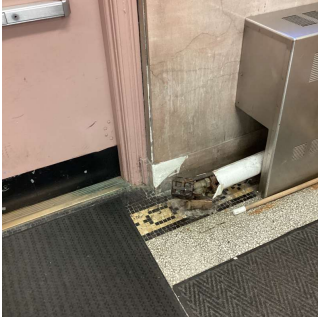
Main Entrance Lobby
Violations	No violations recorded.
Deficiency	MASONRY: CRACKS/SPALLING
Deficiency Location/Instance	Room 376
Deficiency Quantity	20
Quantity Uom	S.F.
Potential Action	REPLACE
Urgency of Action	PRIORITY 3

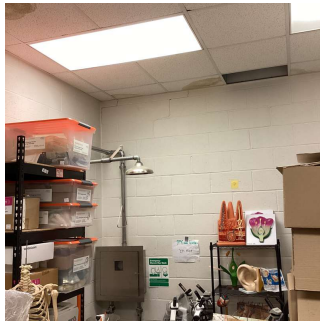
Room 376
Violations	No violations recorded.
Deficiency	PLASTER: CRACKS/SPALLING
Deficiency Location/Instance	Corridor near Rooms 403, 308, 200, 103A, Room 402 and others
Deficiency Quantity	220
Quantity Uom	S.F.
Potential Action	REPLACE
Urgency of Action	PRIORITY 3
Purpose of Action	LEVEL 2
Deficiency Photo1

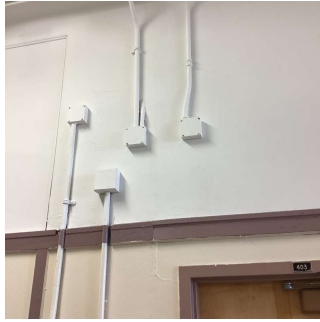
Corridor near Room 403
Violations	No violations recorded.
<b>Specialties</b>	Does not Exist
<b>GYMNASIUM</b>	Inspected
Instance on 2nd Floor	Inspected
<b>Ceiling</b>	
Instance on 2nd Floor	Inspected
Condition	2 - Between Good and Fair
Deficiency	GYPSUM BOARD: DAMAGED/DETERIORATED
Deficiency Location/Instance	Near Stair C
Deficiency Quantity	20
Quantity Uom	S.F.
Potential Action	REPLACE
Urgency of Action	PRIORITY 3
Purpose of Action	LEVEL 2

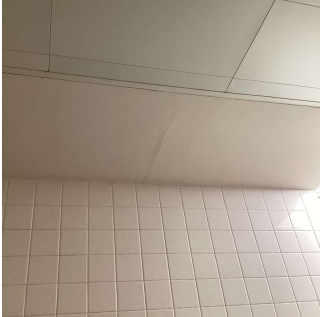
Question	Response
<b>INTERIOR</b>	
<b>KITCHEN</b>	
Instance on Ground Floor	Inspected
<b>Ceiling</b>	
Instance on Ground Floor	Inspected
Condition	2 - Between Good and Fair
Deficiency	GYPSUM BOARD: DAMAGED/DETERIORATED
Deficiency Location/Instance	Near Windows, Womens Locker Room, Room 026
Deficiency Quantity	30
Quantity Uom	S.F.
Potential Action	REPLACE
Urgency of Action	PRIORITY 3
Purpose of Action	LEVEL 2
Deficiency Photo1

Violations	Near Windows No violations recorded.
<b>Door(s)</b>	
Instance on Ground Floor	Inspected
Condition	2 - Between Good and Fair
Deficiency	No deficiencies recorded
<b>Floor Finish</b>	
Instance on Ground Floor	Inspected
Condition	3 - Fair
Deficiency	CONCRETE: CRACKS
Deficiency Location/Instance	Room 016
Deficiency Quantity	25
Quantity Uom	S.F.
Potential Action	REPLACE
Urgency of Action	PRIORITY 3
Purpose of Action	LEVEL 2
Deficiency Photo1

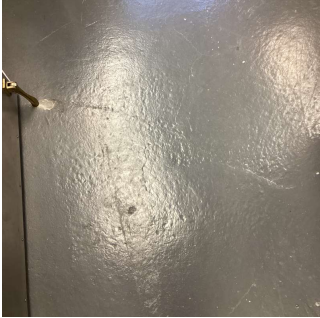
Violations	Room 016 No violations recorded.

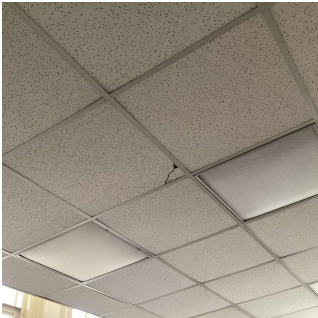
Question	Response
<b>INTERIOR</b>	
<b>KITCHEN</b>	
<b>Floor Finish</b>	
Deficiency Location/Instance	Near prep area
Deficiency Quantity	10
Quantity Uom	S.F.
Potential Action	REPLACE
Urgency of Action	PRIORITY 3
Purpose of Action	LEVEL 2
Deficiency Photo1	 
Violations	Near prep area No violations recorded.
<b>Walls</b>	
Instance on Ground Floor	Inspected
Condition	2 - Between Good and Fair
Deficiency	CERAMIC TILE: BROKEN/ MISSING
Deficiency Location/Instance	Serving area
Deficiency Quantity	10
Quantity Uom	S.F.
Potential Action	REPLACE
Urgency of Action	PRIORITY 3
Purpose of Action	LEVEL 2
Deficiency Photo1	 
Violations	Serving area No violations recorded.
<b>LIBRARY</b>	
Instance on Room 002	Inspected
<b>Built-in Furnishing</b>	
Instance on Room 002	Does not Exist
<b>Ceiling</b>	
Instance on Room 002	Inspected
Condition	2 - Between Good and Fair
Deficiency	ACOUSTIC TILES: DAMAGED/MISSING
Deficiency Location/Instance	Room 002A, Near Circulation desk

Question	Response
<b>INTERIOR</b>	
<b>LIBRARY</b>	
<b>Ceiling</b>	
Deficiency Quantity	20
Quantity Uom	S.F.
Potential Action	REPLACE
Urgency of Action	PRIORITY 3
Purpose of Action	LEVEL 2
Deficiency Photo1

Room 002A
Violations	No violations recorded.
<b>Door(s)</b>	
Instance on Room 002	Inspected
Condition	2 - Between Good and Fair
Deficiency	No deficiencies recorded
<b>Floor Finish</b>	
Instance on Room 002	Inspected
Condition	2 - Between Good and Fair
Deficiency	No deficiencies recorded
<b>Walls</b>	
Instance on Room 002	Inspected
Condition	2 - Between Good and Fair
Deficiency	No deficiencies recorded
<b>LOCKER ROOM</b>	
Instance on 2nd Floor - Girls (24 Lockers)	Inspected
Alternative use	Yes
Instance on 2nd Floor - Boys	Inaccessible
<b>Ceiling</b>	
Instance on 2nd Floor - Girls (24 Lockers)	Inspected
Condition	2 - Between Good and Fair
Deficiency	ACOUSTIC TILES: DAMAGED/MISSING
Deficiency Location/Instance	Center

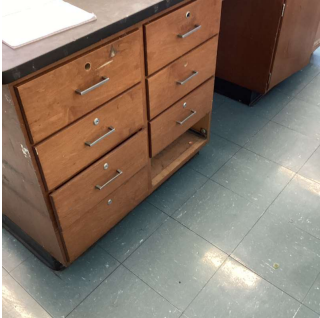
Question	Response
<b>INTERIOR</b>	
<b>LOCKER ROOM</b>	
<b>Walls</b>	
Potential Action	REPLACE
Urgency of Action	PRIORITY 3
Purpose of Action	LEVEL 2
Deficiency Photo1	 
	Right Side
Violations	No violations recorded.
<b>MULTI-PURPOSE ROOM</b>	Does not Exist
<b>SCIENCE DEMO ROOM</b>	Inspected
Instance on Rooms 201, 202	Inspected
Alternative use	No
<b>Fixed Equipment</b>	
Instance on Rooms 201, 202	Inspected
Condition	3 - Fair
Deficiency	CABINETRY: MISSING/DAMAGED
Deficiency Location/Instance	Rooms 201, 202
Deficiency Quantity	10
Quantity Uom	L.F.
Potential Action	REPLACE
Urgency of Action	PRIORITY 3
Purpose of Action	LEVEL 2
Deficiency Photo1

Room 201
Violations	No violations recorded.
<b>SCIENCE LAB</b>	Inspected
Instance on Room 407	Inspected
Alternative use	No
Instance on Room 372	Inspected
Alternative use	No
<b>Fixed Equipment</b>	
Instance on Room 372	Inspected
Condition	3 - Fair

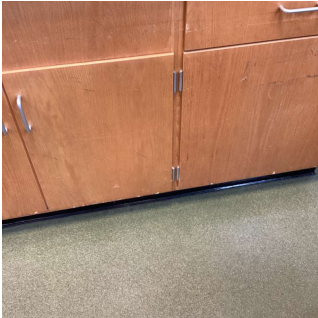
Question	Response
<b>INTERIOR</b>	
<b>SCIENCE LAB</b>	
<b>Fixed Equipment</b>	
Deficiency	CABINETRY: MISSING/DAMAGED
Deficiency Location/Instance	Room 372
Deficiency Quantity	10
Quantity Uom	L.F.
Potential Action	REPLACE
Urgency of Action	PRIORITY 3
Purpose of Action	LEVEL 2
Deficiency Photo1

Room 372
Violations	No violations recorded.
<b>SCIENCE PREP ROOM</b>	Inspected
Instance on Room 376	Inspected
Alternative use	No
Instance on Room 252	Inspected
Alternative use	Yes
<b>Fixed Equipment</b>	
Instance on Room 376	Inspected
Condition	2 - Between Good and Fair
Deficiency	No deficiencies recorded
Instance on Room 252	Inspected
Condition	2 - Between Good and Fair
Deficiency	No deficiencies recorded
<b>SHOWER ROOM</b>	Does not Exist
<b>STAIRS/RAMPS: INTERIOR</b>	Inspected
Do Letter Stair Signs Exist?	Yes
<b>Ceiling</b>	
Condition	2 - Between Good and Fair
Deficiency	PLASTER: CRACKS/SPALLING
Deficiency Location/Instance	Stair HI/4

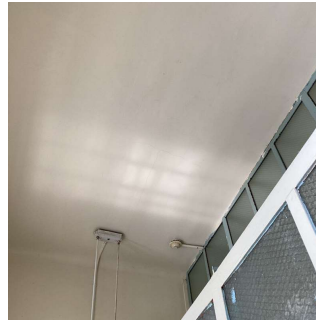
Stair HI/4

Deficiency Quantity	20
Quantity Uom	S.F.
Potential Action	REPLACE
Urgency of Action	PRIORITY 3
Purpose of Action	LEVEL 2

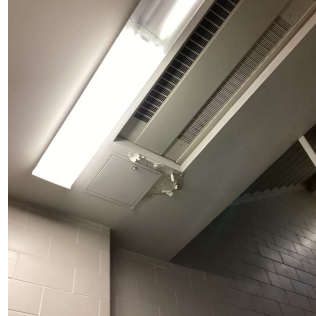
Stair B/Ground Floor

**GYPSUM BOARD: DAMAGED/DETERIORATED**

REPLACE

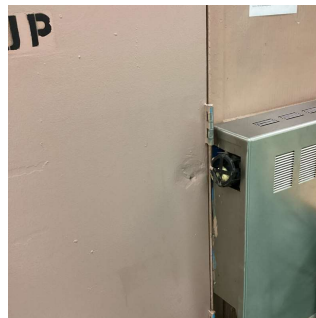
**METAL: DETERIORATED DOOR**

Question	Response
<b>INTERIOR</b>	
<b>STAIRS/RAMPS: INTERIOR</b>	
<b>Door(s)</b>	Inspected
	Stair HI/Ground Floor
Violations	No violations recorded.
<b>Partition</b>	Inspected
Condition	2 - Between Good and Fair
Deficiency	METAL FRAME: DAMAGED/DETERIORATED
Deficiency Location/Instance	Stairs DE/4, 3, 1, HI/4, 3 and others
Deficiency Quantity	20
Quantity Uom	L.F.
Potential Action	REPLACE
Urgency of Action	PRIORITY 3
Purpose of Action	LEVEL 2
Deficiency Photo1

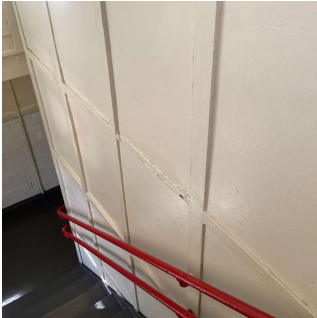
Violations	Stair HI/4 No violations recorded.
<b>Railings</b>	Inspected
Condition	2 - Between Good and Fair
Deficiency	No deficiencies recorded
<b>Stairs and Landings</b>	Inspected
Condition	2 - Between Good and Fair
Deficiency	STONE: BROKEN/MISSING
Deficiency Location/Instance	Main Entrance Lobby
Deficiency Quantity	20
Quantity Uom	S.F.
Potential Action	REPLACE
Urgency of Action	PRIORITY 3
Purpose of Action	LEVEL 2
Deficiency Photo1

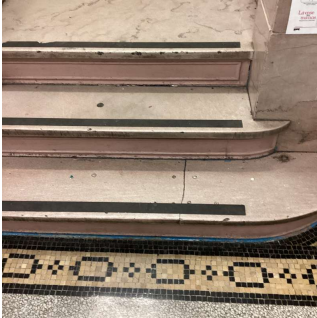
Violations	Main Entrance Lobby No violations recorded.

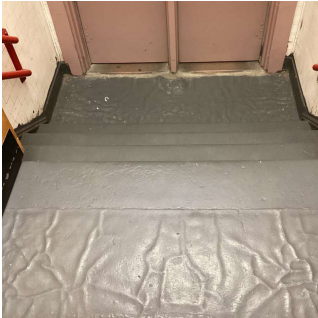
Deficiency	ROLLED ASPHALT: CRACKS
Deficiency Location/Instance	Exit 15, 14, 1, 2 Vestibules

Question	Response
<b>INTERIOR</b>	
<b>STAIRS/RAMPS: INTERIOR</b>	
<b>Stairs and Landings</b>	
Deficiency Quantity	80
Quantity Uom	S.F.
Potential Action	REPLACE
Urgency of Action	PRIORITY 3
Purpose of Action	LEVEL 2
Deficiency Photo1

Violations	Exit 15 Vestibule No violations recorded.
Deficiency	TERRAZZO: CRACKS
Deficiency Location/Instance	Near Exit 5
Deficiency Quantity	20
Quantity Uom	S.F.
Potential Action	REPLACE
Urgency of Action	PRIORITY 3
Purpose of Action	LEVEL 2
Deficiency Photo1

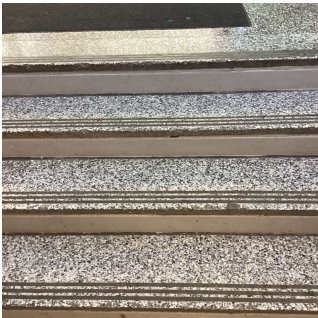
Violations	Near Exit 5 No violations recorded.
<b>Walls</b>	Inspected
Condition	2 - Between Good and Fair
Deficiency	PLASTER: CRACKS/SPALLING
Deficiency Location/Instance	Stairs F/4, G/Ground Floor, HI/4
Deficiency Quantity	30
Quantity Uom	S.F.
Potential Action	REPLACE
Urgency of Action	PRIORITY 3
Purpose of Action	LEVEL 2

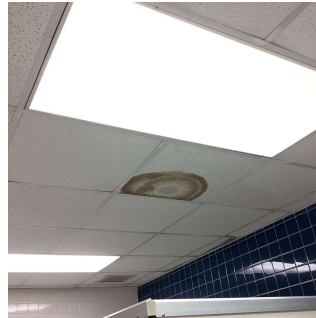
Room 362B

ACOUSTIC TILES: DAMAGED/MISSING

REPLACE

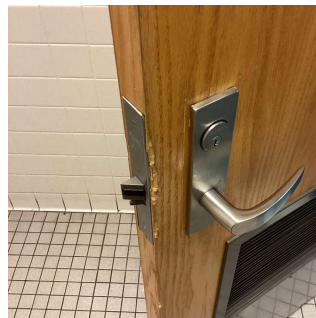
WOOD: DETERIORATED DOOR

Question	Response
<b>INTERIOR</b>	
<b>TOILET ROOMS - STAFF</b>	
<b>Door(s)</b>	
Violations	Room 260C No violations recorded.
Deficiency	WOOD: DAMAGED LOUVER
Deficiency Location/Instance	Rooms 362A, 362B, 362C
Deficiency Quantity	3
Quantity Uom	EACH
Potential Action	MAINTENANCE
Urgency of Action	PRIORITY 3
Purpose of Action	LEVEL 2
Deficiency Photo1	 
Violations	Room 362C No violations recorded.
<b>Floor Finish</b>	Inspected
Condition	2 - Between Good and Fair
Deficiency	CERAMIC TILE: BROKEN/MISSING TILES
Deficiency Location/Instance	Room G9
Deficiency Quantity	10
Quantity Uom	S.F.
Potential Action	REPLACE
Urgency of Action	PRIORITY 3
Purpose of Action	LEVEL 2
Deficiency Photo1	 
Violations	Room G9 No violations recorded.
<b>Stalls</b>	Inspected
Condition	2 - Between Good and Fair
Deficiency	No deficiencies recorded
<b>Walls</b>	Inspected
Condition	2 - Between Good and Fair
Deficiency	CERAMIC TILE: BROKEN/ MISSING
Deficiency Location/Instance	Room G10

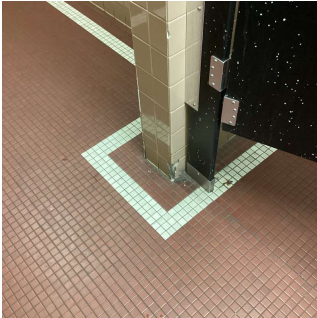
Question	Response
<b>INTERIOR</b>	
<b>TOILET ROOMS - STAFF</b>	
<b>Walls</b>	
Deficiency Quantity	10
Quantity Uom	S.F.
Potential Action	REPLACE
Urgency of Action	PRIORITY 3
Purpose of Action	LEVEL 2
Deficiency Photo1

Violations	Room G10 No violations recorded.
<b>TOILET ROOMS - STUDENTS</b>	
<b>Ceiling</b>	Inspected
Condition	2 - Between Good and Fair
Deficiency	ACOUSTIC TILES: DAMAGED/MISSING
Deficiency Location/Instance	Rooms 260B, 162B
Deficiency Quantity	30
Quantity Uom	S.F.
Potential Action	REPLACE
Urgency of Action	PRIORITY 3
Purpose of Action	LEVEL 2
Deficiency Photo1

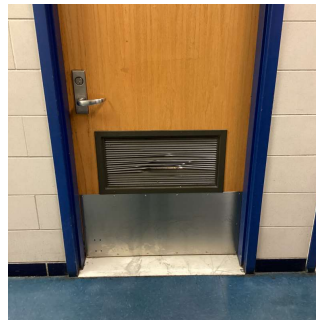
Room 260B

WOOD: DAMAGED LOUVER

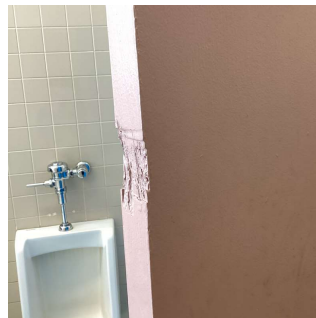
WOOD: DETERIORATED DOOR

Question	Response
<b>INTERIOR</b>	
<b>TOILET ROOMS - STUDENTS</b>	
<b>Door(s)</b>	Inspected Room 452
Violations	No violations recorded.
<b>Floor Finish</b>	Inspected
Condition	2 - Between Good and Fair
Deficiency	CERAMIC TILE: BROKEN/MISSING TILES
Deficiency Location/Instance	Rooms 452, 204B
Deficiency Quantity	20
Quantity Uom	S.F.
Potential Action	REPLACE
Urgency of Action	PRIORITY 3
Purpose of Action	LEVEL 2
Deficiency Photo1	 
Violations	Room 452 No violations recorded.
<b>Stalls</b>	Inspected
Condition	2 - Between Good and Fair
Deficiency	No deficiencies recorded
<b>Walls</b>	Inspected
Condition	2 - Between Good and Fair
Deficiency	CERAMIC TILE: BROKEN/ MISSING
Deficiency Location/Instance	Rooms 452, 204B, 204B, 104B
Deficiency Quantity	40
Quantity Uom	S.F.
Potential Action	REPLACE
Urgency of Action	PRIORITY 3
Purpose of Action	LEVEL 2
Deficiency Photo1	 
Violations	Room 452 No violations recorded.
<b>LIFE SAFETY</b>	Inspected

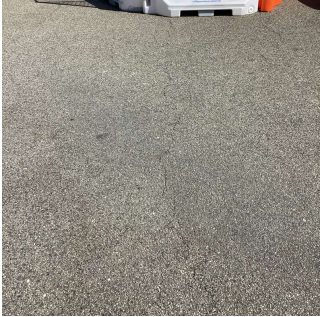
Question	Response
<b>SITE</b>	Inspected
<b>PAVING</b>	
<b>Student Non-Use</b>	
Gravel Exists?	No
<b>Asphalt</b>	Inspected
Condition	4 - Between Fair and Poor
Deficiency	CRACKS - MAJOR
Deficiency Location/Instance	Parking Lot
Deficiency Quantity	600
Quantity Uom	S.F.
Potential Action	REPLACE
Urgency of Action	PRIORITY 3
Purpose of Action	LEVEL 2
Deficiency Photo1

Violations	Parking Lot No violations recorded.
<b>Concrete</b>	Inaccessible
<b>Pavers</b>	Does not Exist
<b>Student Use</b>	Inspected
Gravel Exists?	No
<b>Asphalt</b>	Inspected
Condition	4 - Between Fair and Poor
Deficiency	CRACKS - MAJOR
Deficiency Location/Instance	Schoolyard
Deficiency Quantity	2,200
Quantity Uom	S.F.
Potential Action	REPLACE
Urgency of Action	PRIORITY 3
Purpose of Action	LEVEL 2
Deficiency Photo1

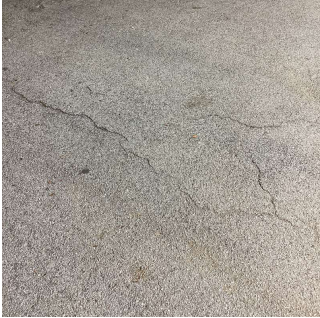
Violations	Schoolyard No violations recorded.
<b>Concrete</b>	Does not Exist
<b>Pavers</b>	Does not Exist

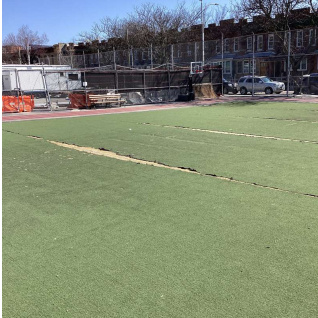
Deficiency	ARTIFICIAL TURF: DAMAGED/WORN OUT

Question	Response
<b>SITE</b>	
<b>PLAYING SURFACE</b>	
<b>Playing Field</b>	
Deficiency Location/Instance	Center, Right and Left Side
Deficiency Quantity	1,200
Quantity Uom	S.F.
Potential Action	REPLACE
Urgency of Action	PRIORITY 3
Purpose of Action	LEVEL 2
Deficiency Photo1

Violations	Center No violations recorded.
<b>Running Track</b>	Does not Exist
<b>RETAINING WALLS</b>	
Are there any Retaining Walls 6' OR higher facing public street/sidewalk?	Inspected No
Condition	4 - Between Fair and Poor
Deficiency	CAST IN PLACE CONCRETE: BULGING/DISPLACED
Deficiency Location/Instance	George Street
Deficiency Quantity	100
Quantity Uom	S.F.
Potential Action	REPLACE
Urgency of Action	PRIORITY 3
Purpose of Action	LEVEL 2
Deficiency Photo1	 
Violations	George Street No violations recorded.
Deficiency	CAST IN PLACE CONCRETE: DETERIORATED COPING STONE
Deficiency Location/Instance	George Street
Deficiency Quantity	80
Quantity Uom	S.F.

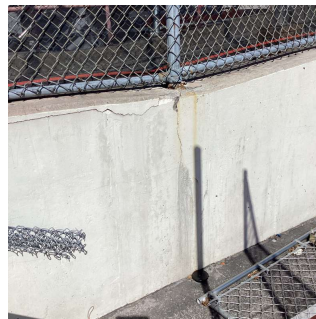
Schoolyard

CAST IN PLACE CONCRETE: CRACKS/SPALLING - MAJOR

REPLACE

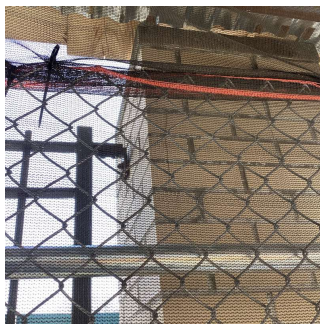
Question	Response
<b>SITE</b>	
<b>SEATING</b>	
<b>Benches</b>	Inspected
<b>Concrete</b>	Does not Exist
<b>Metal/Wood/Plastic</b>	Inaccessible
<b>Bleachers</b>	Does not Exist
<b>SITE WALLS (NOT RETAINING WALLS)</b>	Inspected
Condition	3 - Fair
Deficiency	BRICK: CRACKS/SPALLING - MAJOR
Deficiency Location/Instance	Centre Street
Deficiency Quantity	30
Quantity Uom	S.F.
Potential Action	REPLACE
Urgency of Action	PRIORITY 3
Purpose of Action	LEVEL 2
Deficiency Photo1

Centre Street
Violations	No violations recorded.
<b>STAIRS/RAMPS: EXTERIOR</b>	Inaccessible
<b>ARTWORK</b>	Does not Exist
