NYC Department of Education
Building Condition Assessment Survey 2023 - 2024

Architectural Inspection

Asset: P.S. 60 MINISCHOOL - QUEENS, 91-02 88TH AVENUE, New York, 11421

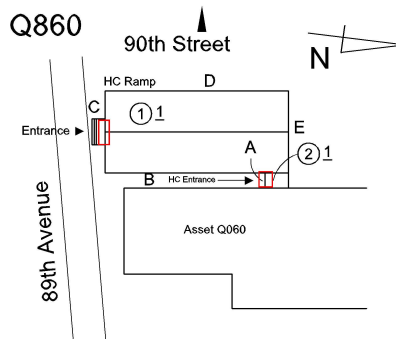
Question	Response
Architectural	
EXTERIOR	Inspected
AREAWAY	Does not Exist
AWNINGS AND CANOPIES	Does not Exist
CHIMNEY	Does not Exist
COPING	Does not Exist
CORNICE	Does not Exist
DOORS	Inspected
DOORS AND FRAMES	Inspected
Condition	3 - Fair
Deficiency	METAL: DETERIORATED DOOR AND FRAME - MINOR DETERIORATION
Roof Plan reference

Question	Response
EXTERIOR	
DOORS	
DOORS AND FRAMES	
Deficiency Quantity	4
Quantity Uom	EACH
Potential Action	MAINTENANCE
Urgency of Action	PRIORITY 3
Purpose of Action	LEVEL 2
Deficiency Photo1	No photo recorded
Violations	No violations recorded.
DOOR HARDWARE	
Condition	Inspected
Deficiency	3 - Fair
Deficiency	No deficiencies recorded
LINTELS	
	Does not Exist
TRANSOM/SIDE LIGHT	
	Does not Exist
EXTERIOR WALLS	
Material Type(s)	Inspected
Replacement Quantity	Steel
Replacement Uom	3,200
Replacement Uom	S.F.
Instance on All Facades	Inspected
Instance Condition	4 - Between Fair and Poor
Instance Quantity	3,200
Instance Quantity Uom	S.F.
Deficiency	METAL PANEL: DAMAGED TRIM
Roof Plan reference	<p>Q860</p>
Elevation	
Deficiency Quantity	20
Quantity Uom	L.F.
Potential Action	REPLACE
Urgency of Action	PRIORITY 4
Purpose of Action	LEVEL 2

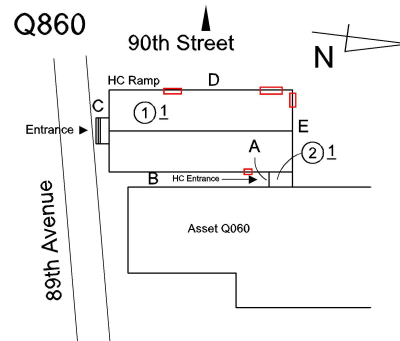
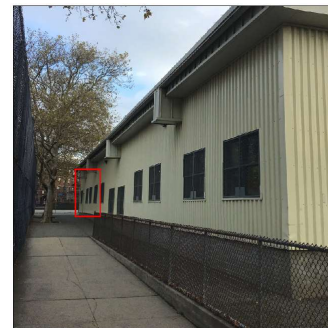
METAL PANEL: SEVERE DENTS

REPLACE

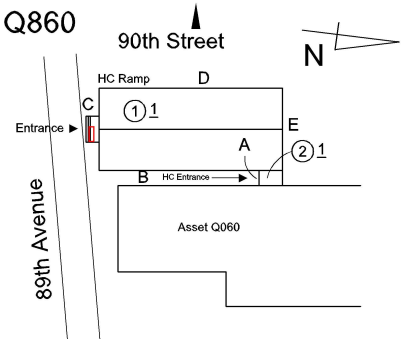
Question	Response
EXTERIOR	
STAIRS/RAMPS: EXTERIOR	
STAIRS/RAMPS	
Roof Plan reference

Do solar panels exist on these roofs?	No
Is/Are the roof(s) suitable for Solar Panel installation?	No
Installation Year	1987
Source of Installation	Custodial Staff
Deficiency	No deficiencies recorded
ROOFING DRAINS	Does not Exist
Specialties	Does not Exist
STAIRS/RAMPS: EXTERIOR	Inspected
BUILDING CHEEK/FLANK WALLS	Does not Exist
RAILINGS	Inspected
Condition	2 - Between Good and Fair
Deficiency	No deficiencies recorded
STAIRS/RAMPS	Inspected
Condition	3 - Fair
Deficiency	CONCRETE: CRACKS/SPALLING - MINOR

Deficiency Quantity	15
Quantity Uom	S.F.
Potential Action	REPAIR
Urgency of Action	PRIORITY 3
Purpose of Action	LEVEL 2
Deficiency Photo1
