NYC Department of Education
Building Condition Assessment Survey 2023 - 2024

Architectural Inspection

Asset: P.S. 99 ANNEX - QUEENS, 83-34 KEW GARDEN ROAD, New York, 11415

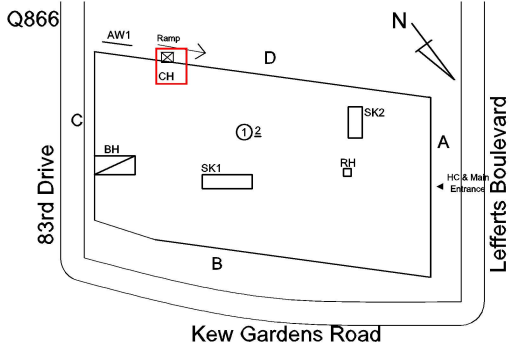
Violations	Facade D - AW1 No violations recorded.
AWNINGS AND CANOPIES	
Condition	Inspected 2 - Between Good and Fair
Deficiency	No deficiencies recorded
CHIMNEY	
Material Type(s)	Inspected Masonry
Condition	3 - Fair
Deficiency	BRICK: MINOR CRACKS AND SPALLING
Roof Plan reference

Deficiency Quantity	10
Quantity Uom	S.F.
Potential Action	RESTITCH
Urgency of Action	PRIORITY 3
Purpose of Action	LEVEL 2
Deficiency Photo1

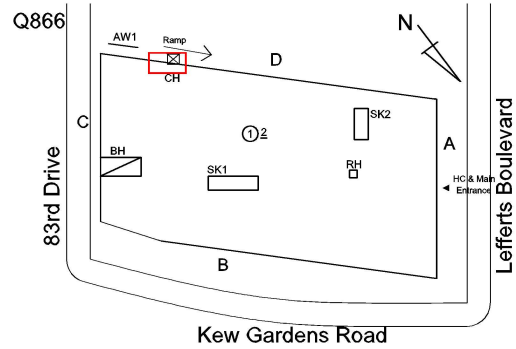
Violations	Roof 1 No violations recorded.
Deficiency	BRICK: DETERIORATED JOINTS

CHIMNEY

200
S.F.
REPOINT
PRIORITY 4
LEVEL 2

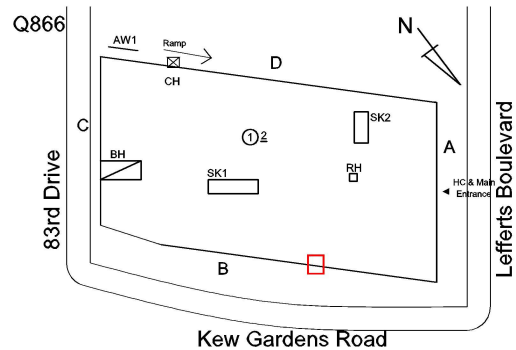
CAST STONE: CRACKED/BROKEN PIECES

10
L.F.
REPLACE-IN-KIND
PRIORITY 4
LEVEL 2

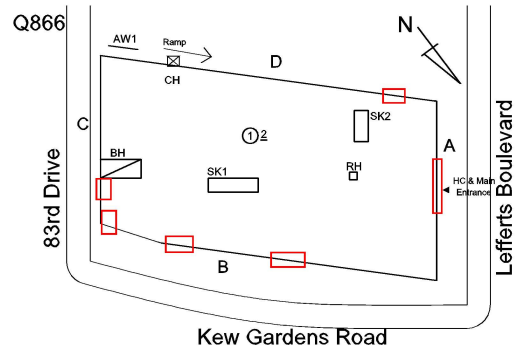
CAST STONE: DETERIORATED TRANSVERSE JOINTS

30

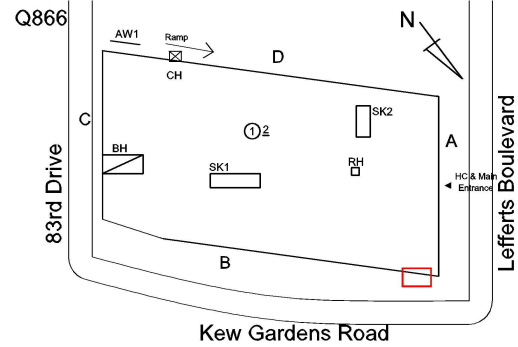
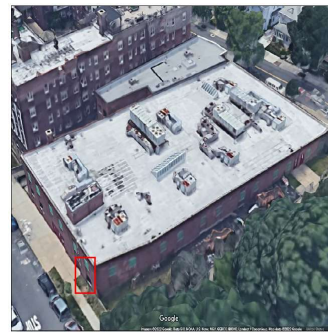
BRICK: WATER INFILTRATION IN INSTRUCTIONAL SPACE

100

REPAIR

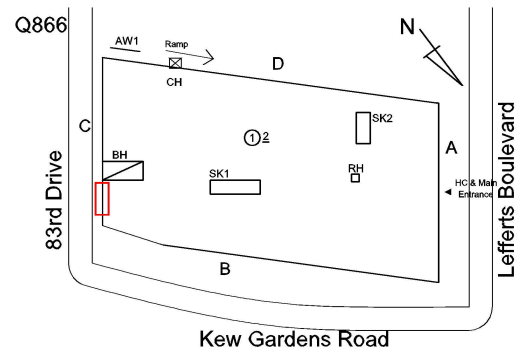
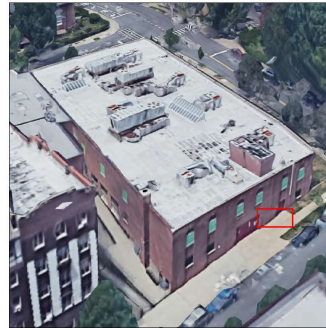
BRICK: MINOR CRACKS AND SPALLING

30

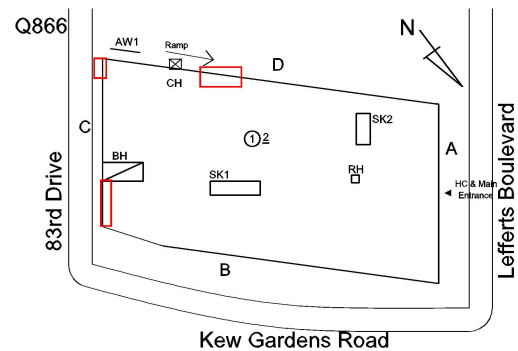
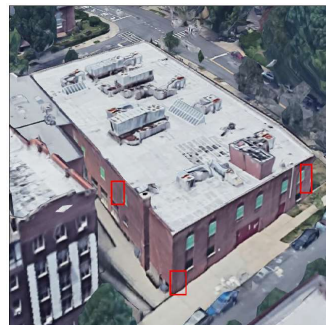
BRICK: DETERIORATED JOINTS

300

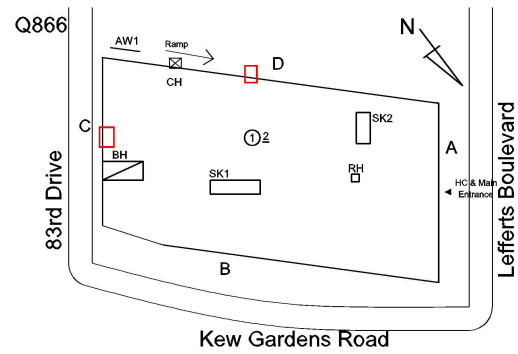
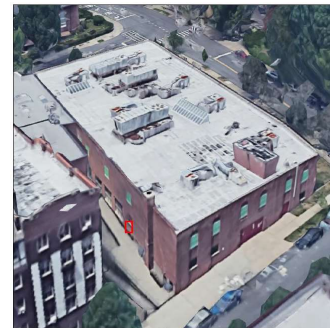
BRICK: MAJOR / THRU CRACKS

20

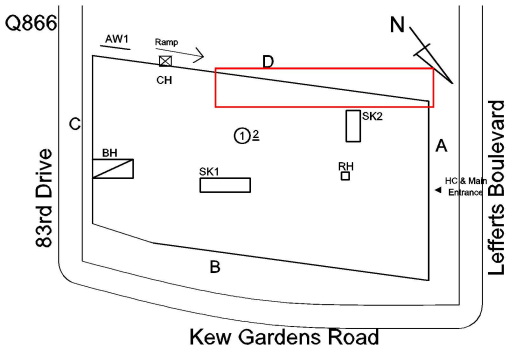
Question	Response
EXTERIOR	
PARAPETS	
Instance Condition	3 - Fair
Instance Quantity	3,500
Instance Quantity Uom	C.F.
Deficiency	BRICK: DETERIORATED JOINTS
Roof Plan reference

Deficiency Quantity	100
Quantity Uom	S.F.
Potential Action	REPOINT
Urgency of Action	PRIORITY 3
Purpose of Action	LEVEL 2
Deficiency Photo1

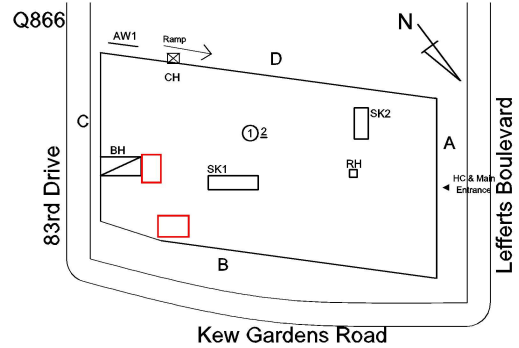
Deficiency	MODIFIED BITUMEN: ROOFING: DELAMINATION
------------	---

Deficiency Quantity	30
---------------------	----

Potential Action	REPLACE ROOFING WITHOUT MAJOR EQUIPMENT REMOVAL
------------------	---

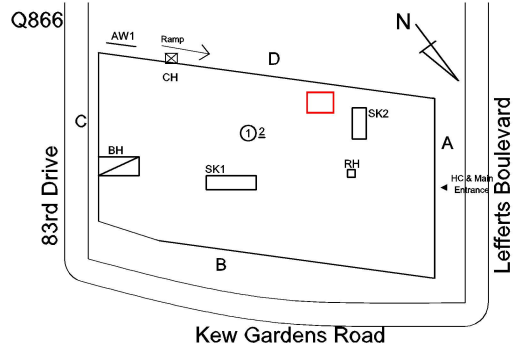
Roof 1 - Room 211
 No violations recorded.

Deficiency	MODIFIED BITUMEN: ROOFING: MAJOR ACTIVE ROOF LEAKS IN INSTRUCTIONAL SPACE
------------	---

100
 S.F.
 REPLACE ROOFING WITHOUT MAJOR EQUIPMENT
 REMOVAL
 PRIORITY 5
 LEVEL 2

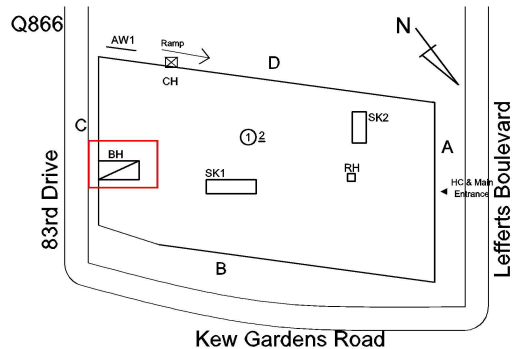
BULKHEAD/PENTHOUSE WALLS/EXTERIOR:
 CRACKS/SPALLING - MAJOR

10
 S.F.

Question	Response
EXTERIOR	
ROOF	
Specialties	
BULKHEAD/PENTHOUSE	
Potential Action	REPLACE
Urgency of Action	PRIORITY 4
Purpose of Action	LEVEL 2
Deficiency Photo1

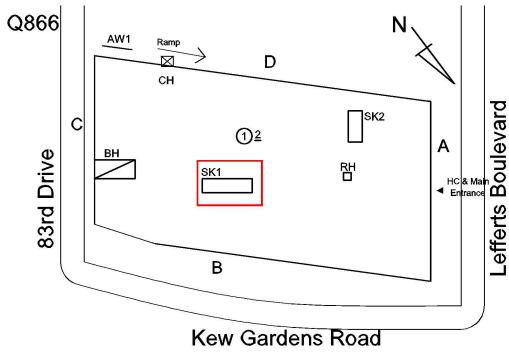
Violations	Roof 1 - Bulkhead No violations recorded.
CUPOLA/ SPIRES/ TOWERS	Does not Exist
DORMER	Does not Exist
DUNNAGE STEEL	Inspected
Condition	2 - Between Good and Fair
Deficiency	No deficiencies recorded
SKYLIGHT/ROOF VENT	Inspected
Material Type(s)	Glass
Condition	3 - Fair
Deficiency	WATER INFILTRATION
Roof Plan reference

Deficiency Quantity	30
Quantity Uom	S.F.
Potential Action	MAINTENANCE
Urgency of Action	PRIORITY 3
Purpose of Action	LEVEL 2

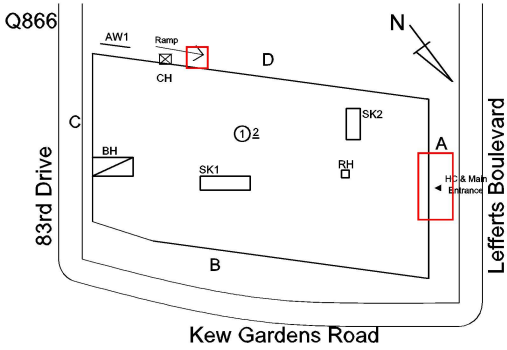
Question	Response
EXTERIOR	
STAIRS/RAMPS: EXTERIOR	
STAIRS/RAMPS	
Condition	3 - Fair
Deficiency	CONCRETE: CRACKS/SPALLING - MINOR
Roof Plan reference	<p>Q866</p>

Deficiency Quantity	30
Quantity Uom	S.F.
Potential Action	REPAIR
Urgency of Action	PRIORITY 3
Purpose of Action	LEVEL 2
Deficiency Photo1
