**NYC Department of Education**  
**Building Condition Assessment Survey 2023 - 2024**

Architectural Inspection

**Asset:** P.S. 69 PORTABLE - QUEENS, 77-02 37TH AVENUE, New York, 11372

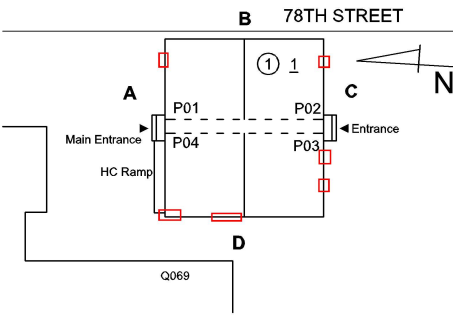
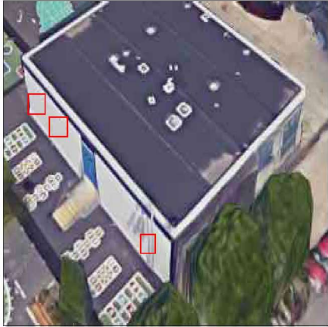
Question	Response
<b>EXTERIOR</b>	
<b>EXTERIOR WALLS</b>	
Replacement Quantity	3,000
Replacement Uom	S.F.
Instance on All Facades	Inspected
Instance Condition	4 - Between Fair and Poor
Instance Quantity	3,000
Instance Quantity Uom	S.F.
Deficiency	STUCCO CEMENT SURFACE: CRACKS, SPALLING
Roof Plan reference	<p><b>Q869</b></p>

Deficiency Quantity	60
Quantity Uom	S.F.
Potential Action	REPLACE
Urgency of Action	PRIORITY 4
Purpose of Action	LEVEL 2
Deficiency Photo1

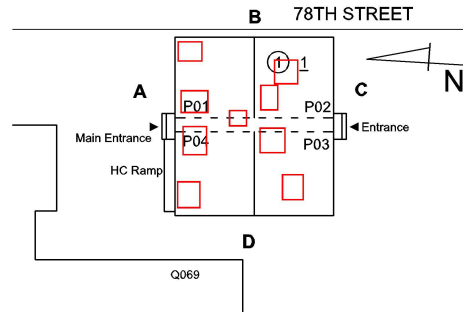
Deficiency	SINGLE PLY, FULLY ADHERED ROOF: ROOFING: MAJOR ACTIVE ROOF LEAKS IN INSTRUCTIONAL SPACE
Roof Plan reference	<b>Q869</b>

Deficiency Quantity	900
Quantity Uom	S.F.
Potential Action	REPLACE ROOFING WITHOUT MAJOR EQUIPMENT REMOVAL
Urgency of Action	PRIORITY 5
Purpose of Action	LEVEL 2

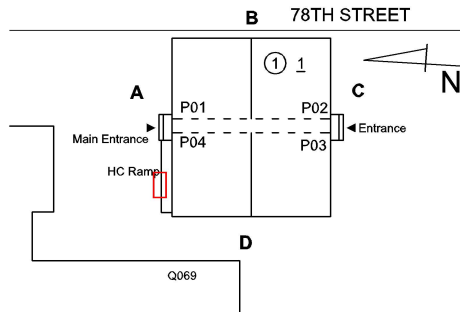
Violations	No violations recorded.
<b>ROOFING DRAINS</b>	Inspected
Condition	2 - Between Good and Fair
Deficiency	No deficiencies recorded
<b>Specialties</b>	Does not Exist
<b>STAIRS/RAMPS: EXTERIOR</b>	Inspected
<b>BUILDING CHEEK/FLANK WALLS</b>	Inspected
Condition	3 - Fair
Deficiency	CAST IN PLACE CONCRETE: CRACKS/SPALLING - MAJOR
Roof Plan reference	<b>Q869</b>

Deficiency Quantity	10
Quantity Uom	S.F.
Potential Action	REPLACE
Urgency of Action	PRIORITY 4
Purpose of Action	LEVEL 2
Deficiency Photo1

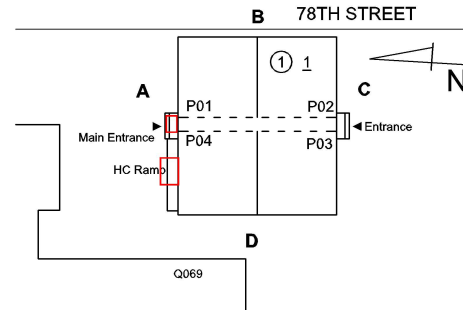
CONCRETE: CRACKS/SPALLING - MAJOR

REPLACE

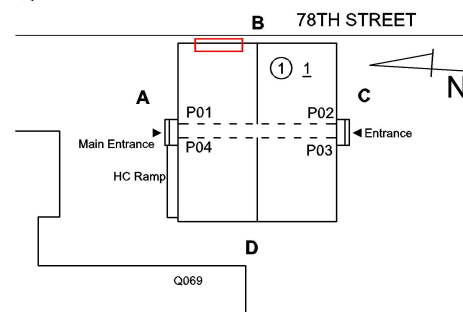
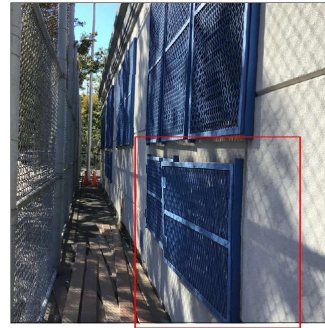
DETERIORATED/TORN-OUT/MISSING

10  
S.F.  
REPLACE  
PRIORITY 4  
LEVEL 2

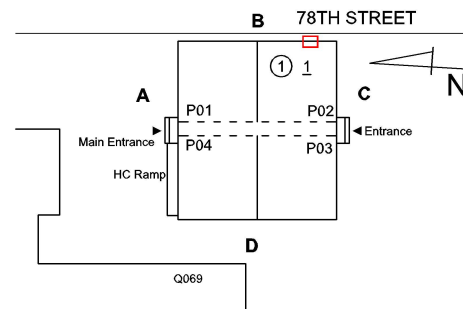
ALUMINUM - DOUBLE HUNG: DETERIORATED

Question	Response
<b>EXTERIOR</b>	
<b>WINDOWS</b>	
<b>WINDOWS</b>	
Elevation	 
Deficiency Quantity	15
Quantity Uom	S.F.
Potential Action	REPLACE WINDOW
Urgency of Action	PRIORITY 4
Purpose of Action	LEVEL 2
Deficiency Photo1	 
Violations	Facade B - Room P02 No violations recorded.
<b>INTERIOR</b>	Inspected
<b>POOLS</b>	Does not Exist
<b>STRUCTURAL</b>	Inspected
<b>COLUMNS/BEAMS/BEARING WALLS</b>	Inspected
Condition	2 - Between Good and Fair
Deficiency	No deficiencies recorded
<b>FLOOR STRUCTURE</b>	Inspected
Condition	2 - Between Good and Fair
Deficiency	No deficiencies recorded
<b>FOUNDATION WALLS</b>	Does not Exist
<b>ROOF STRUCTURE</b>	Inspected
Condition	2 - Between Good and Fair
Deficiency	No deficiencies recorded
<b>VAULTS-BUNKERS</b>	Does not Exist
<b>AUDITORIUM</b>	Does not Exist
<b>CAFETERIA</b>	Does not Exist
<b>CLASSROOMS/CORRIDORS/ADMIN SPACES</b>	Inspected
<b>Ceiling</b>	Inspected
Condition	2 - Between Good and Fair
