NYC Department of Education
Building Condition Assessment Survey 2023 - 2024

Architectural Inspection

Q876

Asset: P.S. 88 ANNEX - QUEENS, 869 CYPRESS AVENUE, New York, 11385

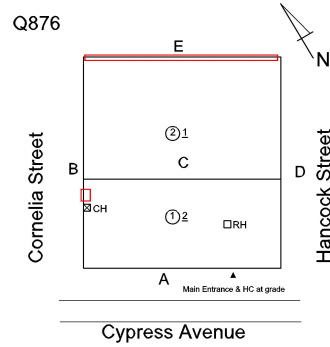
Roof Plan reference

Question	Response
Architectural	
EXTERIOR	Inspected
AREAWAY	Does not Exist
AWNINGS AND CANOPIES	Does not Exist
CHIMNEY	Inspected
Material Type(s)	Masonry
Condition	2 - Between Good and Fair
Deficiency	No deficiencies recorded
COPING	Inspected
Condition	3 - Fair
Deficiency	TERRA COTTA: CRACKED/BROKEN PIECES

50
L.F.
REPLACE-IN-KIND
PRIORITY 4
LEVEL 2

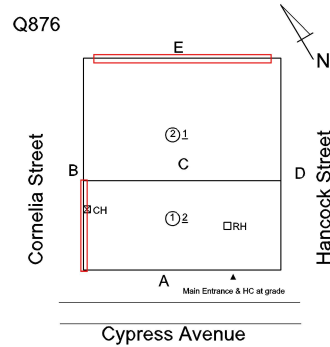
Roof Plan reference

TERRA COTTA: DETERIORATED TRANSVERSE JOINTS

60
L.F.
MAINTENANCE
PRIORITY 3
LEVEL 2
No photo recorded
No violations recorded.

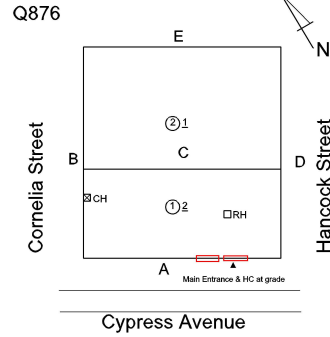
Roof Plan reference

METAL CLAD: DETERIORATED DOOR AND FRAME - MAJOR DETERIORATION

REPLACE

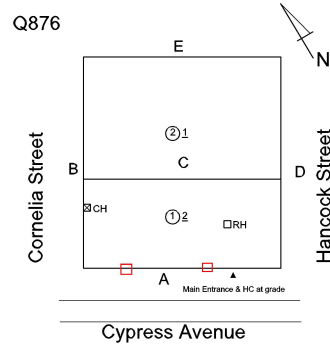
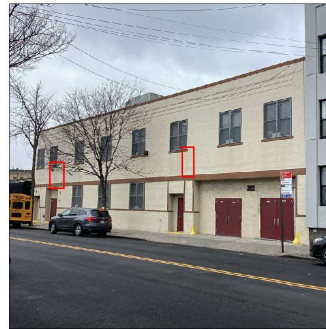
BRICK: MAJOR / THRU CRACKS

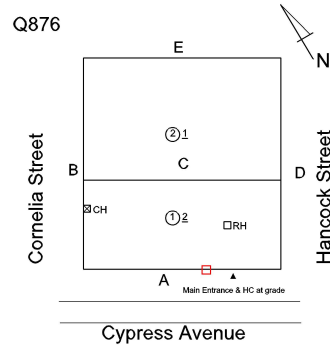
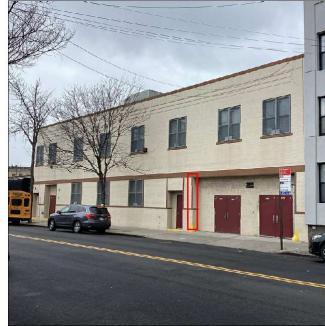
BRICK: CRACKS/DISPLACED/SPALLED BRICK AT BUILDING CORNERS

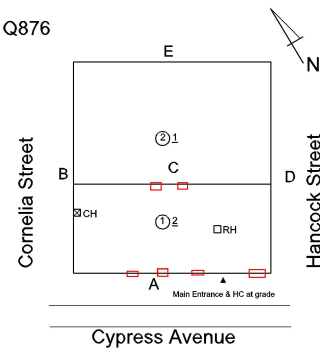
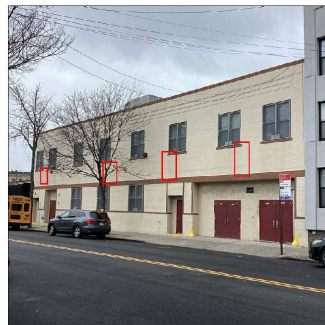
BRICK: MINOR CRACKS AND SPALLING

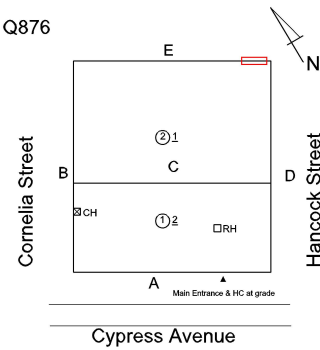
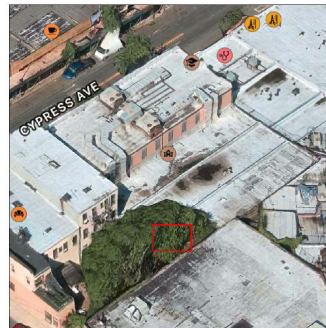
BRICK: WATER INFILTRATION IN INSTRUCTIONAL SPACE

REPAIR

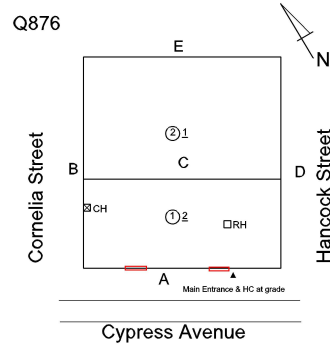
Question	Response
EXTERIOR	
EXTERIOR WALLS	Inspected
Violations	No violations recorded.
EXTERIOR SOFFITS	Inspected
Condition	2 - Between Good and Fair
Deficiency	No deficiencies recorded
LOADING DOCK	Does not Exist
LOUVER	Inspected
Condition	2 - Between Good and Fair
Deficiency	No deficiencies recorded
PARAPETS	Inspected
Material Type(s)	Masonry
Replacement Quantity	2,500
Replacement Uom	C.F.
Instance on All Facades	Inspected
Instance Condition	4 - Between Fair and Poor
Instance Quantity	2,500
Instance Quantity Uom	C.F.
Deficiency	BRICK: DETERIORATED JOINTS
Roof Plan reference	Q876
Deficiency Quantity	20
Quantity Uom	S.F.
Potential Action	REPOINT
Urgency of Action	PRIORITY 3
Purpose of Action	LEVEL 2
Deficiency Photo1	
	Roof 1
Violations	No violations recorded.
Deficiency	BRICK: MAJOR DETERIORATION/CRACKS

40
S.F.
REMOVE AND REBUILD
PRIORITY 4
LEVEL 2

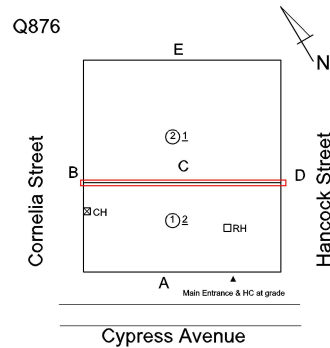
Roof Plan reference

DAMAGED/MISSING

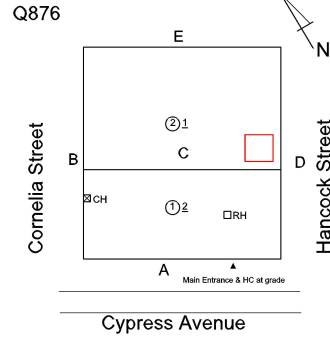
Roof Plan reference

Question	Response
EXTERIOR	
ROOF	
Roofing	
LEADERS, GUTTERS, DOWNSPOUTS, SCUPPERS	
Quantity Uom	L.F.
Potential Action	REPLACE
Urgency of Action	PRIORITY 4
Purpose of Action	LEVEL 2
Deficiency Photo1	 
Violations	Roof 2 - Facade C No violations recorded.
ROOF BARRIER/FENCE	Does not Exist
ROOF CAGE	Does not Exist
ROOFING	Inspected
Instance on Single Ply, Fully Adhered Roof: All Roofs	Inspected
Instance Condition	5 - Poor
Instance Photo	 
	Roof 1
Instance Quantity	10,000
Instance Quantity Uom	S.F.
Does the roof have major mechanical equipment sitting on Dunnage Steel less than 18" above the Roofing?	Yes
Does this roof instance have a Sustainable Roof System?	Yes
Sustainable Roof Type	White Roof
Sustainable Roof Location (Roof Number)	All Roofs
Do solar panels exist on these roofs?	No
Is/Are the roof(s) suitable for Solar Panel installation?	No
Installation Year	1997
Source of Installation	Custodial Staff
Deficiency	SINGLE PLY, FULLY ADHERED ROOF: ROOFING: OPEN SEAMS

Q876
 20
 L.F.
 REPAIR
 PRIORITY 4
 LEVEL 2

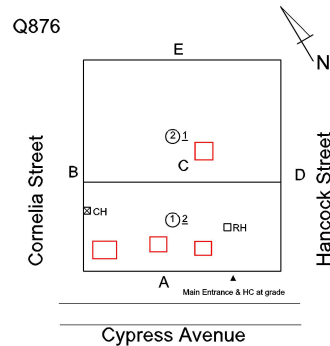
Roof Plan reference

SINGLE PLY, FULLY ADHERED ROOF: ROOFING: MAJOR ACTIVE ROOF LEAKS IN INSTRUCTIONAL SPACE

Q876
 400
 S.F.
 REPLACE ROOFING WITHOUT MAJOR EQUIPMENT REMOVAL
 PRIORITY 5
 LEVEL 2

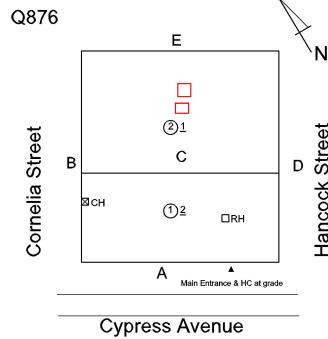
Roof Plan reference

DETERIORATED

REPLACE

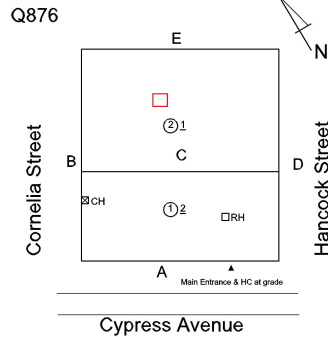
Roof Plan reference

Deficiency	HEIGHT LESS THAN 18"
------------	----------------------

REPLACE

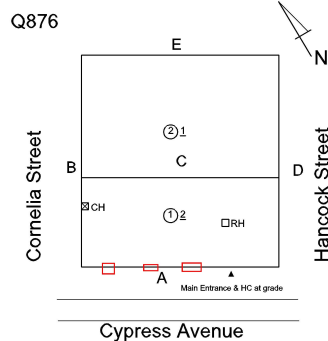
Roof Plan reference

Deficiency	CONCRETE: CRACKS/SPALLING - MINOR
------------	-----------------------------------

Question	Response
EXTERIOR	
STAIRS/RAMPS: EXTERIOR	
STAIRS/RAMPS	
Deficiency Quantity	30
Quantity Uom	S.F.
Potential Action	REPAIR
Urgency of Action	PRIORITY 3
Purpose of Action	LEVEL 2
Deficiency Photo1	 
Violations	Facade A No violations recorded.
WINDOWS	Inspected
Replacement Quantity	800
Replacement Uom	S.F.
EXTERIOR GUARDS	Inspected
Condition	2 - Between Good and Fair
Deficiency	No deficiencies recorded
LINTELS	Inspected
Condition	2 - Between Good and Fair
Deficiency	No deficiencies recorded
WINDOWS	Inspected
Material Type(s)	Aluminum
Instance on Aluminum - Double Hung: Facades A, C	Inspected
Instance Condition	3 - Fair
Instance Quantity	800
Instance Quantity Uom	S.F.
Are these windows insulated	No
Installation Year	1997
Source of Installation	Custodial Staff
Deficiency	No deficiencies recorded
INTERIOR	Inspected
POOLS	Does not Exist
STRUCTURAL	Inspected
COLUMNS/BEAMS/BEARING WALLS	Inspected
Condition	2 - Between Good and Fair

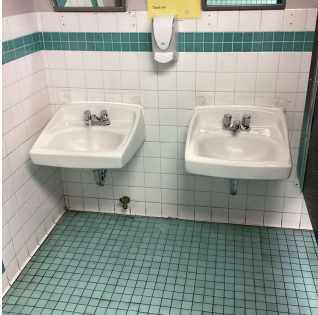
Question	Response
INTERIOR	
TOILET ROOMS - STUDENTS	
Floor Finish	Inspected
	Room 105
Violations	No violations recorded.
Stalls	Inspected
Condition	2 - Between Good and Fair
Deficiency	No deficiencies recorded
Walls	Inspected
Condition	2 - Between Good and Fair
Deficiency	CERAMIC TILE: BROKEN/ MISSING
Deficiency Location/Instance	Room 102
Deficiency Quantity	10
Quantity Uom	S.F.
Potential Action	REPLACE
Urgency of Action	PRIORITY 3
Purpose of Action	LEVEL 2
Deficiency Photo1

Room 102
Violations	No violations recorded.
Deficiency	GYPSUM BOARD: DETERIORATED
Deficiency Location/Instance	Rooms 105, 102
Deficiency Quantity	20
Quantity Uom	S.F.
Potential Action	REPLACE
Urgency of Action	PRIORITY 3
Purpose of Action	LEVEL 2
Deficiency Photo1

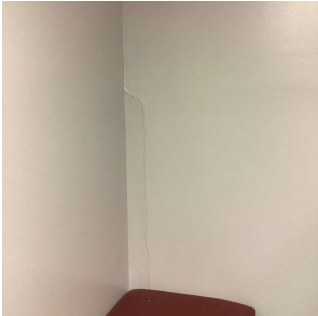
Room 105
Violations	No violations recorded.
LIFE SAFETY	Inspected
F.D. HOLDING AREA	Does not Exist
STEEL STAIRS	Does not Exist

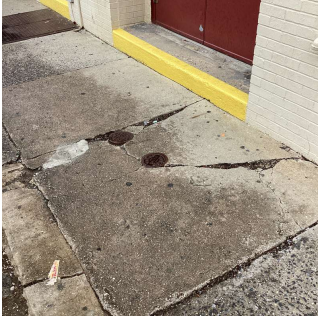
Question	Response
SITE	Inspected
CONTAINERIZATION	Does not Exist
Drainage System for Asphalt	Does not Exist
Drainage System for Concrete	Does not Exist
Drainage System for Soil	Does not Exist
DRINKING FOUNTAINS	Does not Exist
FENCES	Does not Exist
IRRIGATION SYSTEM	Does not Exist
PAVING	Inspected
Student Non-Use	Does not Exist
Student Use	Does not Exist
Site Sidewalks & Walkways	Does not Exist
DOT Sidewalk	Inspected
Asphalt	Does not Exist
Concrete	Inspected
Condition	3 - Fair
Deficiency	DAMAGED/DETERIORATED/MISSING SECTIONS
Deficiency Location/Instance	Cypress Avenue
Deficiency Quantity	100
Quantity Uom	S.F.
Potential Action	REPLACE
Urgency of Action	PRIORITY 3
Purpose of Action	LEVEL 2
Deficiency Photo1

Violations	Cypress Avenue No violations recorded.
Deficiency	HEAVING
Deficiency Location/Instance	Cypress Avenue
Deficiency Quantity	100
Quantity Uom	S.F.
Potential Action	REPLACE
Urgency of Action	PRIORITY 3
Purpose of Action	LEVEL 2

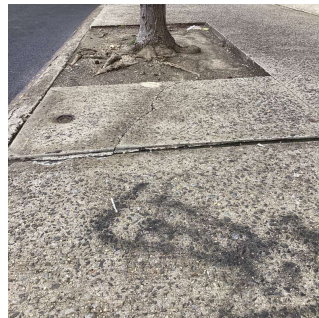
Question	Response
SITE	
PAVING	
DOT Sidewalk	
Concrete	Inspected
Deficiency Photo1

Cypress Avenue
Violations	No violations recorded.
Pavers	Does not Exist
PLAYGROUNDS	Does not Exist
PLAYING SURFACE	Does not Exist
RETAINING WALLS	Does not Exist
SEATING	Does not Exist
SITE WALLS (NOT RETAINING WALLS)	Does not Exist
STAIRS/RAMPS: EXTERIOR	Does not Exist
ARTWORK	Does not Exist
