NYC Department of Education
Building Condition Assessment Survey 2023 - 2024

Architectural Inspection

Q877

Asset: 51ST AVENUE ACADEMY - QUEENS, 76-05 51 AVENUE, New York, 11373

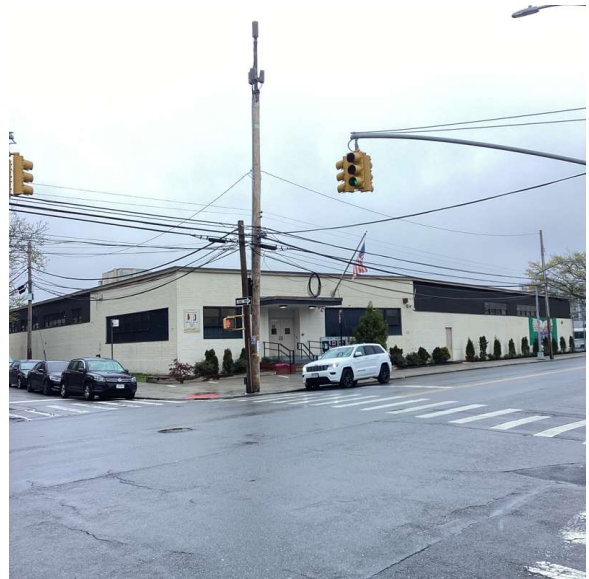
Corner of 51st Avenue and Jacobus Street - Northeast View

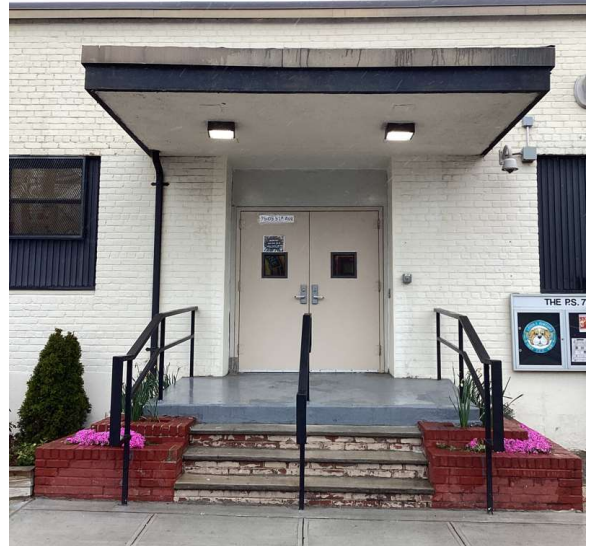
Facade A - 51st Avenue

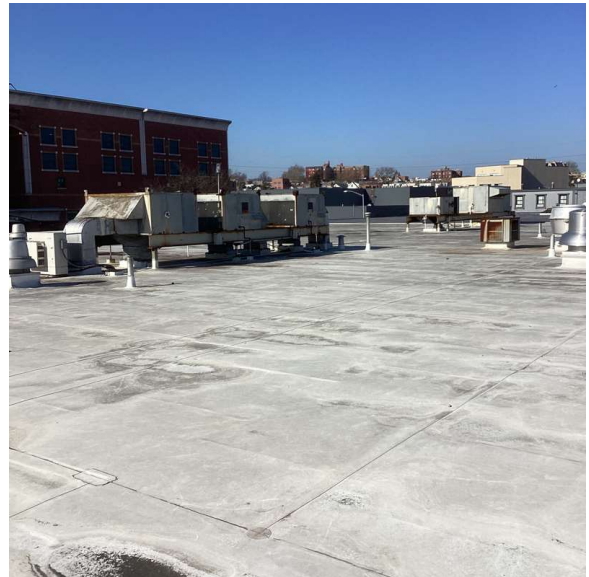
Roof 1 - Northwest View

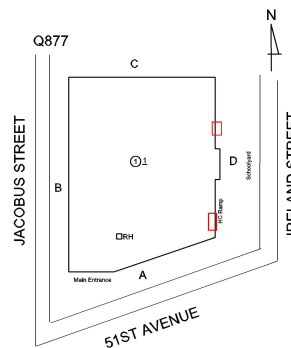
Question	Response
Architectural	
EXTERIOR	Inspected
AREAWAY	Does not Exist
AWNINGS AND CANOPIES	Inspected
Condition	2 - Between Good and Fair
Deficiency	No deficiencies recorded
CHIMNEY	Does not Exist
COPING	Does not Exist
CORNICE	Does not Exist
DOORS	Inspected
DOORS AND FRAMES	Inspected
Condition	4 - Between Fair and Poor
Deficiency	METAL CLAD: DETERIORATED DOOR AND FRAME - MINOR DETERIORATION
Roof Plan reference

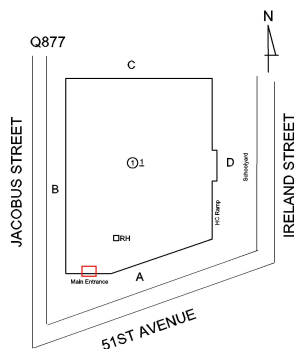
Question	Response
EXTERIOR	
DOORS	
DOORS AND FRAMES	
Deficiency Quantity	4
Quantity Uom	EACH
Potential Action	MAINTENANCE
Urgency of Action	PRIORITY 3
Purpose of Action	LEVEL 2
Deficiency Photo1	No photo recorded
Violations	No violations recorded.
Deficiency	METAL CLAD: DETERIORATED DOOR AND FRAME - MAJOR DETERIORATION
Roof Plan reference

Deficiency Quantity	2
Quantity Uom	EACH
Potential Action	REPLACE
Urgency of Action	PRIORITY 4
Purpose of Action	LEVEL 2
Deficiency Photo1

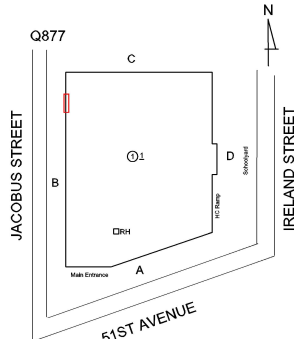
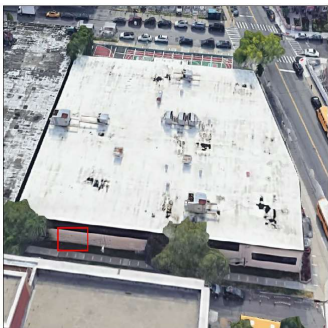
Question	Response
EXTERIOR	
EXTERIOR WALLS	
Instance Condition	4 - Between Fair and Poor
Instance Quantity	12,000
Instance Quantity Uom	S.F.
Deficiency	BRICK: DETERIORATED JOINTS
Roof Plan reference

Deficiency Quantity	20
Quantity Uom	S.F.
Potential Action	REPOINT
Urgency of Action	PRIORITY 4
Purpose of Action	LEVEL 2
Deficiency Photo1

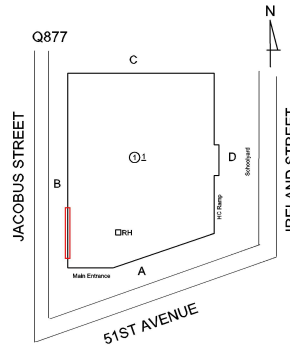
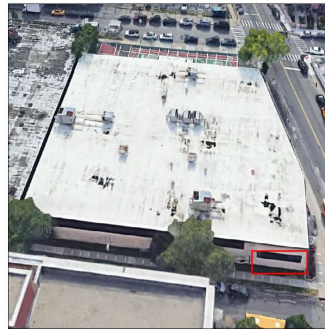
Violations	Facade B No violations recorded.
Deficiency	METAL PANEL: DAMAGED TRIM

REPLACE

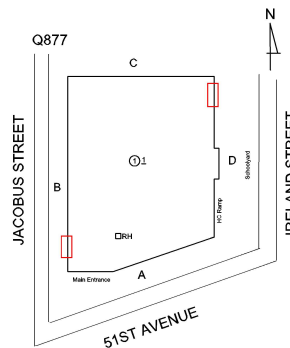
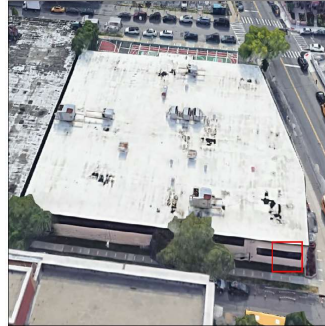
METAL PANEL: SEVERE DENTS

REPLACE

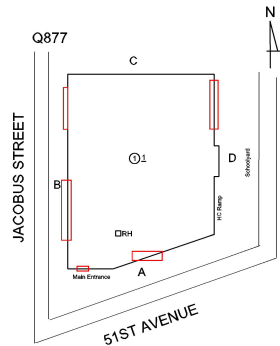
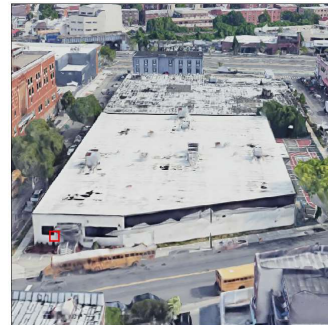
BRICK: MAJOR / THRU CRACKS

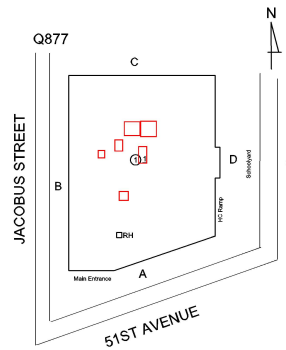
Deficiency	SINGLE PLY, FULLY ADHERED ROOF: ROOFING: MAJOR ACTIVE ROOF LEAKS IN INSTRUCTIONAL SPACE
------------	---

Deficiency Quantity	600
Quantity Uom	S.F.
Potential Action	REPLACE ROOFING WITHOUT MAJOR EQUIPMENT REMOVAL
Urgency of Action	PRIORITY 5
Purpose of Action	LEVEL 2
Deficiency Photo1

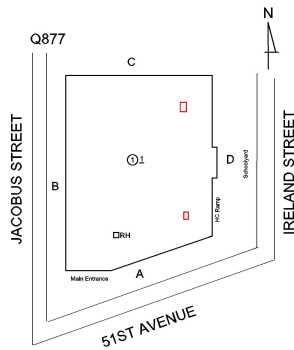
Deficiency	DETERIORATED
------------	--------------

Question	Response
EXTERIOR	
ROOF	
Roofing	
ROOFING DRAINS	
Roof Plan reference

Deficiency Quantity	2
Quantity Uom	EACH
Potential Action	REPLACE
Urgency of Action	PRIORITY 4
Purpose of Action	LEVEL 2
Deficiency Photo1

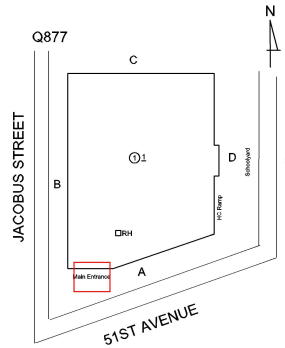
Violations	Roof 1 No violations recorded.
Specialties	Inspected
BULKHEAD/PENTHOUSE	Does not Exist
CUPOLA/ SPIRES/ TOWERS	Does not Exist
DORMER	Does not Exist
DUNNAGE STEEL	Inspected
Condition	2 - Between Good and Fair
Deficiency	No deficiencies recorded
SKYLIGHT/ROOF VENT	Does not Exist
ROOF/GRAVITY TANK	Does not Exist
STAIRS/RAMPS: EXTERIOR	Inspected
BUILDING CHEEK/FLANK WALLS	Inspected
Condition	2 - Between Good and Fair
Deficiency	No deficiencies recorded
RAILINGS	Inspected
Condition	2 - Between Good and Fair
Deficiency	No deficiencies recorded
STAIRS/RAMPS	Inspected
Condition	5 - Poor
Deficiency	CONCRETE: CRACKS/SPALLING - MAJOR

10
 S.F.
 REPLACE
 PRIORITY 4
 LEVEL 2

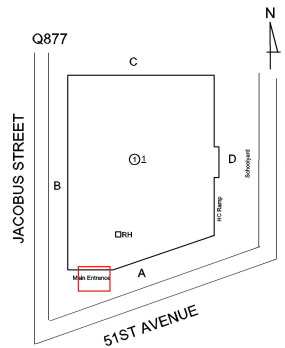
CONCRETE: WORN-OUT TREAD/RISER/NOSING

20
 S.F.
 REPLACE
 PRIORITY 4
 LEVEL 2

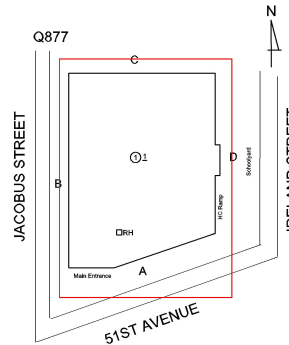
ALUMINUM - DOUBLE HUNG: INOPERABLE BALANCE

Question	Response
EXTERIOR	
WINDOWS	
WINDOWS	
Elevation	 
Deficiency Quantity	20
Quantity Uom	EACH
Potential Action	REPLACE BALANCES
Urgency of Action	PRIORITY 3
Purpose of Action	LEVEL 2
Deficiency Photo1	No photo recorded
Violations	No violations recorded.
INTERIOR	Inspected
POOLS	Does not Exist
STRUCTURAL	Inspected
COLUMNS/BEAMS/BEARING WALLS	Inspected
Condition	2 - Between Good and Fair
Deficiency	No deficiencies recorded
FLOOR STRUCTURE	Inspected
Condition	2 - Between Good and Fair
Deficiency	No deficiencies recorded
FOUNDATION WALLS	Inspected
Material Type(s)	Concrete
Condition	3 - Fair
Deficiency	CONCRETE: CRACKED/SPALLED/REINFORCEMENT EXPOSED
Deficiency Location/Instance	Facade A10
Deficiency Quantity	10
Quantity Uom	S.F.
Potential Action	REPAIR
Urgency of Action	PRIORITY 4
Purpose of Action	LEVEL 5
Deficiency Photo1	 
Violations	Facade A No violations recorded.
