NYC Department of Education
Building Condition Assessment Survey 2023 - 2024

Architectural Inspection

Q883

Asset: P.S. 182 - QUEENS, 90-40 150 STREET, New York, 11435

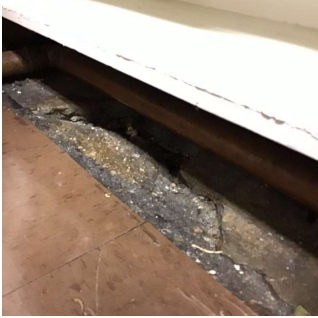
Question	Response
INTERIOR	
STRUCTURAL	
COLUMNS/BEAMS/BEARING WALLS	Inspected
	Boiler Room
Violations	No violations recorded.
FLOOR STRUCTURE	Inspected
Condition	3 - Fair
Deficiency	CONCRETE: CRACKS/SPALLED/REINFORCEMENT EXPOSED
Deficiency Location/Instance	Room 310
Deficiency Quantity	10
Quantity Uom	S.F.
Potential Action	REPAIR
Urgency of Action	PRIORITY 4
Purpose of Action	LEVEL 5
Deficiency Photo1

Room 310
Violations	No violations recorded.
Deficiency	CINDER CONCRETE FLAT SLAB: CRACKED/SPALLED/REINFORCEMENT EXPOSED
Deficiency Location/Instance	Boiler Room
Deficiency Quantity	40
Quantity Uom	S.F.
Potential Action	REPAIR
Urgency of Action	PRIORITY 4
Purpose of Action	LEVEL 5
Deficiency Photo1

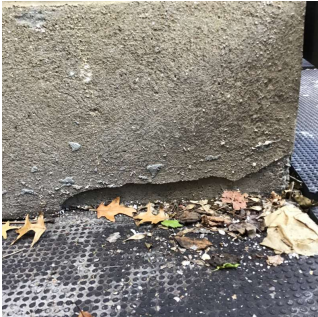
Question	Response
INTERIOR	
STRUCTURAL	
FLOOR STRUCTURE	Inspected
Urgency of Action	PRIORITY 3
Purpose of Action	LEVEL 5
Deficiency Photo1	 
Violations	Boiler Room No violations recorded.
FOUNDATION WALLS	Inspected
Material Type(s)	Concrete
Condition	3 - Fair
Deficiency	CONCRETE: CRACKED/SPALLED/REINFORCEMENT EXPOSED
Deficiency Location/Instance	Facade E, Boiler Room
Deficiency Quantity	40
Quantity Uom	S.F.
Potential Action	REPAIR
Urgency of Action	PRIORITY 3
Purpose of Action	LEVEL 5
Deficiency Photo1

Violations	Facade E No violations recorded.
ROOF STRUCTURE	Inspected
Condition	2 - Between Good and Fair
Deficiency	No deficiencies recorded
VAULTS-BUNKERS	Inspected
Foundation Walls	Inspected
Condition	2 - Between Good and Fair
Deficiency	No deficiencies recorded
Slab Structure	Inspected
Condition	3 - Fair
Deficiency	CONCRETE: CRACKS/SPALLED/REINFORCEMENT EXPOSED
Deficiency Location/Instance	Ash Hoist Vault, Oil Tank Room

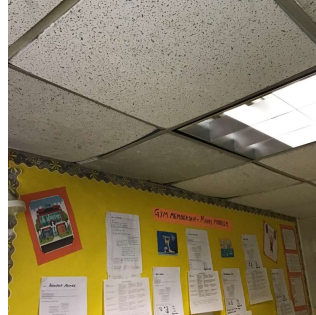
Corridor near Room 110
No violations recorded.

Question	Response
INTERIOR	
STRUCTURAL	
VAULTS-BUNKERS	
Slab Structure	
Quantity Uom	S.F.
Potential Action	REPAIR
Urgency of Action	PRIORITY 4
Purpose of Action	LEVEL 5
Deficiency Photo1	 
	Oil Tank Room
Violations	No violations recorded.
Vault/Ash Hoist Doors and Framing	Inspected
Condition	1 - Good
Deficiency	No deficiencies recorded
AUDITORIUM	Does not Exist
CAFETERIA	Does not Exist
CLASSROOMS/CORRIDORS/ADMIN SPACES	Inspected
Ceiling	Inspected
Condition	2 - Between Good and Fair
Deficiency	ACOUSTIC TILES: DAMAGED/MISSING
Deficiency Location/Instance	Corridor near Stair B/2
Deficiency Quantity	20
Quantity Uom	S.F.
Potential Action	REPLACE
Urgency of Action	PRIORITY 5
Purpose of Action	LEVEL 6
Deficiency Photo1	 
	Corridor near Stair B/2
Violations	No violations recorded.
Deficiency	ACOUSTIC TILES: DAMAGED/MISSING
Deficiency Location/Instance	Corridor near Rooms 312, 208, 206, 204, 110 and others
Deficiency Quantity	70

Quantity Uom	S.F.
Potential Action	REPLACE

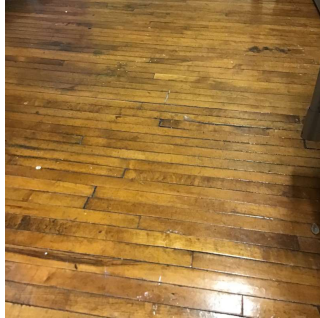
Question	Response
INTERIOR	
MULTI-PURPOSE ROOM	
Door(s)	
Deficiency Photo1	 
Violations	Right Side of Stage No violations recorded.
Fixed Equipment	
Instance on Basement	Does not Exist
Floor Finish	
Instance on Basement	Inspected
Condition	5 - Poor
Deficiency	VINYL TILES: BROKEN/DETERIORATED/MISSING TILES
Deficiency Location/Instance	Left and Right Side, Center, Near Stair A and B
Deficiency Quantity	420
Quantity Uom	S.F.
Potential Action	REPLACE
Urgency of Action	PRIORITY 3
Purpose of Action	LEVEL 2
Deficiency Photo1	 
Violations	Left Side No violations recorded.
Sliding-folding Partition	
Instance on Basement	Does not Exist
Stage	
Instance on Basement	Inspected
Stage	
Instance on Basement	Inspected
Condition	3 - Fair
Deficiency	DAMAGED FLOOR
Deficiency Location/Instance	Right and Left Side, Center
Deficiency Quantity	30
Quantity Uom	S.F.
Potential Action	REPLACE
Urgency of Action	PRIORITY 3

Right Side
Violations	No violations recorded.
Stage Curtain Rigging	Does not Exist
Instance on Basement	Does not Exist
Stage Curtains	Does not Exist
Instance on Basement	Does not Exist
Walls	
Instance on Basement	Inspected
Condition	2 - Between Good and Fair
Deficiency	PLASTER: CRACKS/SPALLING
Deficiency Location/Instance	Left and Right Side
Deficiency Quantity	60
Quantity Uom	S.F.
Potential Action	REPLACE
Urgency of Action	PRIORITY 3
Purpose of Action	LEVEL 2
Deficiency Photo1

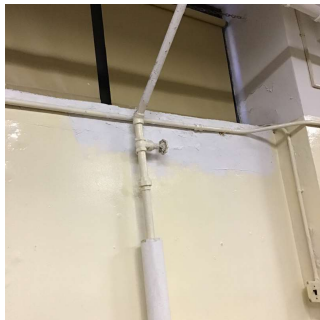
Left Side
Violations	No violations recorded.
Window Curtains/Shades/Blinds	
Instance on Basement	Inspected
Condition	2 - Between Good and Fair
Deficiency	No deficiencies recorded
SCIENCE DEMO ROOM	Does not Exist
SCIENCE LAB	Does not Exist
SCIENCE PREP ROOM	Does not Exist
SHOWER ROOM	Does not Exist

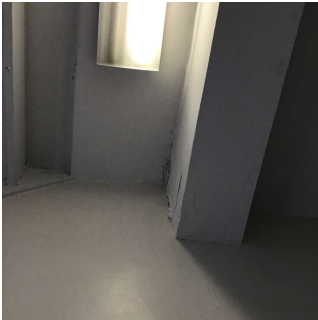
Question	Response
INTERIOR	
STAIRS/RAMPS: INTERIOR	Inspected
Do Letter Stair Signs Exist?	No
Ceiling	Inspected
Condition	2 - Between Good and Fair
Deficiency	PLASTER: CRACKS/SPALLING
Deficiency Location/Instance	Stair B/3
Deficiency Quantity	10
Quantity Uom	S.F.
Potential Action	REPLACE
Urgency of Action	PRIORITY 3
Purpose of Action	LEVEL 2
Deficiency Photo1

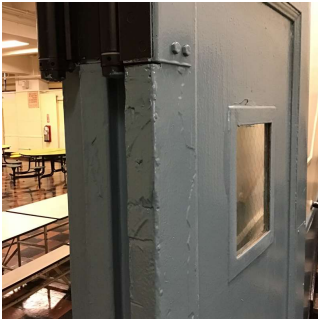
Violations	Stair B/3 No violations recorded.
Door(s)	Inspected
Condition	5 - Poor
Deficiency	METAL CLAD WOOD: DETERIORATED DOOR
Deficiency Location/Instance	Stairs A/Basement
Deficiency Quantity	2
Quantity Uom	EACH
Potential Action	MAINTENANCE
Urgency of Action	PRIORITY 3
Purpose of Action	LEVEL 2
Deficiency Photo1

Violations	Stair A/Basement No violations recorded.
Partition	Does not Exist
Railings	Inspected
Condition	3 - Fair
Deficiency	METAL: BROKEN BRACKET
Deficiency Location/Instance	Stair A/Basement
Deficiency Quantity	1
Quantity Uom	EACH

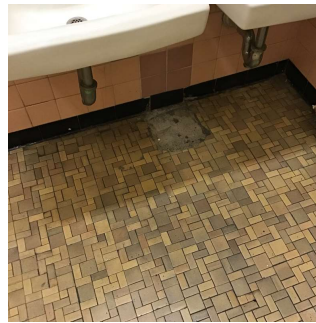
Basement - Womens

Floor Finish

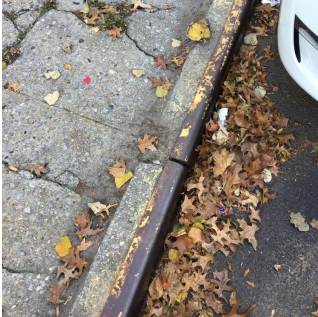
Violations	South Side of the building No violations recorded.
IRRIGATION SYSTEM	Does not Exist
PAVING	Inspected
Student Non-Use	Does not Exist
Student Use	Does not Exist
Site Sidewalks & Walkways	Does not Exist
DOT Sidewalk	Inspected
Asphalt	Does not Exist
Concrete	Inspected
Condition	3 - Fair
Deficiency	DAMAGED CURBS
Deficiency Location/Instance	150th Street
Deficiency Quantity	10
Quantity Uom	L.F.
Potential Action	REPLACE
Urgency of Action	PRIORITY 3
Purpose of Action	LEVEL 2
Deficiency Photo1

Violations	150th Street No violations recorded.
Deficiency	DAMAGED/DETERIORATED/MISSING SECTIONS
Deficiency Location/Instance	150th Street
Deficiency Quantity	400
