NYC Department of Education
Building Condition Assessment Survey 2023 - 2024

Architectural Inspection

Q884

Asset: P.S. 65 - QUEENS, 103-22 99TH STREET, New York, 11417

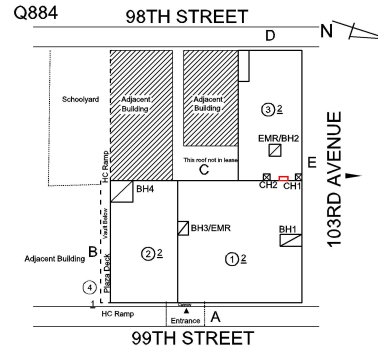
Roof Plan reference

Question	Response
Architectural	
EXTERIOR	Inspected
AREAWAY	Does not Exist
AWNINGS AND CANOPIES	Inspected
Condition	2 - Between Good and Fair
Deficiency	No deficiencies recorded
CHIMNEY	Inspected
Material Type(s)	Masonry
Condition	2 - Between Good and Fair
Deficiency	No deficiencies recorded
COPING	Inspected
Condition	3 - Fair
Deficiency	TERRA COTTA: CRACKED/BROKEN PIECES

COPING

10
 L.F.
 REPLACE-IN-KIND
 PRIORITY 4
 LEVEL 2

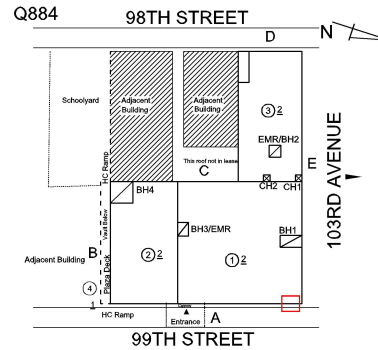
Roof Plan reference

METAL: DETERIORATED DOOR AND FRAME - MINOR DETERIORATION

1
 EACH
 MAINTENANCE
 PRIORITY 3
 LEVEL 2

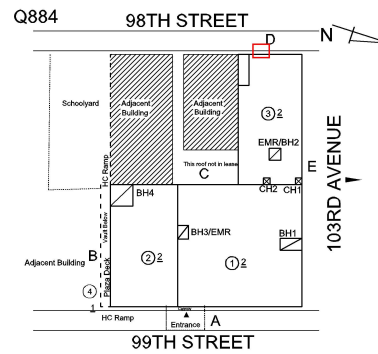
Roof Plan reference

METAL: DETERIORATED DOOR AND FRAME - MAJOR DETERIORATION

REPLACE

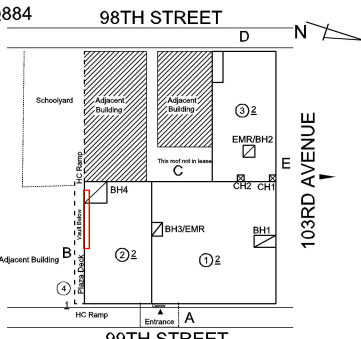
Question	Response
EXTERIOR	
EXTERIOR WALLS	Inspected
Material Type(s)	Masonry
Replacement Quantity	17,000
Replacement Uom	S.F.
Instance on All Facades	Inspected
Instance Condition	3 - Fair
Instance Quantity	17,000
Instance Quantity Uom	S.F.
Deficiency	BRICK: DETERIORATED JOINTS
Roof Plan reference	Q884
Elevation

Deficiency Quantity	30
Quantity Uom	S.F.
Potential Action	REPOINT
Urgency of Action	PRIORITY 4
Purpose of Action	LEVEL 2
Deficiency Photo1

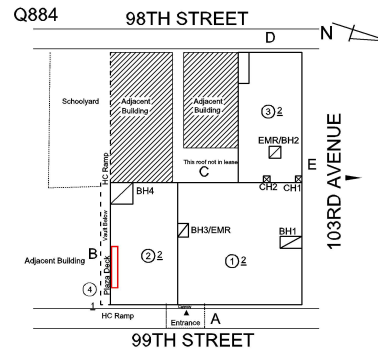
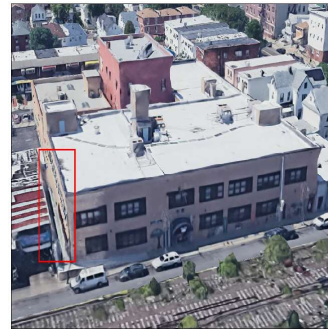
Roof Plan reference

Violations	Facade B No violations recorded.
Deficiency	BRICK: DETERIORATED MASONRY SILLS - MINOR

REPAIR

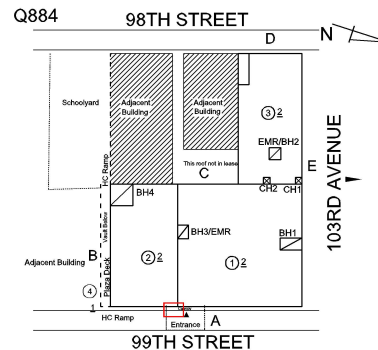
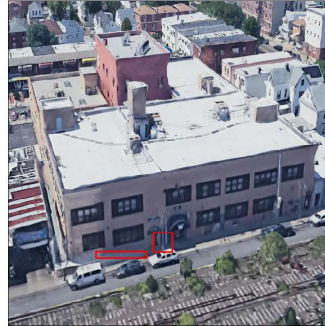
Roof Plan reference

STUCCO CEMENT SURFACE: CRACKS, SPALLING

REPLACE

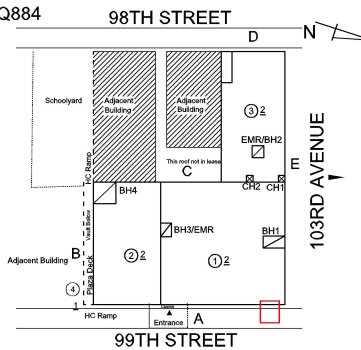
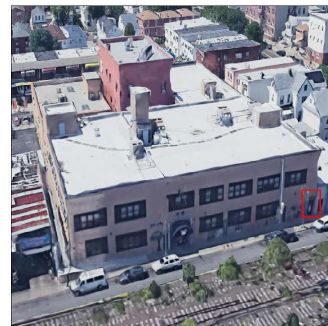
Roof Plan reference

STUCCO/PLASTER: MAJOR CRACKS/SPALLING

Question	Response
EXTERIOR	
EXTERIOR SOFFITS	
Quantity Uom	S.F.
Potential Action	REPLACE
Urgency of Action	PRIORITY 5
Purpose of Action	LEVEL 6
Deficiency Photo1

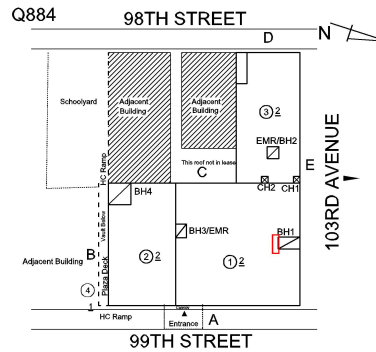
Roof Plan reference

LEADERS, GUTTERS, DOWNSPOUTS, SCUPPERS	Inspected
Condition	3 - Fair
Deficiency	DAMAGED/MISSING

10
L.F.
REPLACE
PRIORITY 4
LEVEL 2

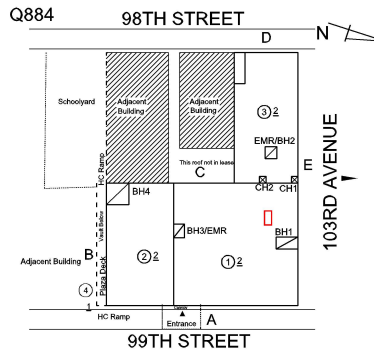
Roof Plan reference	Q884
---------------------	------

Deficiency	MODIFIED BITUMEN: ROOFING: MAJOR ACTIVE ROOF LEAKS IN INSTRUCTIONAL SPACE
------------	---

Deficiency Quantity	100
Quantity Uom	S.F.
Potential Action	REPLACE ROOFING WITHOUT MAJOR EQUIPMENT REMOVAL
Urgency of Action	PRIORITY 5
Purpose of Action	LEVEL 2
Deficiency Photo1

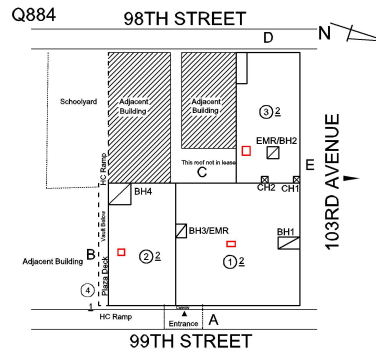
Roof Plan reference

ROOFING DRAINS

3
 EACH
 REPLACE
 PRIORITY 4
 LEVEL 2

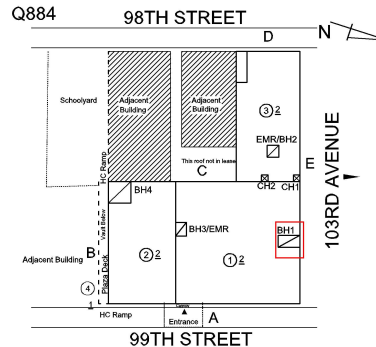
BULKHEAD/PENTHOUSE WALLS/INTERIOR: BRICK CRACKS/SPALLING

30
 S.F.
 REPLACE
 PRIORITY 3
 LEVEL 2

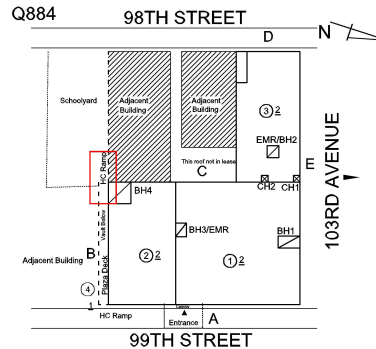
Roof Plan reference

CAST IN PLACE CONCRETE: CRACKS/SPALLING - MINOR

REPAIR

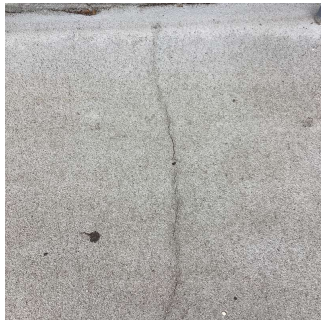
Question	Response
EXTERIOR	
STAIRS/RAMPS: EXTERIOR	
BUILDING CHEEK/FLANK WALLS	Inspected
Violations	Facade B No violations recorded.
RAILINGS	Inspected
Condition	2 - Between Good and Fair
Deficiency	No deficiencies recorded
STAIRS/RAMPS	Inspected
Condition	2 - Between Good and Fair
Deficiency	CONCRETE: CRACKS/SPALLING - MINOR
Roof Plan reference	Q884
Deficiency Quantity	10
Quantity Uom	S.F.
Potential Action	REPAIR
Urgency of Action	PRIORITY 3
Purpose of Action	LEVEL 2
Deficiency Photo1

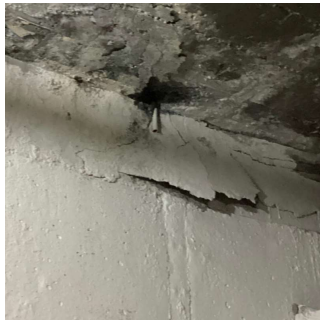
Basement - Room 31
Violations	No violations recorded.
ROOF STRUCTURE	
Condition	Inspected
	2 - Between Good and Fair
Deficiency	No deficiencies recorded
VAULTS-BUNKERS	
	Inspected
Foundation Walls	Inspected
Condition	3 - Fair
Deficiency	CRACKS, SPALLING
Deficiency Location/Instance	Basement - Room 31
Deficiency Quantity	10
Quantity Uom	S.F.
Potential Action	REPAIR
Urgency of Action	PRIORITY 4
Purpose of Action	LEVEL 5
Deficiency Photo1

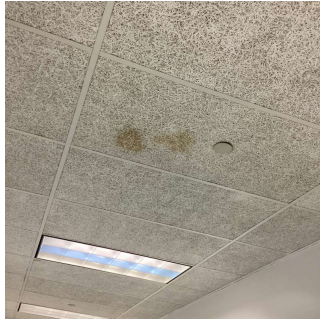
Violations	Near Windows No violations recorded.
Window Curtains/Shades/Blinds	
Instance on 1st Floor (1500SF)	Does not Exist
CLASSROOMS/CORRIDORS/ADMIN SPACES	
Ceiling	Inspected
Condition	2 - Between Good and Fair
Deficiency	TECTUM: DAMAGED/MISSING - ACTIVE LEAK
Deficiency Location/Instance	Corridor near Room 223
Deficiency Quantity	10
Quantity Uom	S.F.
Potential Action	REPLACE
Urgency of Action	PRIORITY 5
Purpose of Action	LEVEL 2
Deficiency Photo1

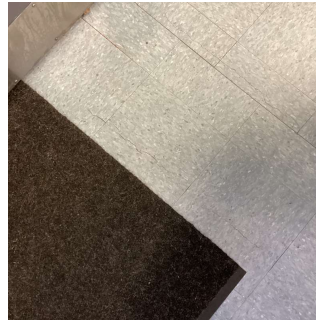
Stair E/1

Violations	Room 212 No violations recorded.
SCIENCE LAB	Does not Exist
SCIENCE PREP ROOM	Inspected
Instance on Room 212A	Inspected
Alternative use	Yes
Fixed Equipment	
Instance on Room 212A	Inspected
Condition	2 - Between Good and Fair
Deficiency	No deficiencies recorded
SHOWER ROOM	Does not Exist
STAIRS/RAMPS: INTERIOR	Inspected
Do Letter Stair Signs Exist?	Yes
Ceiling	Inspected
Condition	2 - Between Good and Fair
Deficiency	No deficiencies recorded
Door(s)	Inspected
Condition	2 - Between Good and Fair
Deficiency	No deficiencies recorded
Partition	Does not Exist
Railings	Inspected
Condition	2 - Between Good and Fair
Deficiency	No deficiencies recorded
Stairs and Landings	Inspected
Condition	2 - Between Good and Fair
Deficiency	VINYL TILES: BROKEN/DETERIORATED/MISSING TILES
Deficiency Location/Instance	Stair E/Basement, 1
Deficiency Quantity	10

Quantity Uom	S.F.
Potential Action	REPLACE
Urgency of Action	PRIORITY 3
Purpose of Action	LEVEL 2

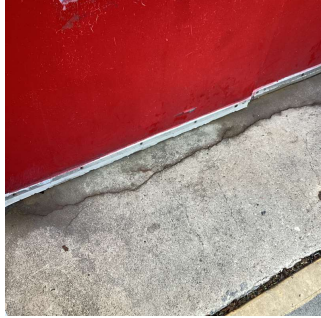
Entrance 98th Street
Violations	No violations recorded.
Pavers	Does not Exist

Near 98th Street
Violations	No violations recorded.
Concrete	Does not Exist
Pavers	Does not Exist
Site Sidewalks & Walkways	Inspected
Asphalt	Does not Exist
Concrete	Inspected
Condition	2 - Between Good and Fair
Deficiency	DAMAGED/DETERIORATED/MISSING SECTIONS
Deficiency Location/Instance	Entrance 98th Street
Deficiency Quantity	30
Quantity Uom	S.F.
Potential Action	REPLACE
Urgency of Action	PRIORITY 3
Purpose of Action	LEVEL 2
Deficiency Photo1
