**NYC Department of Education**  
**Building Condition Assessment Survey 2023 - 2024**

Architectural Inspection

Q891

**Asset:** R. F. WAGNER SEC SCL ARTS & TECH-Q, 47-07 30TH PLACE, New York, 11101

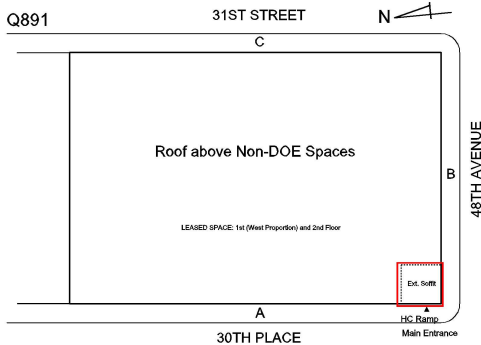
Facade A
Violations	No violations recorded.
<b>EXTERIOR SOFFITS</b>	
Condition	Inspected
Deficiency	2 - Between Good and Fair
	No deficiencies recorded
<b>LOADING DOCK</b>	
	Not Required
<b>LOUVER</b>	
Condition	Inspected
Deficiency	2 - Between Good and Fair
	No deficiencies recorded
<b>PARAPETS</b>	
	Not Required
<b>PLAZA DECK</b>	
	Does not Exist
<b>ROOF</b>	
	Not Required
<b>STAIRS/RAMPS: EXTERIOR</b>	
	Inspected
<b>BUILDING CHEEK/FLANK WALLS</b>	
Condition	Inspected
Deficiency	2 - Between Good and Fair
	No deficiencies recorded
<b>RAILINGS</b>	
Condition	Inspected
Deficiency	4 - Between Fair and Poor
Roof Plan reference	RUST - MAJOR

Deficiency Quantity	20
Quantity Uom	L.F.
Potential Action	REPLACE
Urgency of Action	PRIORITY 4
Purpose of Action	LEVEL 2

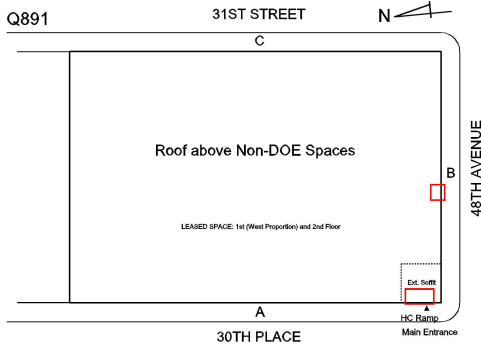
Violations	Facade A No violations recorded.
<b>STAIRS/RAMPS</b>	
Condition	Inspected 5 - Poor
Deficiency	CONCRETE: CRACKS/SPALLING - MAJOR
Roof Plan reference	Q891

Deficiency Quantity	40
Quantity Uom	S.F.
Potential Action	REPLACE
Urgency of Action	PRIORITY 4
Purpose of Action	LEVEL 2
Deficiency Photo1

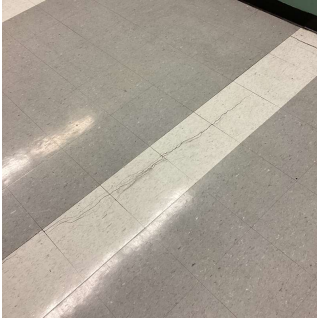
Question	Response
<b>INTERIOR</b>	
<b>CLASSROOMS/CORRIDORS/ADMIN SPACES</b>	
<b>Door(s)</b>	Inspected
Condition	2 - Between Good and Fair
Deficiency	No deficiencies recorded
<b>Floor Finish</b>	Inspected
Condition	2 - Between Good and Fair
Deficiency	VINYL TILES: DETERIORATED SUBSTRATE
Deficiency Location/Instance	Corridor near Cafeteria, Corridor near Rooms 295, 226, 215, 121 and others
Deficiency Quantity	250
Quantity Uom	S.F.
Potential Action	REPLACE
Urgency of Action	PRIORITY 3
Purpose of Action	LEVEL 2
Deficiency Photo1

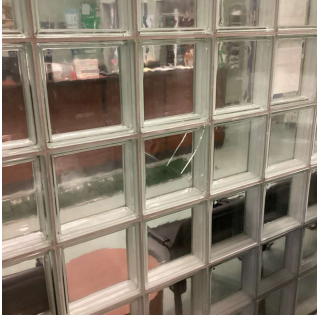
Violations	Corridor near Cafeteria No violations recorded.
<b>Walls</b>	Inspected
Condition	2 - Between Good and Fair
Deficiency	GLASS BLOCK: DAMAGED/MISSING
Deficiency Location/Instance	Corridor near Main Office
Deficiency Quantity	10
Quantity Uom	S.F.
Potential Action	REPLACE
Urgency of Action	PRIORITY 3
Purpose of Action	LEVEL 2
Deficiency Photo1

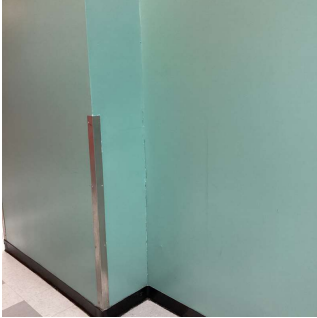
Deficiency	GYPSUM BOARD: DETERIORATED
Deficiency Location/Instance	Corridor near Cafeteria, Rooms 269, 226, 117, Main Entrance Lobby and others
Deficiency Quantity	300
Quantity Uom	S.F.

Question	Response
<b>INTERIOR</b>	
<b>CLASSROOMS/CORRIDORS/ADMIN SPACES</b>	
<b>Walls</b>	
Potential Action	REPLACE
Urgency of Action	PRIORITY 3
Purpose of Action	LEVEL 2
Deficiency Photo1

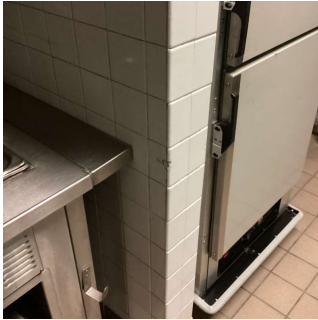
Question	Response
<b>INTERIOR</b>	
<b>KITCHEN</b>	
<b>Walls</b>	
Deficiency Photo1	 
Violations	Students Serving Area No violations recorded.
Deficiency	CERAMIC TILE: BROKEN/ MISSING
Deficiency Location/Instance	Students Serving Area
Deficiency Quantity	10
Quantity Uom	S.F.
Potential Action	REPLACE
Urgency of Action	PRIORITY 3
Purpose of Action	LEVEL 2
Deficiency Photo1

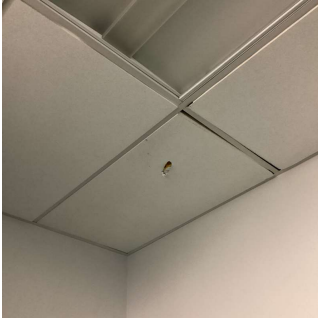
Question	Response
<b>INTERIOR</b>	
<b>LOCKER ROOM</b>	
<b>Ceiling</b>	
Condition	2 - Between Good and Fair
Deficiency	ACOUSTIC TILES: DAMAGED/MISSING
Deficiency Location/Instance	Right Side
Deficiency Quantity	10
Quantity Uom	S.F.
Potential Action	REPLACE
Urgency of Action	PRIORITY 3
Purpose of Action	LEVEL 2
Deficiency Photo1

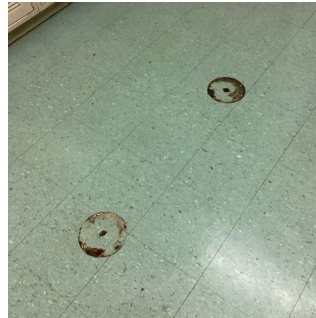
Instance on 2nd Floor - Boys (72 Lockers)	Inspected
Condition	2 - Between Good and Fair
Deficiency	No deficiencies recorded
Instance on 2nd Floor - Girls (75 Lockers)	Inspected
Condition	2 - Between Good and Fair
Deficiency	No deficiencies recorded
<b>Floor Finish</b>	
Instance on 2nd Floor - Boys (72 Lockers)	Inspected
Condition	2 - Between Good and Fair
Deficiency	VINYL TILES: BROKEN/DETERIORATED/MISSING TILES
Deficiency Location/Instance	Center
Deficiency Quantity	10
Quantity Uom	S.F.
Potential Action	REPLACE
Urgency of Action	PRIORITY 3

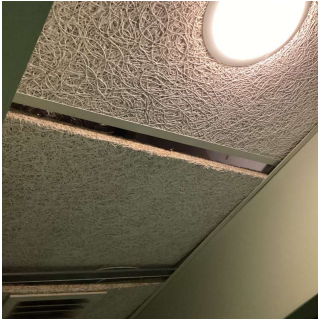
Question	Response
<b>INTERIOR</b>	
<b>SCIENCE PREP ROOM</b>	
	Inspected
Instance on Room 234	Inspected
Alternative use	No
<b>Fixed Equipment</b>	
Instance on Room 234	Inspected
Condition	2 - Between Good and Fair
Deficiency	No deficiencies recorded
<b>SHOWER ROOM</b>	
	Inspected
Instance on 2nd Floor - Boys	Inspected
Alternative use	Yes
Instance on 2nd Floor - Girls	Inspected
Alternative use	Yes
<b>Ceiling</b>	
Instance on 2nd Floor - Boys	Inspected
Condition	3 - Fair
Deficiency	TECTUM: DAMAGED/MISSING
Deficiency Location/Instance	Near Entrance
Deficiency Quantity	10
Quantity Uom	S.F.
Potential Action	REPLACE
Urgency of Action	PRIORITY 3
Purpose of Action	LEVEL 2
Deficiency Photo1
