NYC Department of Education
Building Condition Assessment Survey 2023 - 2024

Architectural Inspection

Asset: P.S. 892 - QUEENS, 199-10 112TH AVENUE, New York, 11412

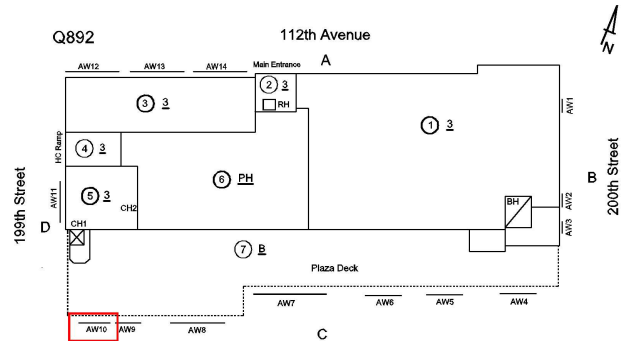
AREAWAY SLAB: CRACKS AND SPALLING

REPAIR

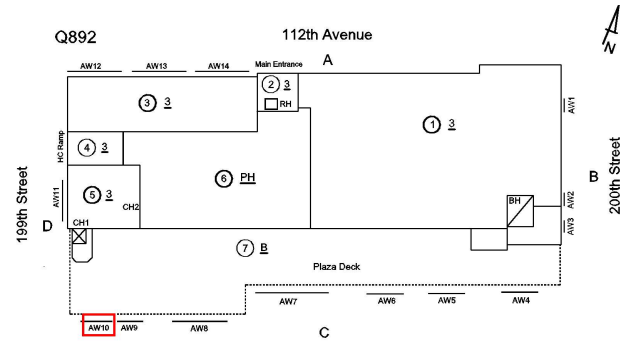
Roof Plan reference

AREAWAY DRAINS: DETERIORATED

REPLACE

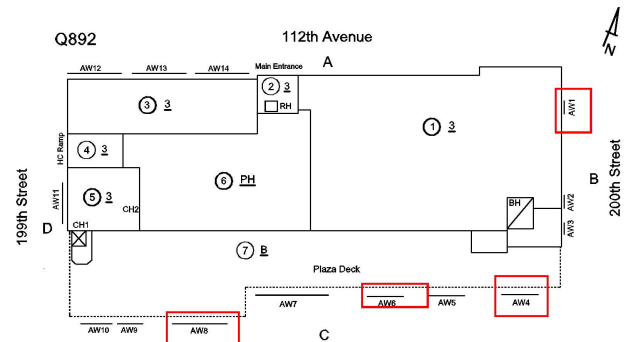
Roof Plan reference

AREAWAY WALLS: CRACKS AND SPALLING

Deficiency Quantity	40
Quantity Uom	S.F.
Potential Action	REPAIR
Urgency of Action	PRIORITY 3
Purpose of Action	LEVEL 2
Deficiency Photo1

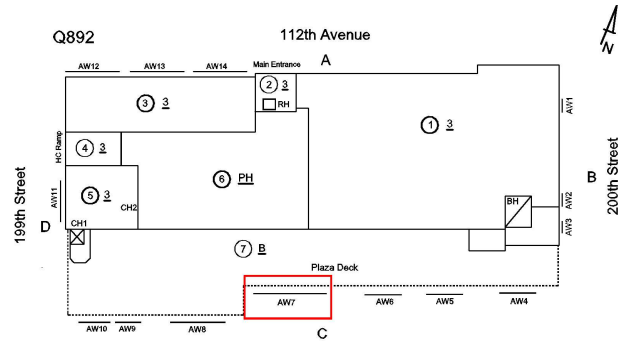
Roof Plan reference

Deficiency AREAWAY STAIRS: DETERIORATED TREADS/RISERS/NOSINGS

Deficiency Quantity	10
Quantity Uom	S.F.
Potential Action	REPAIR
Urgency of Action	PRIORITY 3
Purpose of Action	LEVEL 2
Deficiency Photo1

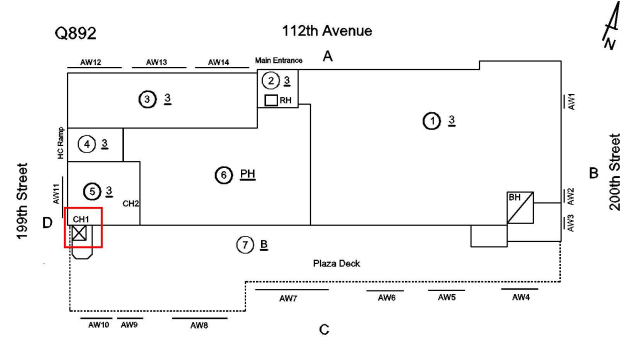
Roof Plan reference

Deficiency BRICK: DETERIORATED JOINTS

50
S.F.
REPOINT
PRIORITY 3
LEVEL 2

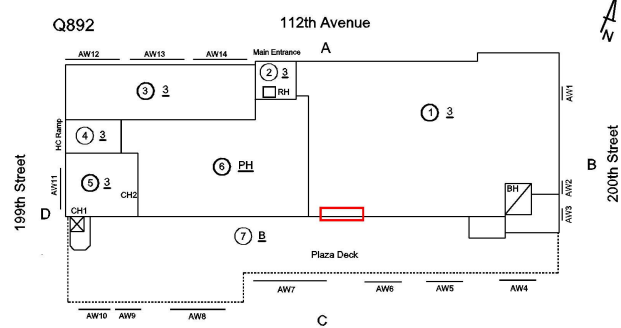
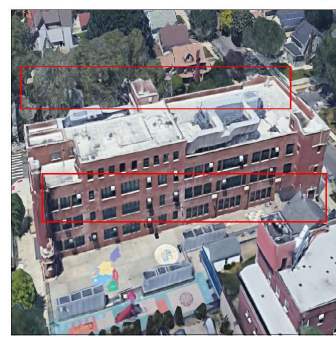
Question	Response
EXTERIOR	
EXTERIOR WALLS	
Instance Condition	5 - Poor
Instance Quantity	12,000
Instance Quantity Uom	S.F.
Deficiency	BRICK: WATER INFILTRATION IN INSTRUCTIONAL SPACE
Roof Plan reference

Violations	Facade C - Room 314, also Rooms 310, 312, 316, 320, 220, 216, 214, 212, 210, Facade A - Rooms 301, 303, 201
Violations	No violations recorded.
Deficiency	BRICK: DETERIORATED JOINTS

Deficiency Quantity	1,300
Quantity Uom	S.F.
Potential Action	REPAIR
Urgency of Action	PRIORITY 5
Purpose of Action	LEVEL 2
Deficiency Photo1

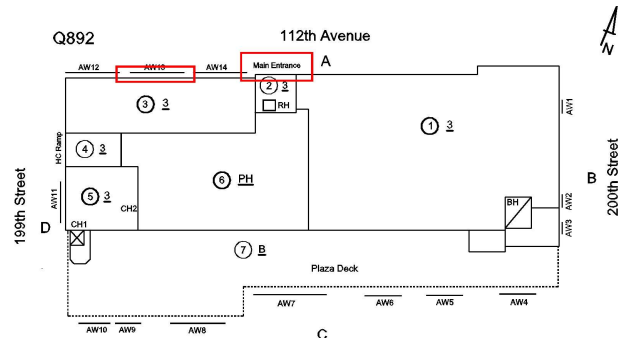
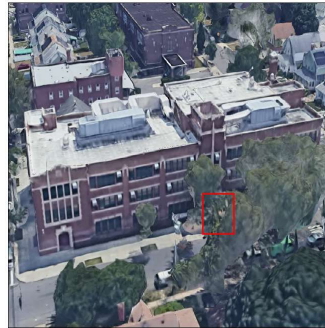
STONE: CHIPPED/SPALLED/BROKEN PIECES - MINOR

REPAIR

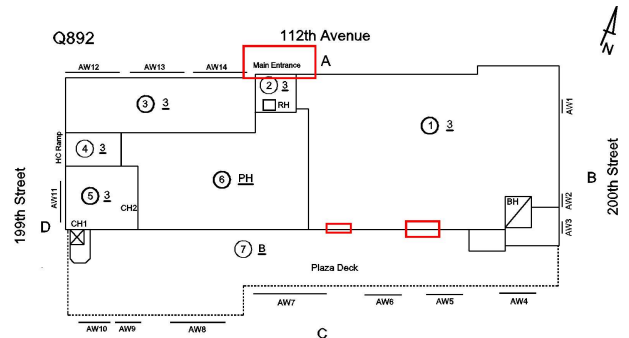
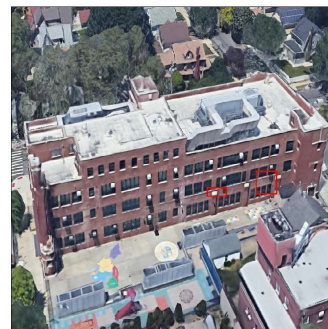
BRICK: DETERIORATED JOINTS

Question	Response
EXTERIOR	
EXTERIOR WALLS	
Urgency of Action	PRIORITY 4
Purpose of Action	LEVEL 2
Deficiency Photo1

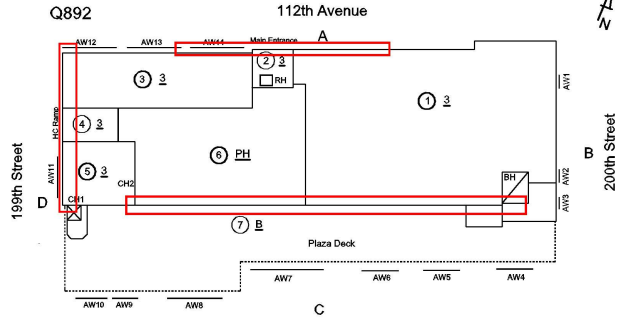
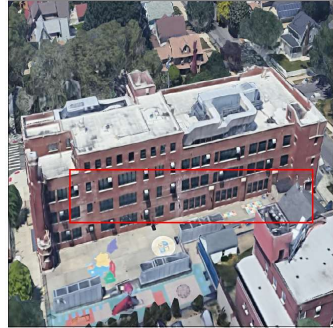
Violations	Facade A No violations recorded.
Deficiency	BRICK: EFFLORESCENCE
Rooftop reference

Deficiency Quantity	2,000
Quantity Uom	S.F.
Potential Action	MAINTENANCE
Urgency of Action	PRIORITY 1
Purpose of Action	LEVEL 1
Deficiency Photo1	No photo recorded
Violations	No violations recorded.
EXTERIOR SOFFITS	
Condition	Inspected
Deficiency	2 - Between Good and Fair
LOADING DOCK	
Deficiency	No deficiencies recorded
LOUVER	
Condition	Does not Exist
Deficiency	Inspected
Condition	2 - Between Good and Fair
Deficiency	No deficiencies recorded
PARAPETS	
Condition	Inspected

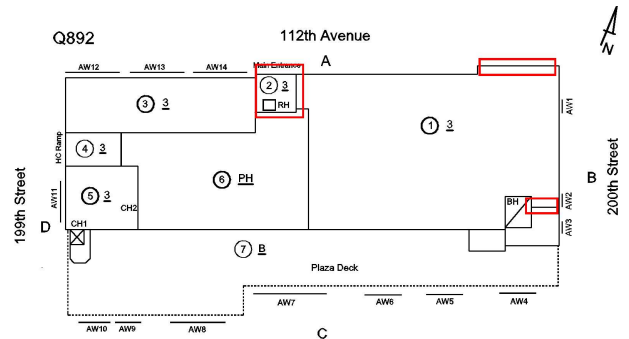
Material Type(s)	Masonry
Replacement Quantity	2,000
Replacement Uom	C.F.
Instance on All Facades	Inspected
Instance Condition	3 - Fair
Instance Quantity	2,000
Instance Quantity Uom	C.F.
Deficiency	BRICK: EFFLORESCENCE
Roof Plan reference

Deficiency Quantity	100
Quantity Uom	S.F.
Potential Action	MAINTENANCE
Urgency of Action	PRIORITY 1
Purpose of Action	LEVEL 1
Deficiency Photo1	No photo recorded
Violations	No violations recorded.

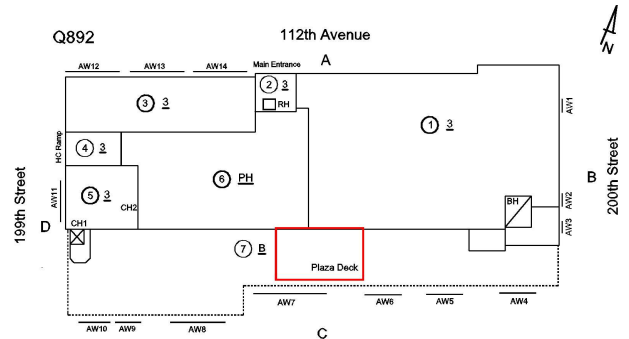
Instance on Concrete: Roof 7	Inspected
Instance Condition	5 - Poor
Instance Quantity	6,000
Instance Quantity Uom	S.F.
Installation Year	2000
Source of Installation	Custodial Staff
Deficiency	CONCRETE: MAJOR ACTIVE PLAZA DECK LEAKS IN INSTRUCTIONAL SPACE
Roof Plan reference

Question	Response
EXTERIOR	
PLAZA DECK	
Deficiency Photo1	 
Violations	Roof 7 - Basement Cafeteria, also Kitchen, Rooms C26g, C14 No violations recorded.
ROOF	Inspected
Roofing	Inspected
Replacement Quantity	12,000
Replacement Uom	S.F.
ROOF HATCH/SMOKE HATCH	Inspected
Condition	2 - Between Good and Fair
Deficiency	No deficiencies recorded
LEADERS, GUTTERS, DOWNSPOUTS, SCUPPERS	Inspected
Condition	2 - Between Good and Fair
Deficiency	No deficiencies recorded
ROOF BARRIER/FENCE	Inspected
Condition	2 - Between Good and Fair
Deficiency	No deficiencies recorded
ROOF CAGE	Does not Exist
ROOFING	Inspected
Instance on Modified Bitumen: Roofs 1-6	Inspected
Instance Condition	3 - Fair
Instance Photo	 
	Roof 1
Instance Quantity	12,000
Instance Quantity Uom	S.F.
Does the roof have major mechanical equipment sitting on Dunnage Steel less than 18" above the Roofing?	No
Does this roof instance have a Sustainable Roof System?	Yes
Sustainable Roof Type	White Roof

Deficiency Quantity	400
Quantity Uom	S.F.
Potential Action	REPLACE
Urgency of Action	PRIORITY 5
Purpose of Action	LEVEL 2

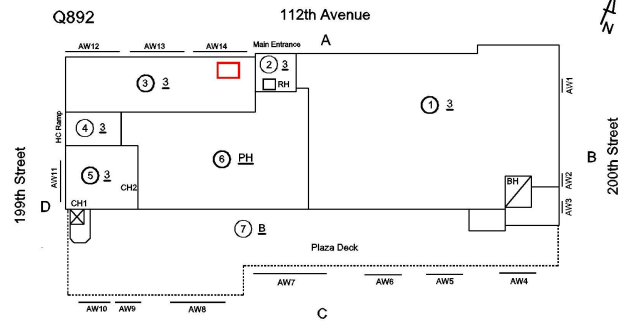
Roof Plan reference

Sustainable Roof Location (Roof Number)	All Roofs
Do solar panels exist on these roofs?	No
Is/Are the roof(s) suitable for Solar Panel installation?	Yes
Installation Year	2015
Source of Installation	Custodial Staff
Deficiency	MODIFIED BITUMEN: ROOFING: MAJOR ACTIVE ROOF LEAKS IN INSTRUCTIONAL SPACE

100
S.F.
REPLACE ROOFING WITHOUT MAJOR EQUIPMENT
REMOVAL
PRIORITY 5
LEVEL 2

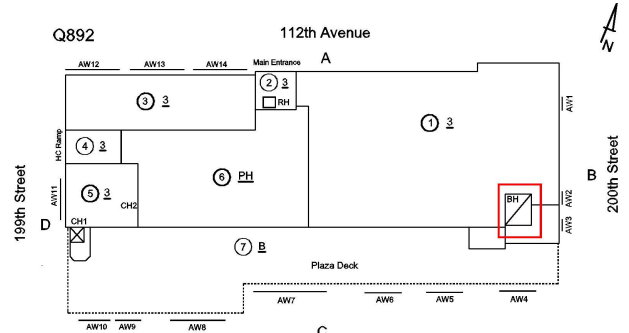
Roof Plan reference

BULKHEAD/PENTHOUSE WALLS/INTERIOR: PLASTER
CRACKS/SPALLING

10
S.F.
REPLACE

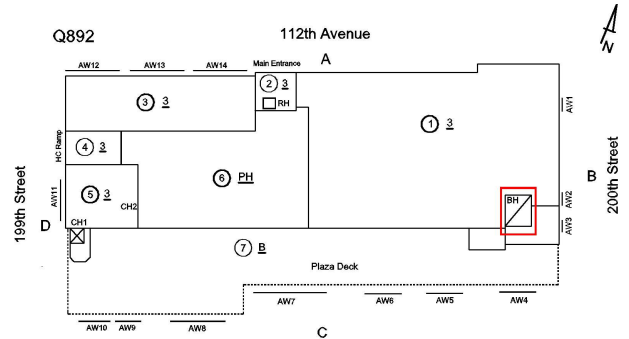
Roof Plan reference

BULKHEAD/PENTHOUSE ROOF: MAJOR LEAKAGE

100
S.F.
REPLACE
PRIORITY 5
LEVEL 2

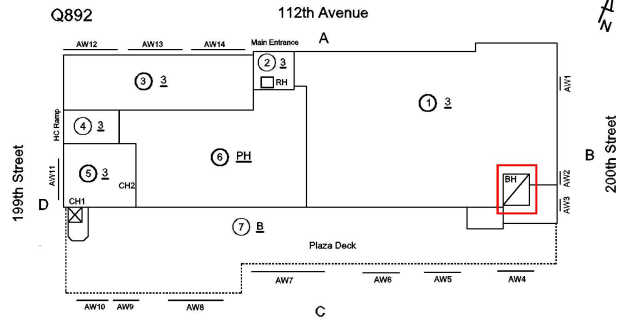
Roof Plan reference

BULKHEAD/PENTHOUSE WINDOWS: AIR/WATER INFILTRATION WITH DAMAGED CAULKING

10
L.F.
MAINTENANCE
PRIORITY 3
LEVEL 2

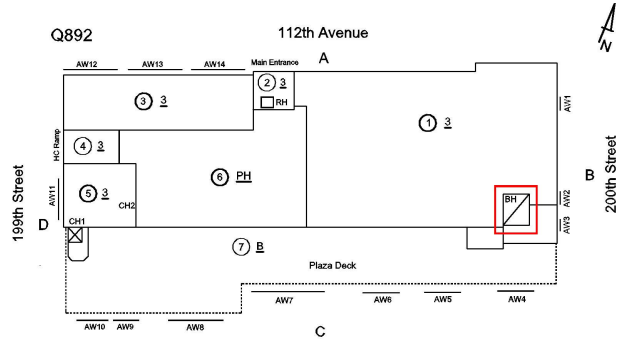
Roof Plan reference

BULKHEAD/PENTHOUSE WALLS/INTERIOR: SALT GLAZED BRICK CRACKS/SPALLING

10
S.F.
REPLACE
PRIORITY 3
LEVEL 2

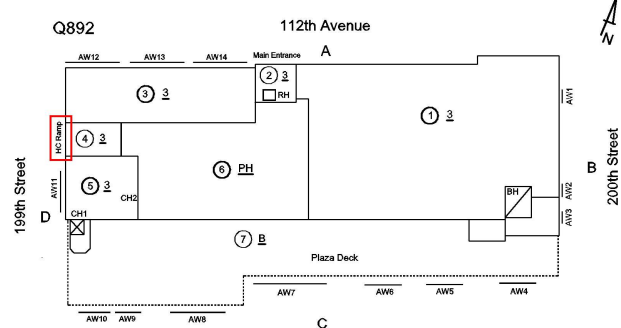
Question	Response
EXTERIOR	
STAIRS/RAMPS: EXTERIOR	Inspected
BUILDING CHEEK/FLANK WALLS	Inspected
Condition	2 - Between Good and Fair
Deficiency	CAST IN PLACE CONCRETE: CRACKS/SPALLING - MINOR
Roof Plan reference

Deficiency Quantity	10
Quantity Uom	S.F.
Potential Action	REPAIR
Urgency of Action	PRIORITY 3
Purpose of Action	LEVEL 2
Deficiency Photo1

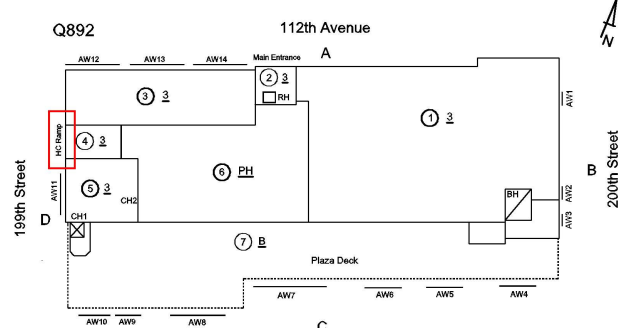
RAILINGS	Inspected
Condition	3 - Fair
Deficiency	DAMAGED
Roof Plan reference

Deficiency Quantity	10
Quantity Uom	L.F.
Potential Action	REPLACE
Urgency of Action	PRIORITY 4
Purpose of Action	LEVEL 2

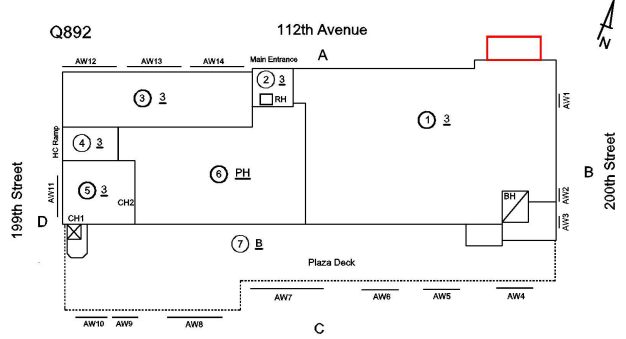
Violations	Facade D No violations recorded.
STAIRS/RAMPS	
Condition	Inspected 3 - Fair
Deficiency	STONE: DETERIORATED JOINTS
Roof Plan reference

Deficiency Quantity	10
Quantity Uom	L.F.
Potential Action	REPOINT
Urgency of Action	PRIORITY 3
Purpose of Action	LEVEL 2
Deficiency Photo1

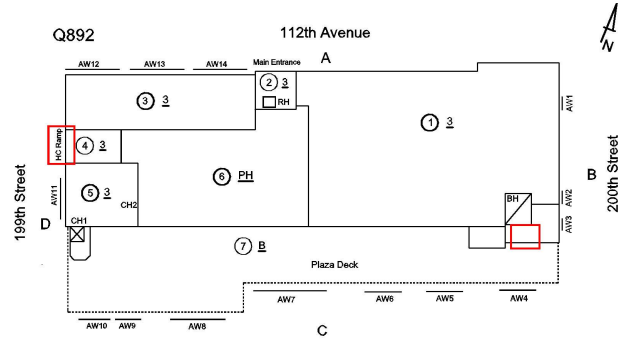
Roof Plan reference

Violations	Facade A No violations recorded.
Deficiency	STONE: CRACKS/SPALLING - MINOR

20
 S.F.
 REPAIR
 PRIORITY 3
 LEVEL 2

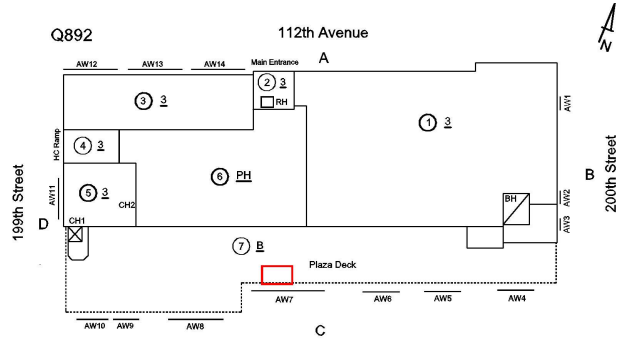
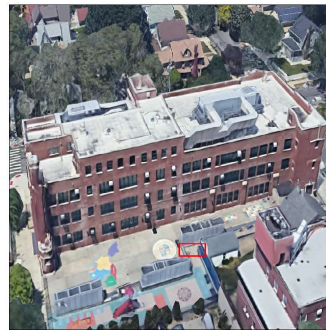
WINDOWS	Inspected
Replacement Quantity	8,000
Replacement Uom	S.F.
EXTERIOR GUARDS	Inspected
Condition	2 - Between Good and Fair
Deficiency	No deficiencies recorded
LINTELS	Inspected
Condition	2 - Between Good and Fair
Deficiency	No deficiencies recorded
WINDOWS	Inspected
Material Type(s)	Aluminum
Instance on Aluminum - Other: All Facades	Inspected
Instance Condition	3 - Fair
Instance Quantity	8,000
Instance Quantity Uom	S.F.
Are these windows insulated	Yes
Installation Year	2015
Source of Installation	Custodial Staff
Deficiency	ALUMINUM - OTHER: AIR/WATER INFILTRATION

Facade C - Room C20
No violations recorded.

20
L.F.
REPLACE TRIM, SILLS OR WEATHERSTRIPPING
PRIORITY 5
LEVEL 2

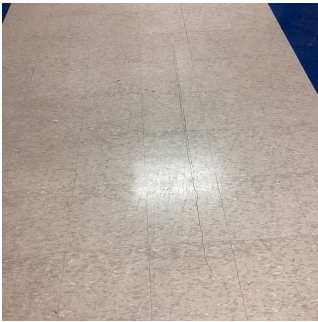
Question	Response
INTERIOR	
CAFETERIA	
Ceiling	
Violations	No violations recorded.
Door(s)	
Instance on Basement (1,500 SF)	Inspected
Condition	2 - Between Good and Fair
Deficiency	No deficiencies recorded
Fixed Equipment	
Instance on Basement (1,500 SF)	Does not Exist
Floor Finish	
Instance on Basement (1,500 SF)	Inspected
Condition	2 - Between Good and Fair
Deficiency	VINYL TILES: DETERIORATED SUBSTRATE
Deficiency Location/Instance	Near Entrance from Stair D
Deficiency Quantity	20
Quantity Uom	S.F.
Potential Action	REPLACE
Urgency of Action	PRIORITY 3
Purpose of Action	LEVEL 2
Deficiency Photo1

Violations	Near Entrance from Stair D No violations recorded.
Sliding-folding Partition	
Instance on Basement (1,500 SF)	Does not Exist
Stage	
Instance on Basement (1,500 SF)	Does not Exist
Walls	
Instance on Basement (1,500 SF)	Inspected
Condition	2 - Between Good and Fair
Deficiency	No deficiencies recorded
Window Curtains/Shades/Blinds

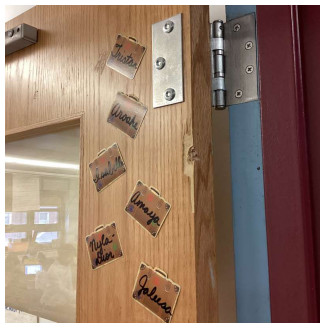
Violations	Corridor near Stair C/Basement No violations recorded.
Door(s)	Inspected
Condition	5 - Poor
Deficiency	WOOD: DETERIORATED DOOR
Deficiency Location/Instance	Rooms 201, 214, 311, 312, 314
Deficiency Quantity	5
Quantity Uom	EACH
Potential Action	MAINTENANCE
Urgency of Action	PRIORITY 3
Purpose of Action	LEVEL 2

Room 312
Violations	No violations recorded.
Floor Finish	Inspected
Condition	2 - Between Good and Fair
Deficiency	No deficiencies recorded
Walls	Inspected
Condition	2 - Between Good and Fair
Deficiency	GLAZED BLOCK: CRACKS/SPALLING
Deficiency Location/Instance	Corridor near Room 208
Deficiency Quantity	10
Quantity Uom	S.F.
Potential Action	REPLACE
Urgency of Action	PRIORITY 3
Purpose of Action	LEVEL 2
Deficiency Photo1

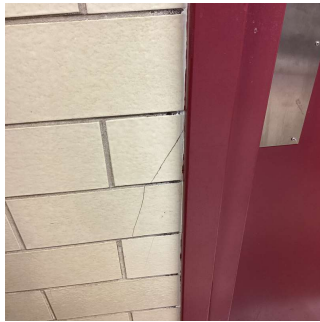
Corridor near Room 208
Violations	No violations recorded.
Deficiency	GYPSUM BOARD: DETERIORATED
Deficiency Location/Instance	Rooms 308, 315, Corridor near Room 210
Deficiency Quantity	30
Quantity Uom	S.F.
Potential Action	REPLACE
Urgency of Action	PRIORITY 3
Purpose of Action	LEVEL 2

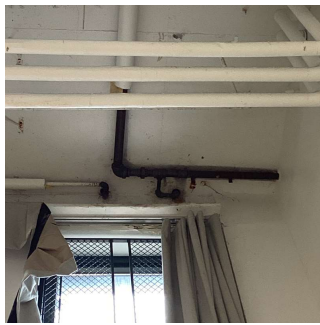
Question	Response
INTERIOR	
GYMNASIUM	
Ceiling	
Deficiency Photo1

Violations	Rear Left Side No violations recorded.
Door(s)	
Instance on Basement	Inspected
Condition	2 - Between Good and Fair
Deficiency	No deficiencies recorded
Fixed Equipment	
Instance on Basement	Inspected
Condition	2 - Between Good and Fair
Deficiency	No deficiencies recorded
Floor Finish	
Instance on Basement	Inspected
Condition	2 - Between Good and Fair
Deficiency	No deficiencies recorded
Seating	
Instance on Basement	Does not Exist
Sliding-folding Partition	
Instance on Basement	Does not Exist
Stage	
Instance on Basement	Inspected
Stage	Inspected
Instance on Basement	Inspected
Condition	2 - Between Good and Fair
Deficiency	No deficiencies recorded
Stage Curtain Rigging	
Instance on Basement	Inspected
Condition	2 - Between Good and Fair
Deficiency	No deficiencies recorded
Stage Curtains	
Instance on Basement	Inspected
Condition	2 - Between Good and Fair

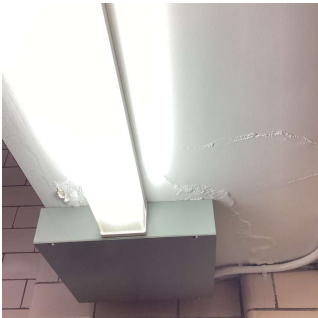
Question	Response
INTERIOR	
SCIENCE LAB	Inspected
Fixed Equipment	
Condition	2 - Between Good and Fair
Deficiency	No deficiencies recorded
SCIENCE PREP ROOM	Inspected
Instance on Room 208	Inspected
Alternative use	No
Fixed Equipment	
Instance on Room 208	Inspected
Condition	2 - Between Good and Fair
Deficiency	No deficiencies recorded
SHOWER ROOM	Does not Exist
STAIRS/RAMPS: INTERIOR	Inspected
Do Letter Stair Signs Exist?	Yes
Ceiling	
Condition	2 - Between Good and Fair
Deficiency	PLASTER: CRACKS/SPALLING
Deficiency Location/Instance	Stair C/3
Deficiency Quantity	20
Quantity Uom	S.F.
Potential Action	REPLACE
Urgency of Action	PRIORITY 3
Purpose of Action	LEVEL 2
Deficiency Photo1

Violations	Stair C/3 No violations recorded.
Deficiency	GYPSUM BOARD: DAMAGED/DETERIORATED
Deficiency Location/Instance	Stair B/1
Deficiency Quantity	10
Quantity Uom	S.F.
Potential Action	REPLACE
Urgency of Action	PRIORITY 3
Purpose of Action	LEVEL 2

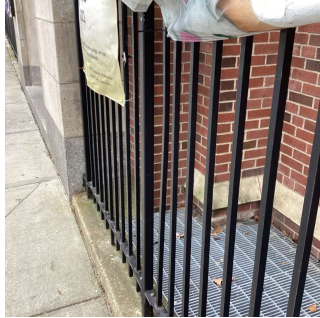
Question	Response
SITE	
FENCES	
Quantity Uom	S.F.
Potential Action	REPLACE
Urgency of Action	PRIORITY 3
Purpose of Action	LEVEL 2
Deficiency Photo1

Violations	112th Avenue No violations recorded.
Deficiency	CONCRETE CURB: DAMAGED/DETERIORATED
Deficiency Location/Instance	112th Avenue, 199th Street
Deficiency Quantity	20
Quantity Uom	S.F.
Potential Action	REPLACE
Urgency of Action	PRIORITY 3
Purpose of Action	LEVEL 2
Deficiency Photo1

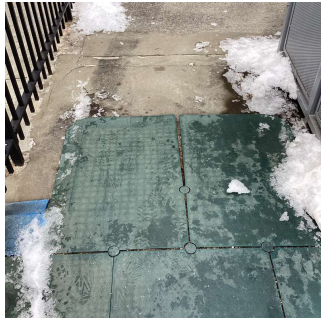
Question	Response
SITE	
PLAYGROUNDS	
Pavement	
Instance on Behind Building	Does not Exist
Play Equipment	
Instance on Behind Building	Inspected
Condition	2 - Between Good and Fair
Deficiency	No deficiencies recorded
Safety Surfacing	
Instance on Behind Building	Inspected
Condition	2 - Between Good and Fair
Deficiency	DETERIORATED/MISSING
Deficiency Location/Instance	Near 199th Street
Deficiency Quantity	10
Quantity Uom	S.F.
Potential Action	REPLACE
Urgency of Action	PRIORITY 3
Purpose of Action	LEVEL 2
Deficiency Photo1

Near 199th Street
Violations	No violations recorded.
Unpaved Area	
Instance on Behind Building	Does not Exist
PLAYING SURFACE	
	Does not Exist
RETAINING WALLS	
Are there any Retaining Walls 6' OR higher facing public street/sidewalk?	No
Condition	3 - Fair
Deficiency	CAST IN PLACE CONCRETE: CRACKS/SPALLING - MAJOR
Deficiency Location/Instance	Near Playground
Deficiency Quantity	25
Quantity Uom	S.F.
Potential Action	REPLACE

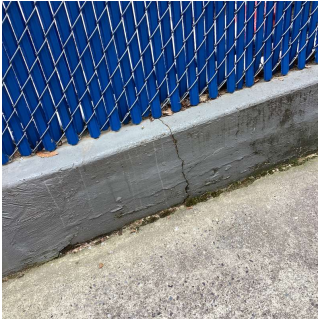
Question	Response
SITE	
RETAINING WALLS	Inspected
Deficiency Photo1

Violations	Near Playground No violations recorded.
SEATING	Does not Exist
SITE WALLS (NOT RETAINING WALLS)	Does not Exist
STAIRS/RAMPS: EXTERIOR	Inspected
Railings	Does not Exist
Site Cheek/flank Walls	Inspected
Condition	2 - Between Good and Fair
Deficiency	No deficiencies recorded
Stairs/ramps	Inspected
Condition	2 - Between Good and Fair
Deficiency	No deficiencies recorded
ARTWORK	Inspected
Instance	Interior - Main Entrance Lobby - 100008
Instance Photo
