NYC Department of Education
Building Condition Assessment Survey 2023 - 2024

Architectural Inspection

Asset: P.S. 116 TRANSPORTABLE - Q, 107-25 WREN PLACE, New York, 11433

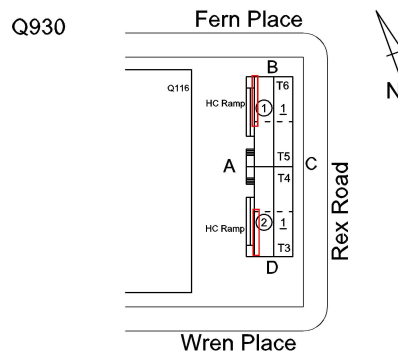
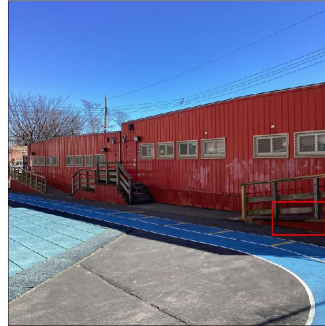
Question	Response
Architectural	
EXTERIOR	Inspected
AWNINGS AND CANOPIES	Does not Exist
DOORS	Inspected
DOORS AND FRAMES	Inspected
Condition	2 - Between Good and Fair
Deficiency	No deficiencies recorded
DOOR HARDWARE	Inspected
Condition	3 - Fair
Deficiency	No deficiencies recorded
EXTERIOR WALLS	Inspected
Material Type(s)	Steel
Replacement Quantity	4,000
Replacement Uom	S.F.
Instance on All Facades	Inspected
Instance Condition	5 - Poor
Instance Quantity	4,000
Instance Quantity Uom	S.F.
Deficiency	METAL PANEL: MAJOR RUSTING
Roof Plan reference	Q930

30

REPLACE

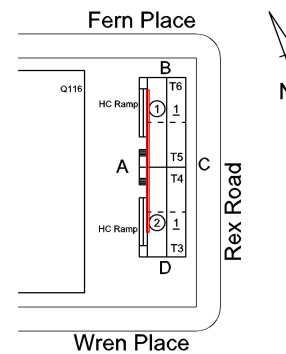
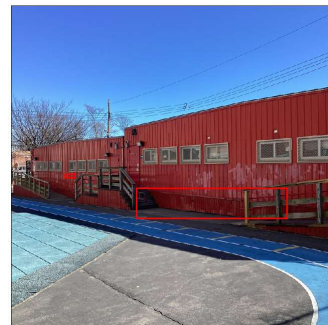
METAL PANEL: DAMAGED TRIM

30

REPLACE

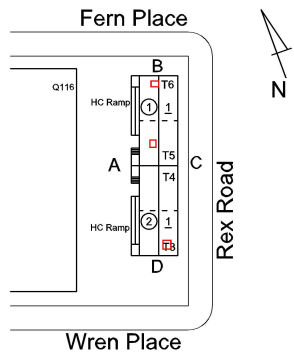
Roof 2
Instance Quantity	2,600
Instance Quantity Uom	S.F.
Does the roof have major mechanical equipment sitting on Dunnage Steel less than 18" above the Roofing?	No
Does this roof instance have a Sustainable Roof System?	No
Do solar panels exist on these roofs?	No
Is/Are the roof(s) suitable for Solar Panel installation?	No
Installation Year	1997
Source of Installation	Custodial Staff
Deficiency	SINGLE PLY, FULLY ADHERED ROOF: ROOFING: MAJOR ACTIVE ROOF LEAKS IN INSTRUCTIONAL SPACE
Roof Plan reference	Q930

Deficiency Quantity	300

Quantity Uom	S.F.
Potential Action	REPLACE ROOFING WITHOUT MAJOR EQUIPMENT REMOVAL
Urgency of Action	PRIORITY 5
Purpose of Action	LEVEL 2

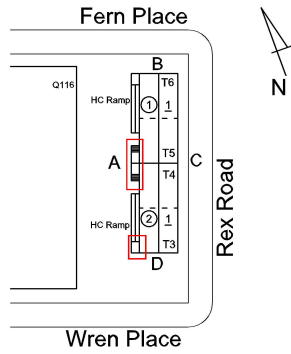
Violations	Roof 1 - Room T-6, also T-5, Roof 2 - Room - T-3 No violations recorded.
STAIRS/RAMPS: EXTERIOR	Inspected
RAILINGS	Inspected
Condition	5 - Poor
Deficiency	DAMAGED
Roof Plan reference	Q930

Deficiency Quantity	30
Quantity Uom	L.F.
Potential Action	REPLACE
Urgency of Action	PRIORITY 4
Purpose of Action	LEVEL 2
Deficiency Photo1
