**NYC Department of Education
Building Condition Assessment Survey 2023 - 2024**

Architectural Inspection

Q943

Asset: B. N. CARDOZO HS TRANSPORTABLE - Q, 57-00 223 STREET, New York, 11364

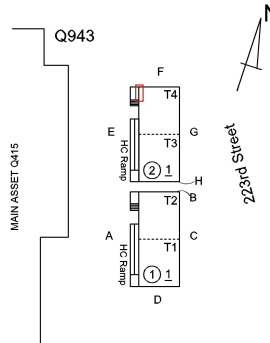
Roof Plan reference

Deficiency

METAL: DETERIORATED DOOR AND FRAME - MINOR DETERIORATION

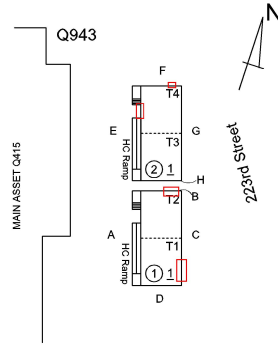
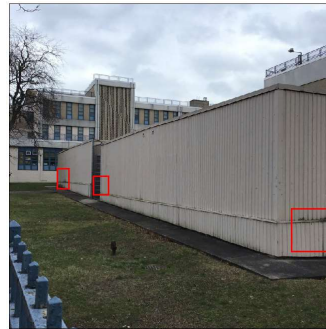
Roof Plan reference

EXTERIOR WALLS

REPLACE

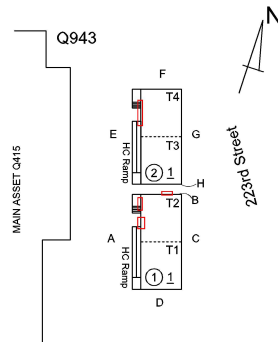
Roof Plan reference

Deficiency

METAL PANEL: MAJOR RUSTING

Question	Response
EXTERIOR	
EXTERIOR WALLS	
Elevation	 
Deficiency Quantity	40
Quantity Uom	S.F.
Potential Action	REPLACE
Urgency of Action	PRIORITY 4
Purpose of Action	LEVEL 2
Deficiency Photo1	 
Violations	Facade A - T2 No violations recorded.
EXTERIOR SOFFITS	Does not Exist
LOUVER	Inspected
Condition	2 - Between Good and Fair
Deficiency	No deficiencies recorded
ROOF	Inspected
Roofing	Inspected
Replacement Quantity	2,600
Replacement Uom	S.F.
LEADERS, GUTTERS, DOWNSPOUTS, SCUPPERS	Does not Exist
ROOFING	Inspected
Instance on Single Ply, Fully Adhered Roof: All Roofs	Inspected
Instance Condition	3 - Fair
Instance Photo	 
	Roof 1
Instance Quantity	2,600
Instance Quantity Uom	S.F.

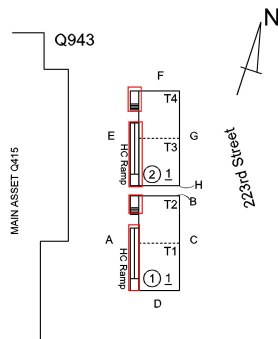
Question	Response
EXTERIOR	
ROOF	
Roofing	
ROOFING	
Does the roof have major mechanical equipment sitting on Dunnage Steel less than 18" above the Roofing?	No
Does this roof instance have a Sustainable Roof System?	No
Do solar panels exist on these roofs?	No
Is/Are the roof(s) suitable for Solar Panel installation?	No
Installation Year	2000
Source of Installation	Custodial Staff
Deficiency	No deficiencies recorded
STAIRS/RAMPS: EXTERIOR	Inspected
RAILINGS	Inspected
Condition	4 - Between Fair and Poor
Deficiency	DAMAGED
Roof Plan reference

Deficiency Quantity	20
Quantity Uom	L.F.
Potential Action	REPLACE
Urgency of Action	PRIORITY 4
Purpose of Action	LEVEL 2
Deficiency Photo1

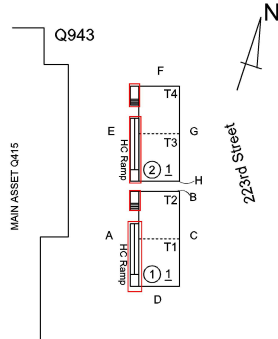
Violations	Facade E - T4 No violations recorded.
STAIRS/RAMPS	Inspected
Condition	5 - Poor
Deficiency	WOOD: DETERIORATED

Question	Response
EXTERIOR	
STAIRS/RAMPS: EXTERIOR	
STAIRS/RAMPS	
Roof Plan reference

Deficiency Quantity	60
Quantity Uom	S.F.
Potential Action	REPLACE
Urgency of Action	PRIORITY 4
Purpose of Action	LEVEL 2
Deficiency Photo1
