NYC Department of Education
Building Condition Assessment Survey 2023 - 2024

Architectural Inspection

Asset: ADULT BASIC EDUCATION - QUEENS, 27-35 JACKSON AVENUE, New York, 11101

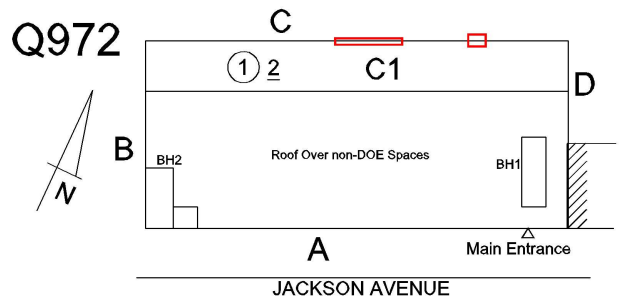
Question	Response
Architectural	
EXTERIOR	Inspected
AREAWAY	Does not Exist
AWNINGS AND CANOPIES	Does not Exist
CHIMNEY	Not Required
COPING	Inspected
Condition	3 - Fair
Deficiency	TERRA COTTA: CRACKED/BROKEN PIECES
Roof Plan reference

Deficiency Quantity	20
Quantity Uom	L.F.
Potential Action	REPLACE-IN-KIND
Urgency of Action	PRIORITY 4

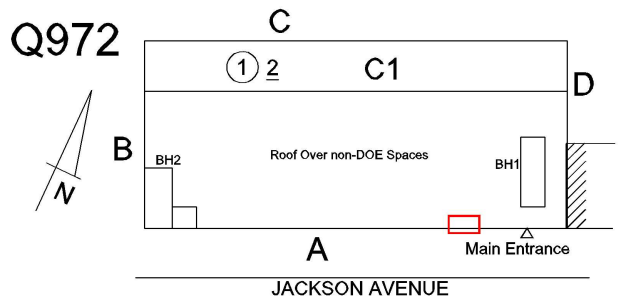
Violations	Roof 1 No violations recorded.
CORNICE	Does not Exist
DOORS	Inspected
DOORS AND FRAMES	Inspected
Condition	5 - Poor
Deficiency	METAL: DETERIORATED DOOR AND FRAME - MAJOR DETERIORATION
Roof Plan reference	<p>Q972</p>

Deficiency Quantity	2
Quantity Uom	EACH
Potential Action	REPLACE
Urgency of Action	PRIORITY 4
Purpose of Action	LEVEL 2
Deficiency Photo1

Violations	Facade A - doors do not close properly No violations recorded.
DOOR HARDWARE	Inspected
Condition	3 - Fair
Deficiency	No deficiencies recorded
LINTELS	Inspected
Condition	2 - Between Good and Fair
Deficiency	No deficiencies recorded

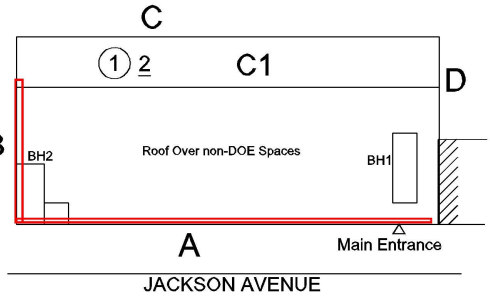
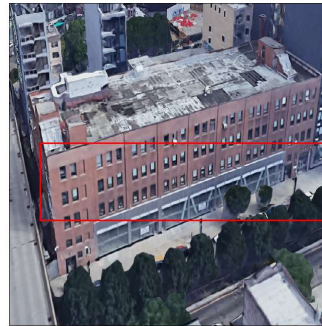
Question	Response
EXTERIOR	
DOORS	Inspected
TRANSOM/SIDE LIGHT	Inspected
Condition	2 - Between Good and Fair
Deficiency	No deficiencies recorded
EXTERIOR WALLS	Inspected
Material Type(s)	Masonry
Replacement Quantity	6,500
Replacement Uom	S.F.
Instance on Facades A, B, C1	Inspected
Instance Condition	3 - Fair
Instance Quantity	4,000
Instance Quantity Uom	S.F.
Deficiency	BRICK: DETERIORATED MASONRY SILLS - MINOR
Roof Plan reference	<p>Q972</p>
Elevation	
Deficiency Quantity	10
Quantity Uom	L.F.
Potential Action	REPAIR
Urgency of Action	PRIORITY 3
Purpose of Action	LEVEL 2
Deficiency Photo1	
Violations	Facade A No violations recorded.
Deficiency	BRICK: DETERIORATED JOINTS

Deficiency Quantity

1,000

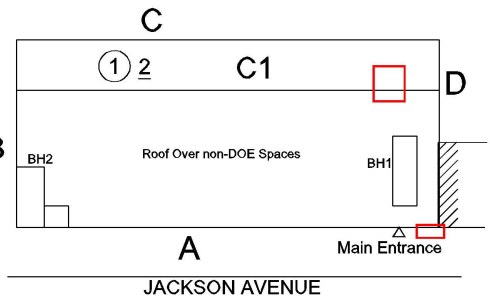
Deficiency

BRICK: DETERIORATED JOINTS

Question	Response
EXTERIOR	
EXTERIOR WALLS	
Elevation	 
Deficiency Quantity	20
Quantity Uom	S.F.
Potential Action	REPOINT
Urgency of Action	PRIORITY 4
Purpose of Action	LEVEL 2
Deficiency Photo1	 
Violations	Facade C1 No violations recorded.
Instance on Facades C, D	Inaccessible
Instance Quantity	2,500
Instance Quantity Uom	S.F.
EXTERIOR SOFFITS	Inspected
Condition	2 - Between Good and Fair
Deficiency	No deficiencies recorded
LOADING DOCK	Does not Exist
LOUVER	Inspected
Condition	2 - Between Good and Fair
Deficiency	No deficiencies recorded
PARAPETS	Inspected
Material Type(s)	Masonry
Replacement Quantity	800
Replacement Uom	C.F.
Instance on Roof 1	Inspected
Instance Condition	3 - Fair
Instance Quantity	800
Instance Quantity Uom	C.F.
Deficiency	BRICK: DETERIORATED JOINTS

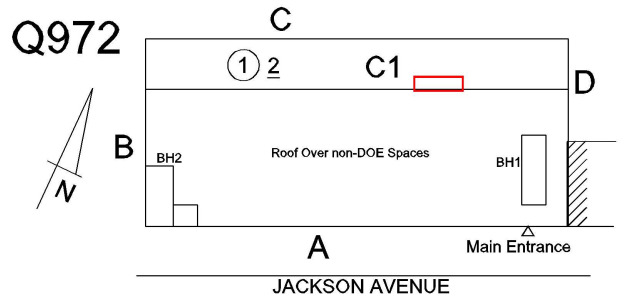
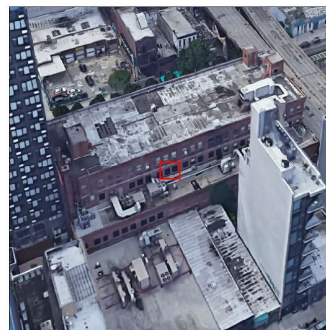
No	Potential Falling Debris	Loos exterior guard is a potential falling debris hazard.	EXTERIOR WINDOWS EXTERIOR GUARDS	North side wall on roof setback.	Donovan Dennis	Custodian
----	--------------------------	---	--------------------------------------	----------------------------------	----------------	-----------

Replacement Quantity	1,300
Replacement Uom	S.F.
EXTERIOR GUARDS	Inspected
Condition	3 - Fair
Deficiency	DETERIORATED/TORN-OUT/MISSING
Roof Plan reference

Deficiency Quantity

20

Question	Response
EXTERIOR	
WINDOWS	
EXTERIOR GUARDS	
Quantity Uom	S.F.
Potential Action	REPLACE
Urgency of Action	PRIORITY 5
Purpose of Action	LEVEL 6
Deficiency Photo1
