**NYC Department of Education
Building Condition Assessment Survey 2023 - 2024**

Architectural Inspection

Asset: P.S. 232 TRANSPORTABLE - Q, 153-23 83RD STRET, New York, 11414

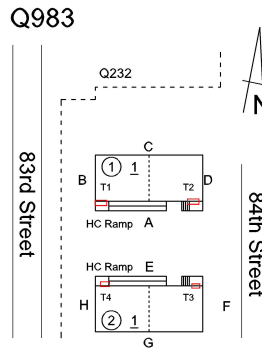
Roof Plan reference

Question	Response
Architectural	
EXTERIOR	Inspected
AWNINGS AND CANOPIES	Does not Exist
DOORS	Inspected
DOORS AND FRAMES	Inspected
Condition	3 - Fair
Deficiency	METAL: DETERIORATED DOOR AND FRAME - MINOR DETERIORATION

DOORS AND FRAMES

Deficiency Quantity
Quantity Uom
Potential Action
Urgency of Action
Purpose of Action
Deficiency Photo1

Q983
4
EACH
MAINTENANCE
PRIORITY 3
LEVEL 2

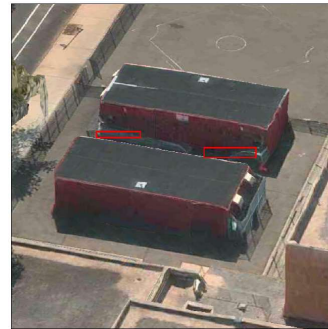
Elevation

Deficiency

METAL PANEL: MAJOR RUSTING

Deficiency Quantity

50

REPLACE

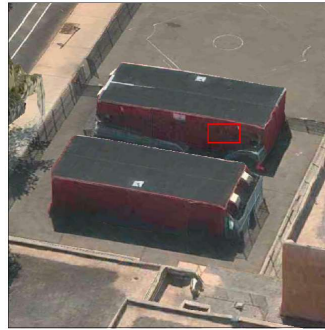
Elevation

DETERIORATED/TORN-OUT/MISSING

EXTERIOR GUARDS

Deficiency Quantity
Quantity Uom
Potential Action
Urgency of Action
Purpose of Action
Deficiency Photo1

30
S.F.
REPLACE
PRIORITY 5
LEVEL 6

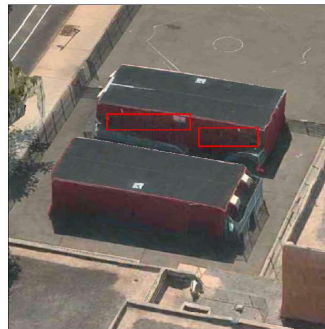
Elevation

Deficiency

DETERIORATED/TORN-OUT/MISSING

Deficiency Quantity
Quantity Uom

200
S.F.

Question	Response
EXTERIOR	
WINDOWS	
EXTERIOR GUARDS	
Potential Action	REPLACE
Urgency of Action	PRIORITY 4
Purpose of Action	LEVEL 2
Deficiency Photo1
