**NYC Department of Education
Building Condition Assessment Survey 2023-2024**

Architectural Inspection

R061

Asset: I.S. 61 - STATEN ISLAND, 445 CASTLETON AVENUE, STATEN ISLAND, NY, 10301

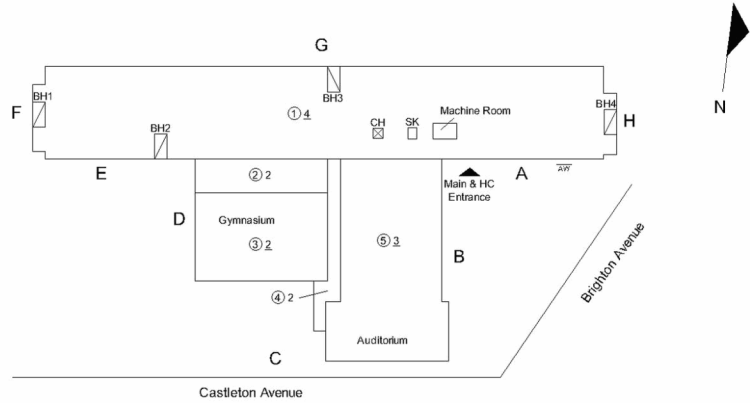
Question	Response
Architectural	
EXTERIOR	Inspected
AREAWAY	Inspected
Instance on AW1	Inspected
Instance Condition	2- Between Good and Fair
Instance Quantity	1
Instance Quantity Uom	EACH
Deficiency	AREAWAY WALLS:CRACKS AND SPALLING
Deficiency Location/Instance

Deficiency Quantity	5
Quantity Uom	S.F.
Potential Action	REPAIR
Urgency of Action	PRIORITY 3
Purpose of Action	LEVEL 2
Deficiency Photo 1
